Monticello Regional Airport

Pavement Management Report

JULY 2024

MONTICELLO REGIONAL AIRPORT PAVEMENT MANAGEMENT REPORT

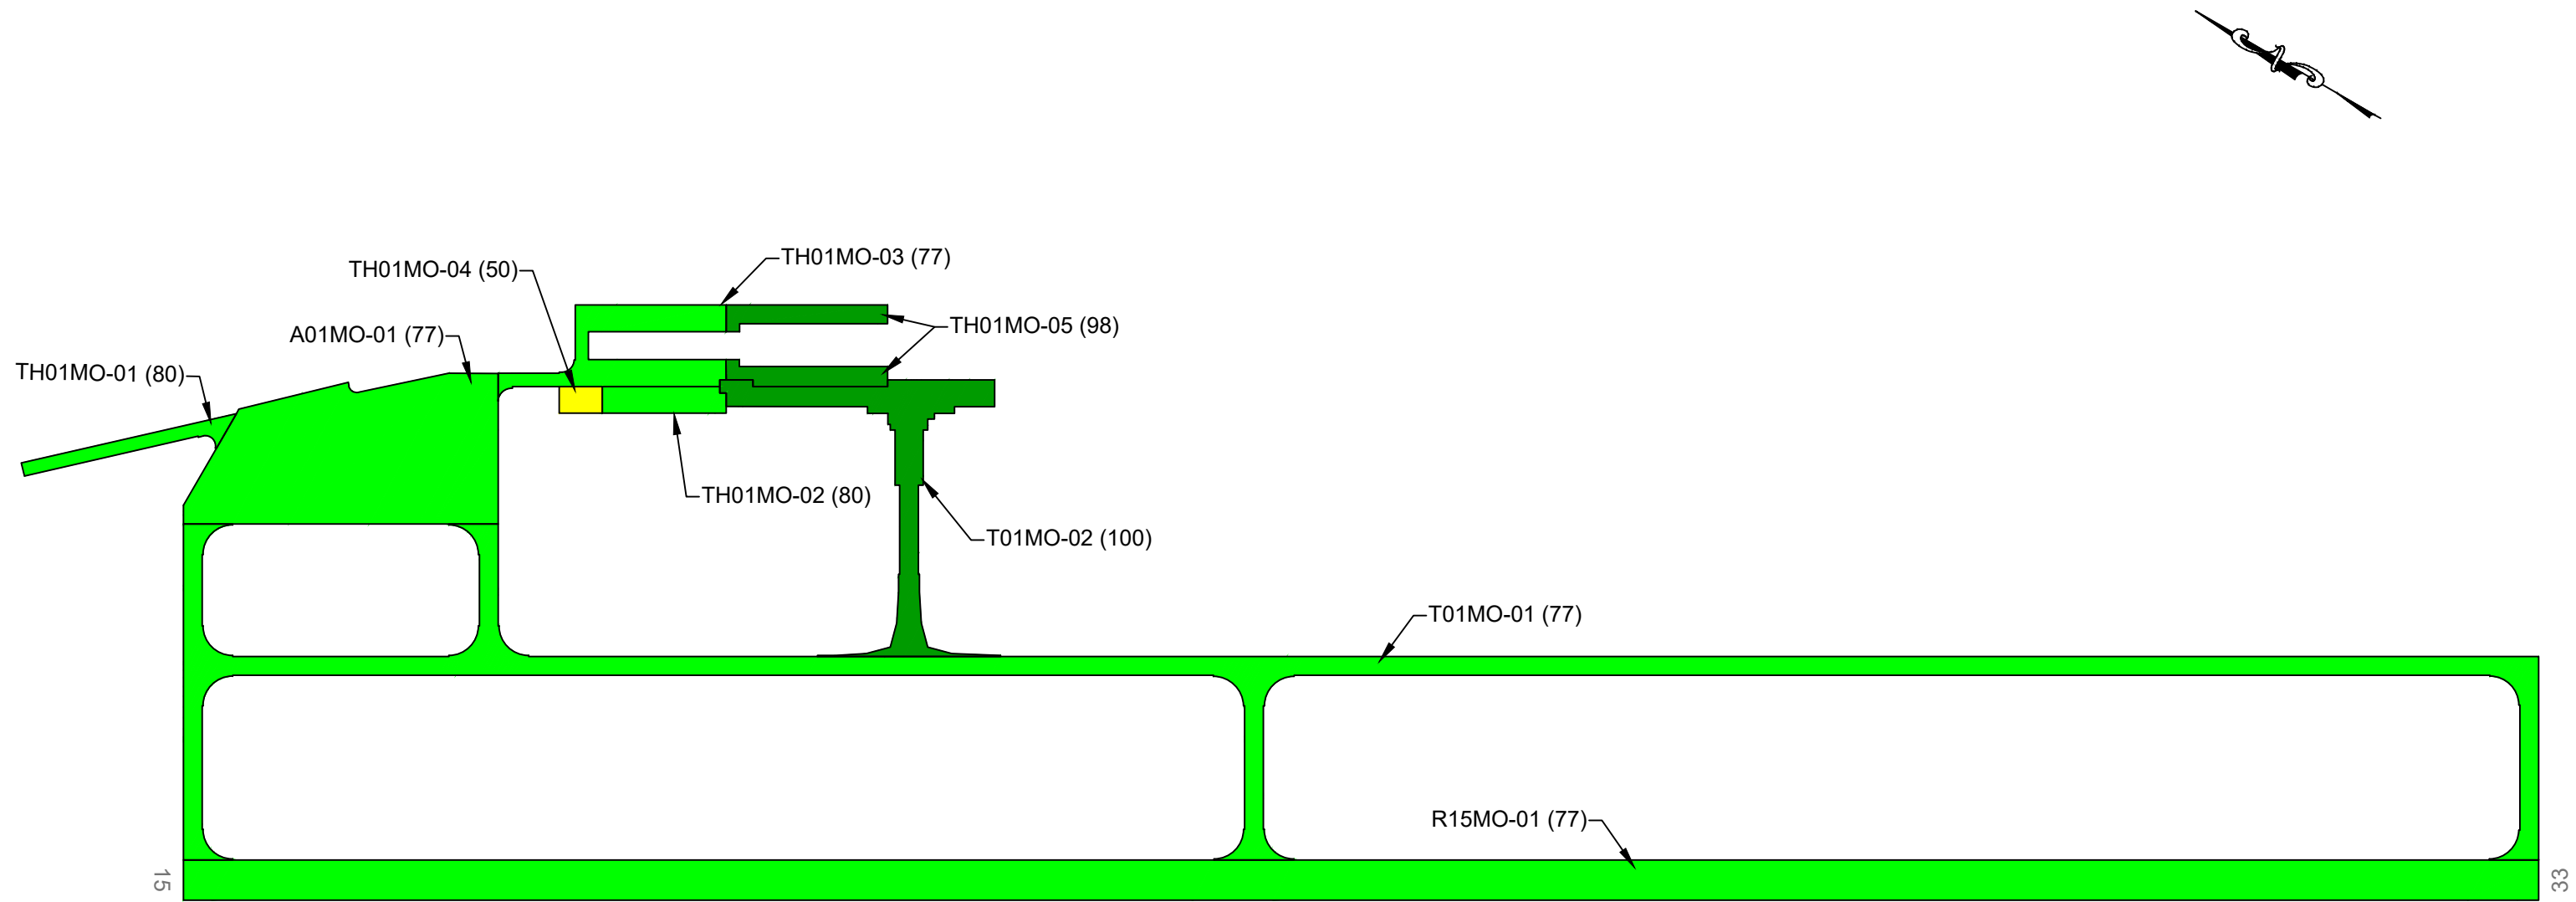
FIGURE 8. PCI MAP.

The pavements at Monticello Regional Airport were inspected in November 2023. The 2023 area-weighted condition of Monticello Regional Airport is 79, with conditions ranging from 50 to 100 (on a scale of 0 [failed] to 100 [excellent]). During the previous pavement inspection in 2020, the area-weighted PCI of the airport was 79.

Figure 6 summarizes the overall condition of the pavements at Monticello Regional Airport, and Figure 7 presents area-weighted condition (average PCI adjusted to account for the relative size of the pavement sections) by branch use. Figure 8 is a map that displays the condition of the evaluated pavements. Table 1 summarizes the results of the pavement evaluation. Appendix B presents photographs taken during the PCI inspection, and Appendix C contains detailed information on the distress types observed during the visual survey. Appendix D includes detailed work history information that was collected during the record review process.
