# Mount Pleasant Municipal Airport

## Pavement Management Report

**JULY 2024**

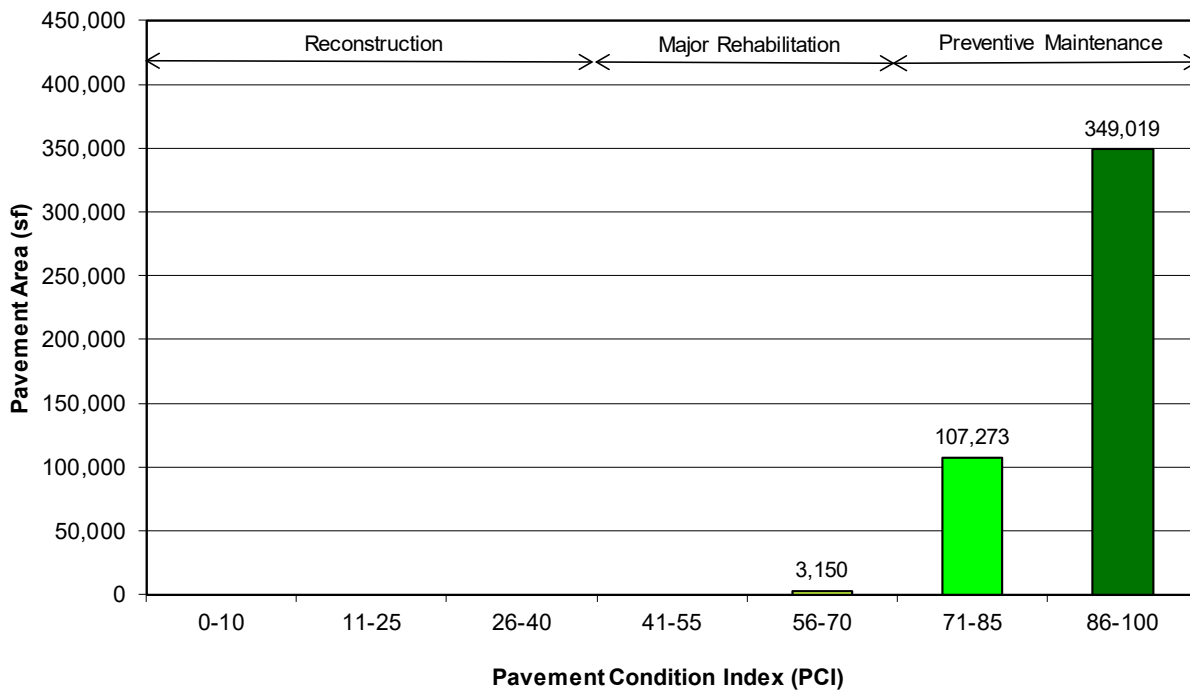
Figure 6. Pavement area by PCI range at Mount Pleasant Municipal Airport.

The pavements at Mount Pleasant Municipal Airport were inspected in November 2023. The 2023 area-weighted condition of Mount Pleasant Municipal Airport is 95, with conditions ranging from 61 to 100 (on a scale of 0 [failed] to 100 [excellent]). During the previous pavement inspection in 2020, the area-weighted PCI of the airport was 96.

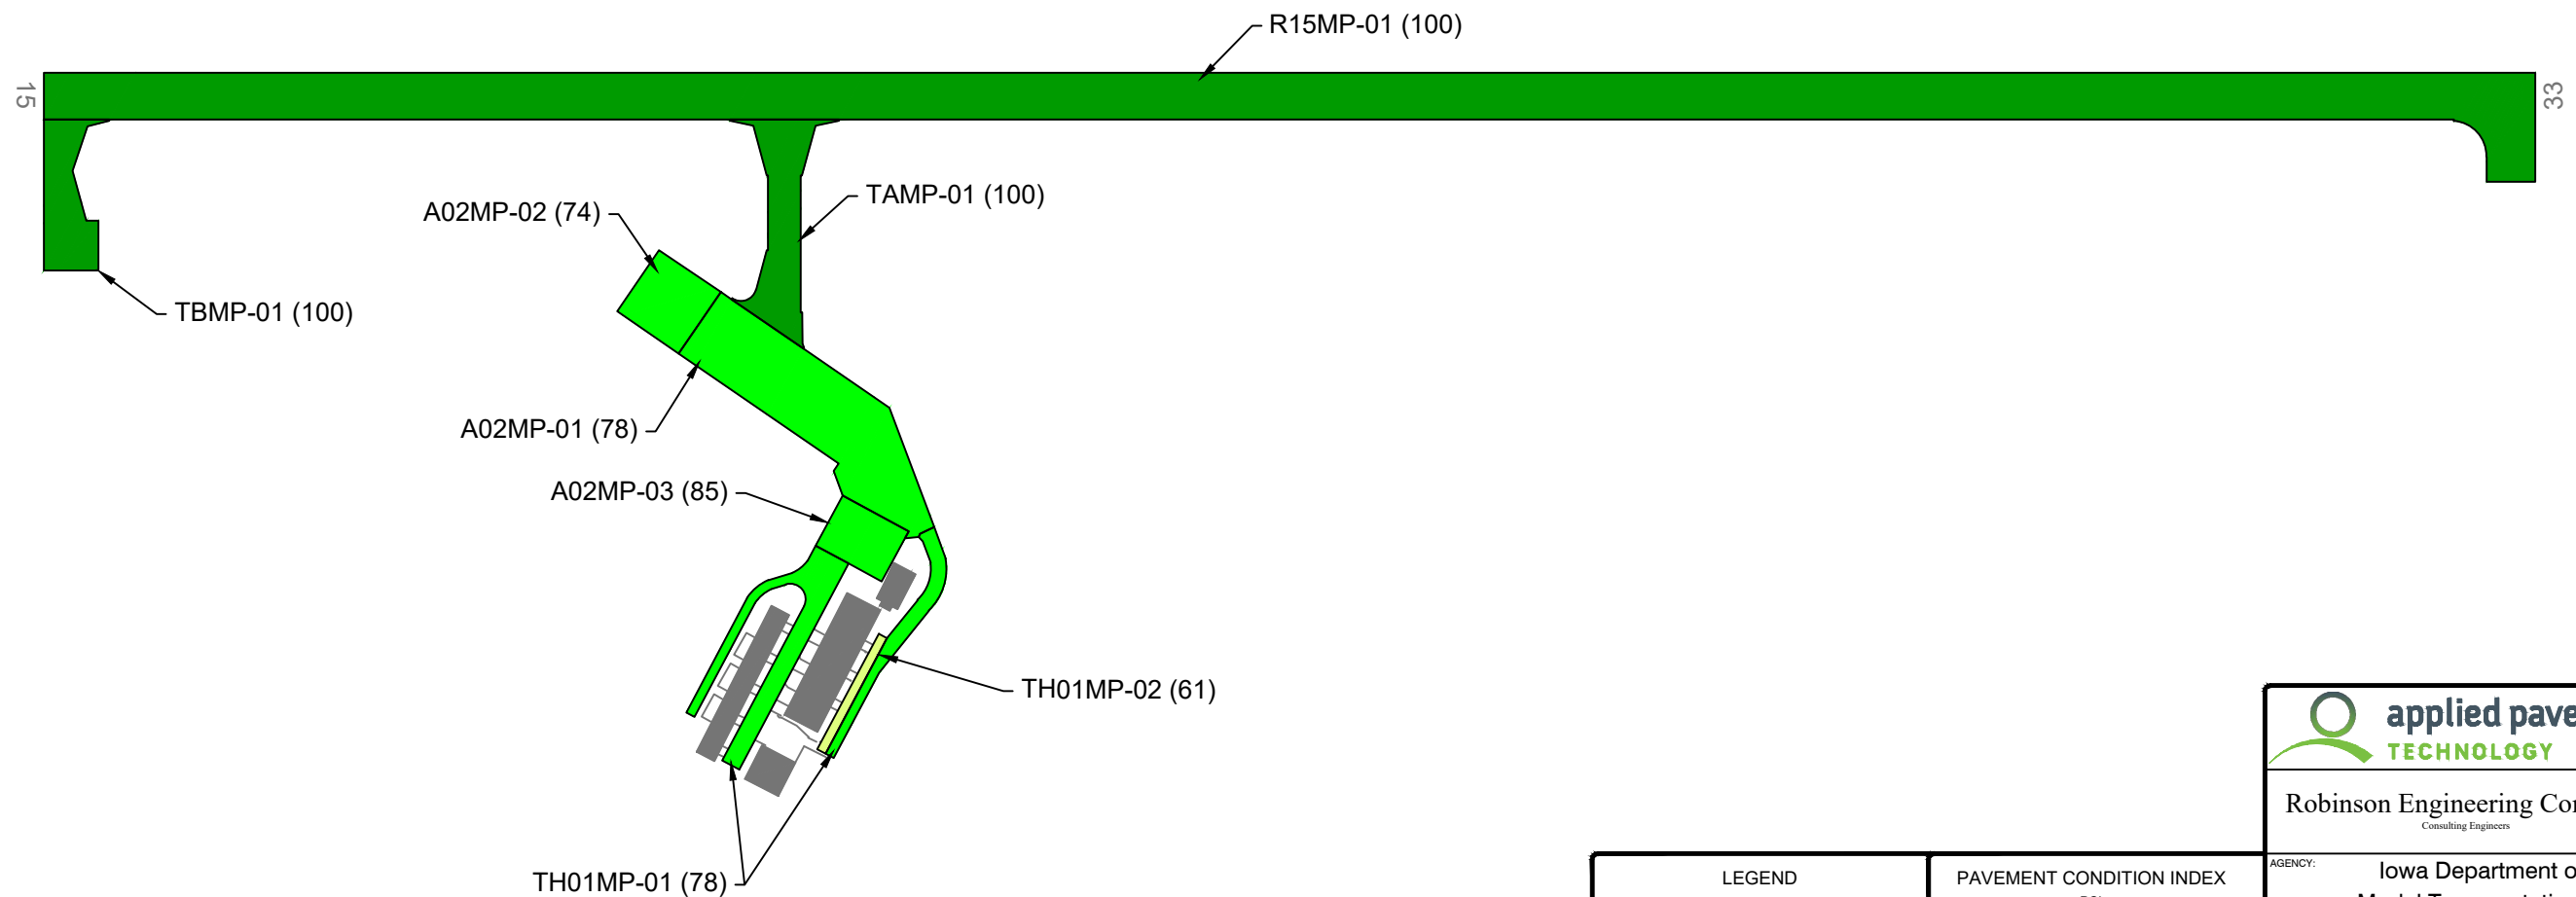
FIGURE 8. PCI MAP.

Figure 6 summarizes the overall condition of the pavements at Mount Pleasant Municipal Airport, and Figure 7 presents area-weighted condition (average PCI adjusted to account for the relative size of the pavement sections) by branch use. Figure 8 is a map that displays the condition of the evaluated pavements. Table 1 summarizes the results of the pavement evaluation. Appendix B presents photographs taken during the PCI inspection, and Appendix C contains detailed information on the distress types observed during the visual survey. Appendix D includes detailed work history information that was collected during the record review process.
