# Newton Municipal Airport– Earl Johnson Field

## PAVEMENT MANAGEMENT REPORT

**JULY 2022**

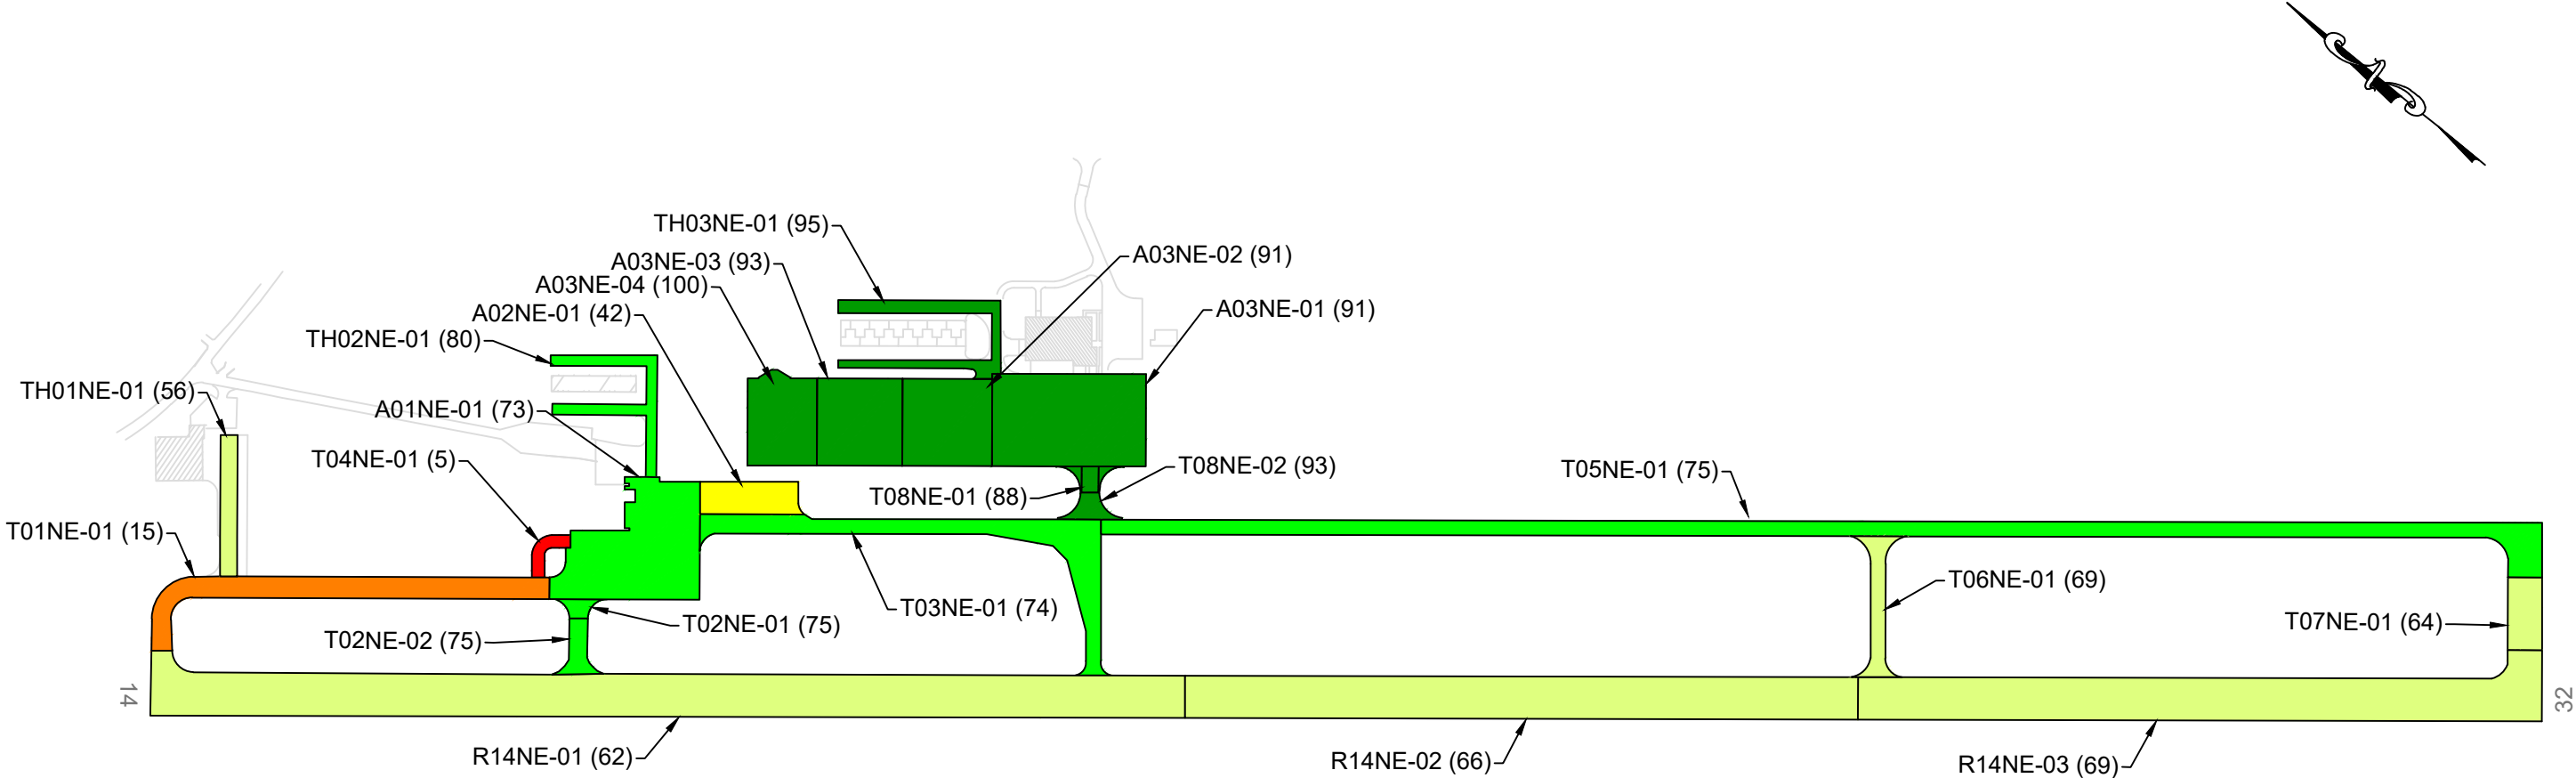
FIGURE 8. PCI MAP.

The pavements at Newton Municipal Airport-Earl Johnson Field were inspected in November 2021. The 2021 area-weighted condition of Newton Municipal Airport-Earl Johnson Field is 70, with conditions ranging from 5 to 100 (on a scale of 0 [failed] to 100 [excellent]). During the previous pavement inspection in 2018, the area-weighted PCI of the airport was 75.

Figure 6 summarizes the overall condition of the pavements at Newton Municipal Airport-Earl Johnson Field, and Figure 7 presents area-weighted condition (average PCI adjusted to account for the relative size of the pavement sections) by branch use. Figure 8 is a map that displays the condition of the evaluated pavements. Table 1 summarizes the results of the pavement evaluation. Appendix B presents photographs taken during the PCI inspection, and Appendix C contains detailed information on the distress types observed during the visual survey. Appendix D includes detailed work history information that was collected during the record review process.

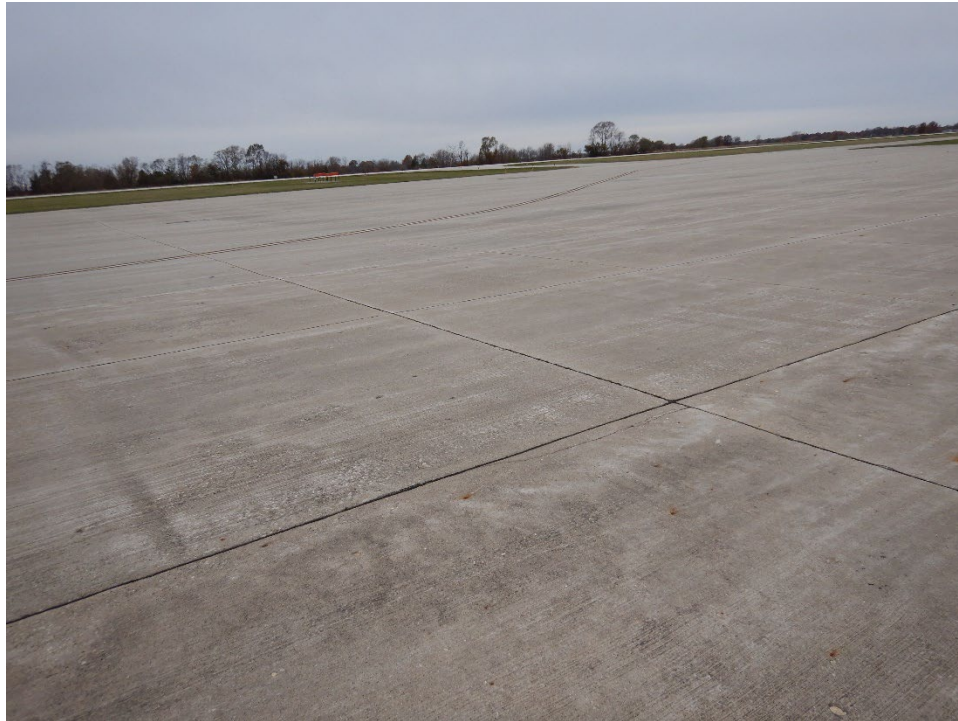
A01NE-01. Overview.

| Branch | Section | Surface Type | Section Area (sf) | LCD | 2021 PCI | % Distress Due to Load | % Distress Due to Climate/ Durability | % Distress Due to Other | Type of Distress |
|---|---|---|---|---|---|---|---|---|--|
| A01NE | 01 | PCC | 72,604 | 7/1/1989 | 73 | 28 | 31 | 41 | ASR, Corner Break, Corner Spalling, Faulting, Joint Spalling, Joint Seal Damage, Large Patch, LTD Cracking |

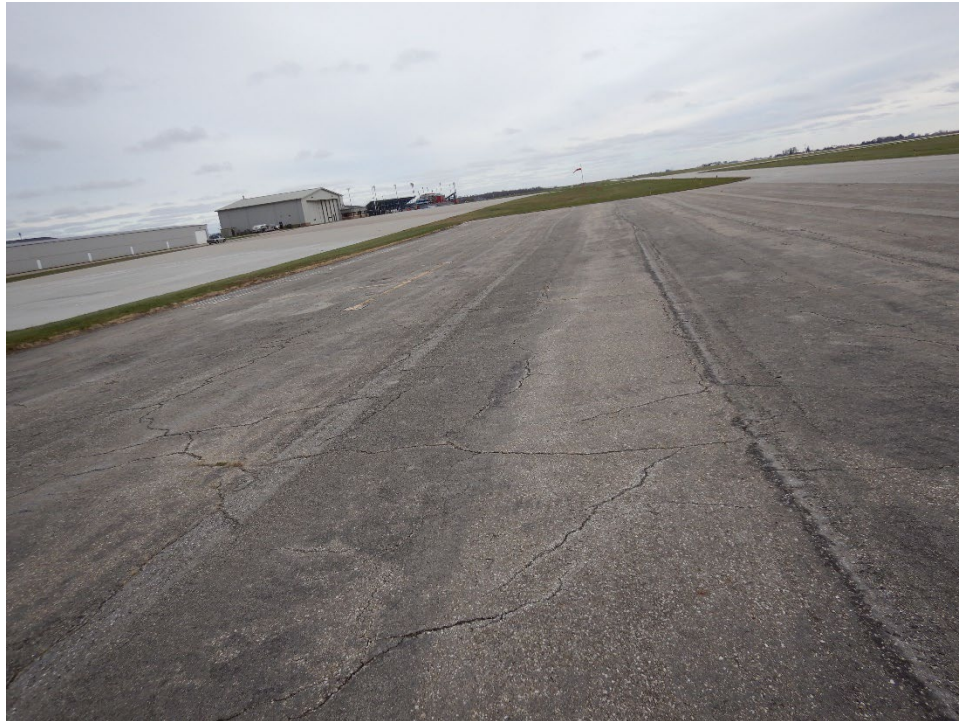
A02NE-01. Overview.

| Branch | Section | Surface Type | Section Area (sf) | LCD | 2021 PCI | % Distress Due to Load | % Distress Due to Climate/ Durability | % Distress Due to Other | Type of Distress |
|---|---|---|---|---|---|---|---|---|--|
| A02NE | 01 | AC | 17,641 | 7/1/1988 | 42 | 0 | 100 | 0 | Block Cracking, Weathering |

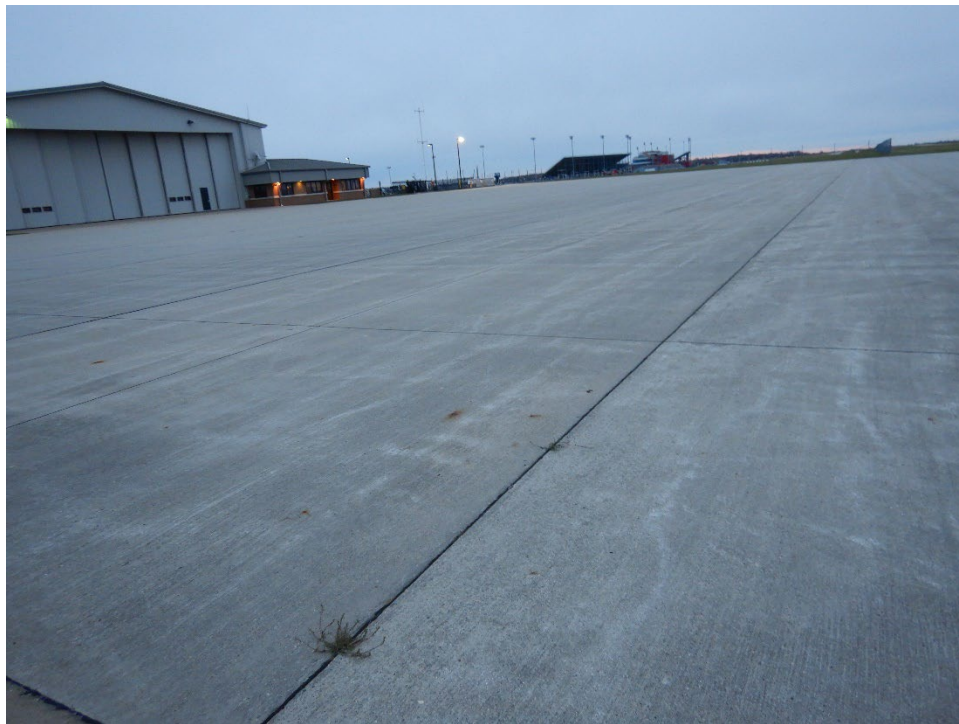
A03NE-01. Overview.

| Branch | Section | Surface Type | Section Area (sf) | LCD | 2021 PCI | % Distress Due to Load | % Distress Due to Climate/ Durability | % Distress Due to Other | Type of Distress |
|---|---|---|---|---|---|---|---|---|--|
| A03NE | 01 | PCC | 77,760 | 6/1/2003 | 91 | 0 | 44 | 56 | Corner Spalling, Joint Spalling, Joint Seal Damage, Large Patch |

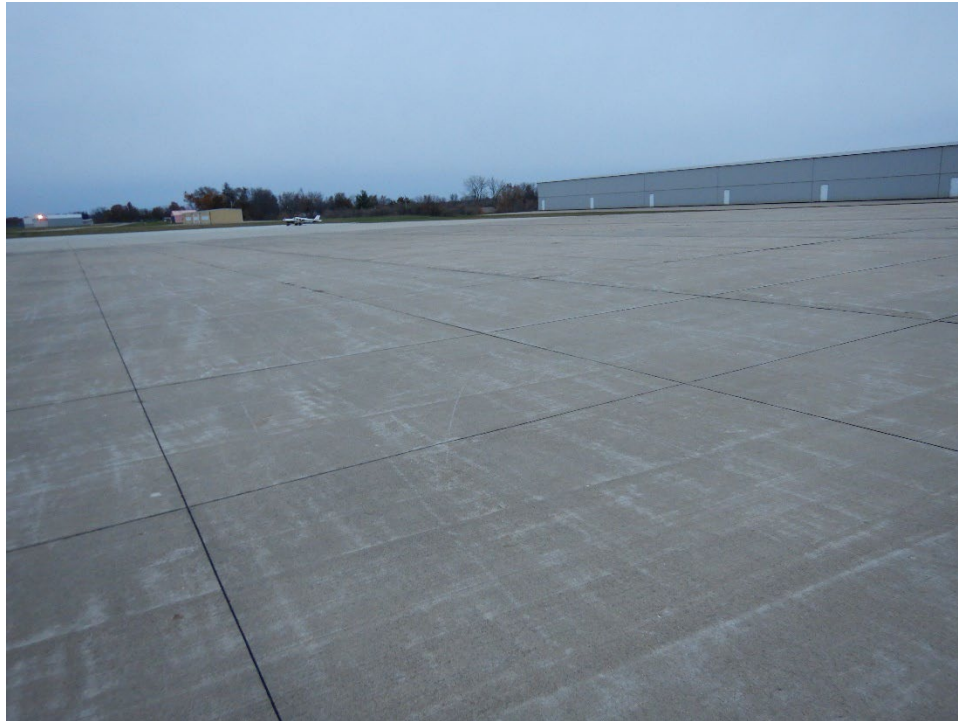
A03NE-02. Overview.

| Branch | Section | Surface Type | Section Area (sf) | LCD | 2021 PCI | % Distress Due to Load | % Distress Due to Climate/ Durability | % Distress Due to Other | Type of Distress |
|---|---|---|---|---|---|---|---|---|--|
| A03NE | 02 | PCC | 42,840 | 6/3/2010 | 91 | 0 | 80 | 20 | Faulting, Joint Seal Damage, Shrinkage Cracking |

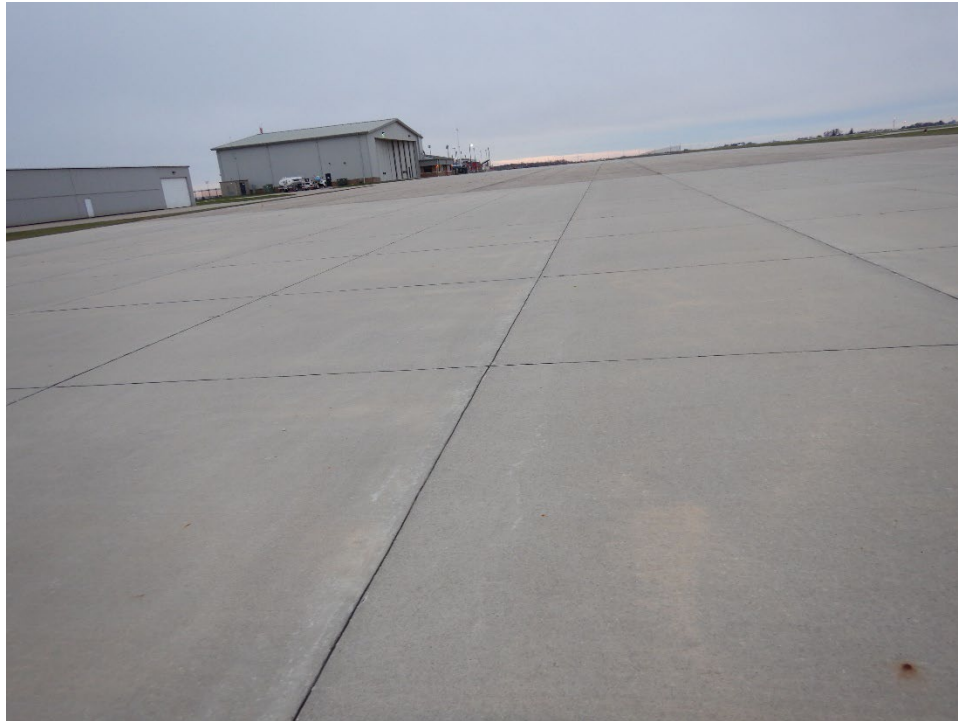
A03NE-03. Overview.

| Branch | Section | Surface Type | Section Area (sf) | LCD | 2021 PCI | % Distress Due to Load | % Distress Due to Climate/ Durability | % Distress Due to Other | Type of Distress |
|---|---|---|---|---|---|---|---|---|--|
| A03NE | 03 | PCC | 40,800 | 6/3/2013 | 93 | 0 | 100 | 0 | Joint Seal Damage |

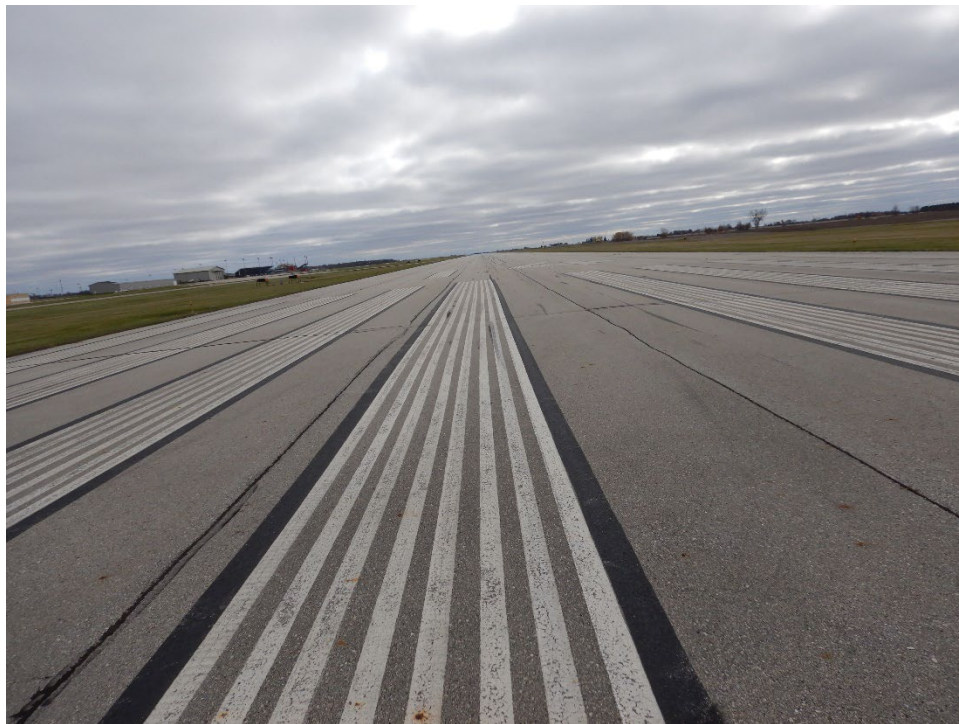
R14NE-01. Overview.

| Branch | Section | Surface Type | Section Area (sf) | LCD | 2021 PCI | % Distress Due to Load | % Distress Due to Climate/ Durability | % Distress Due to Other | Type of Distress |
|---|---|---|---|---|---|---|---|---|--|
| R14NE | 01 | AAC | 244,296 | 5/1/2010 | 62 | 0 | 100 | 0 | L&T Cracking, Weathering |

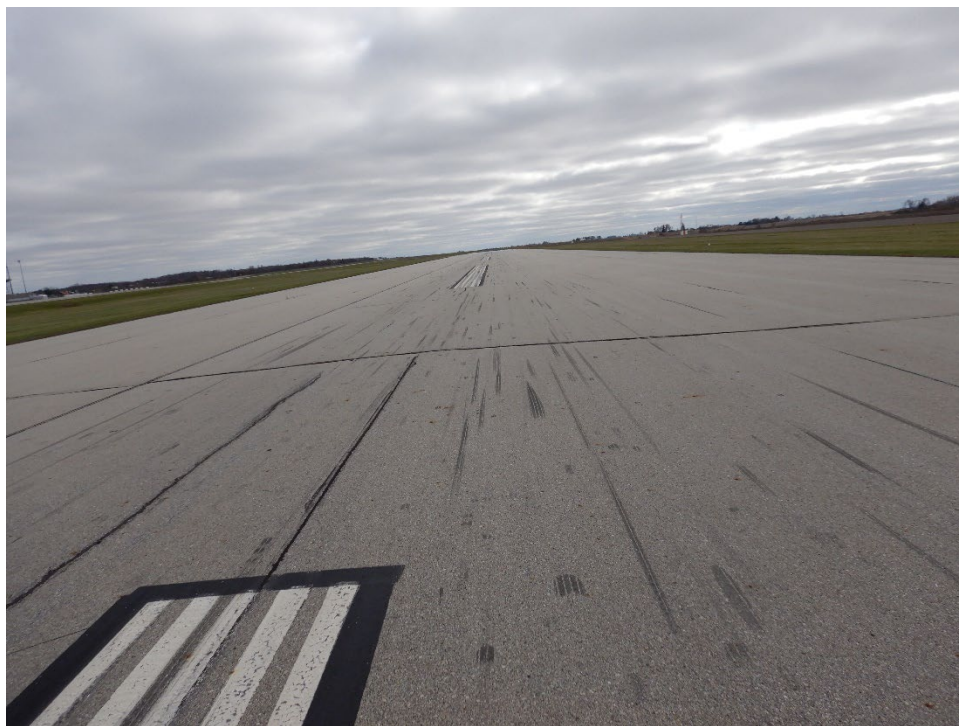
R14NE-02. Overview.

| Branch | Section | Surface Type | Section Area (sf) | LCD | 2021 PCI | % Distress Due to Load | % Distress Due to Climate/ Durability | % Distress Due to Other | Type of Distress |
|---|---|---|---|---|---|---|---|---|--|
| R14NE | 02 | AAC | 155,807 | 5/1/2010 | 66 | 0 | 100 | 0 | L&T Cracking, Weathering |

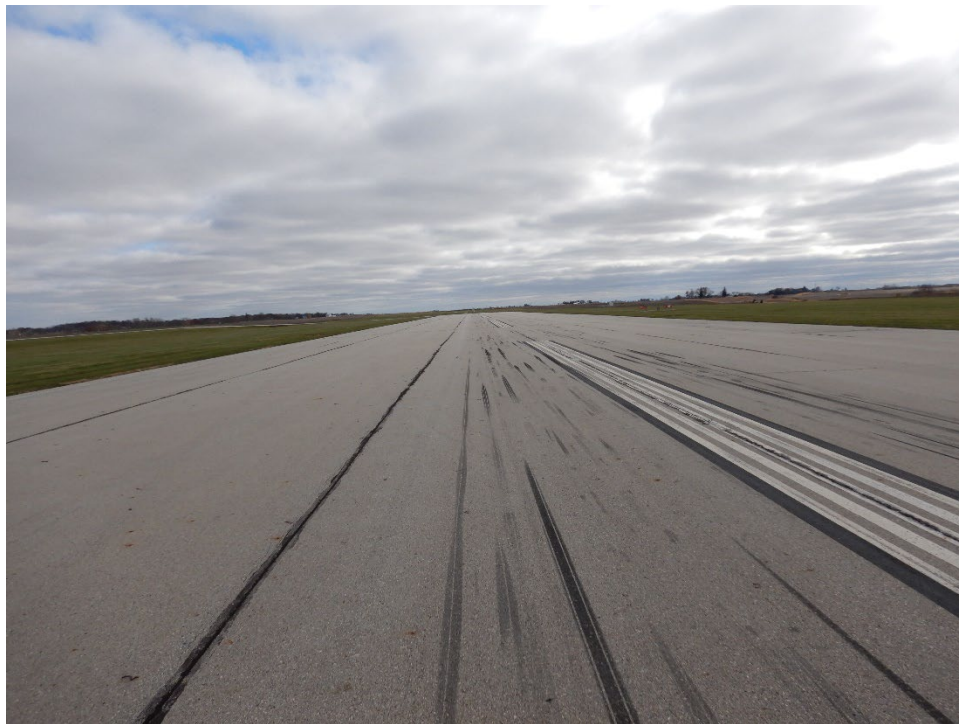
R14NE-03. Overview.

| Branch | Section | Surface Type | Section Area (sf) | LCD | 2021 PCI | % Distress Due to Load | % Distress Due to Climate/ Durability | % Distress Due to Other | Type of Distress |
|---|---|---|---|---|---|---|---|---|--|
| R14NE | 03 | AAC | 165,142 | 4/1/2010 | 69 | 0 | 100 | 0 | L&T Cracking, Weathering |

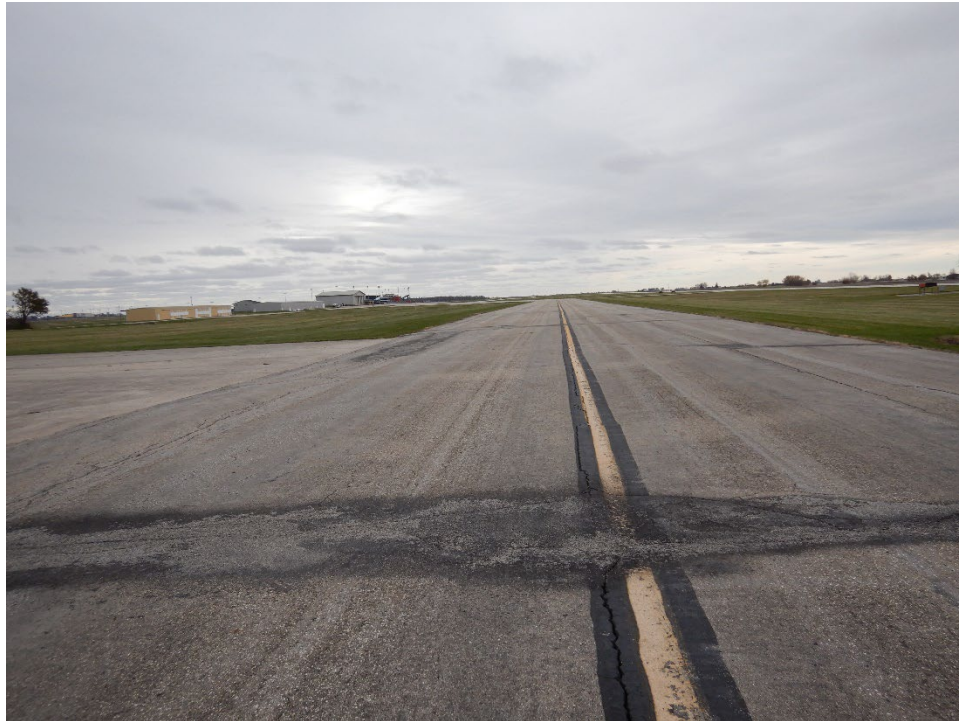
T01NE-01. Overview.

| Branch | Section | Surface Type | Section Area (sf) | LCD | 2021 PCI | % Distress Due to Load | % Distress Due to Climate/ Durability | % Distress Due to Other | Type of Distress |
|---|---|---|---|---|---|---|---|---|--|
| T01NE | 01 | AAC | 50,873 | 7/1/1988 | 15 | 35 | 65 | 0 | Alligator Cracking, L&T Cracking, Patching, Raveling, Weathering |

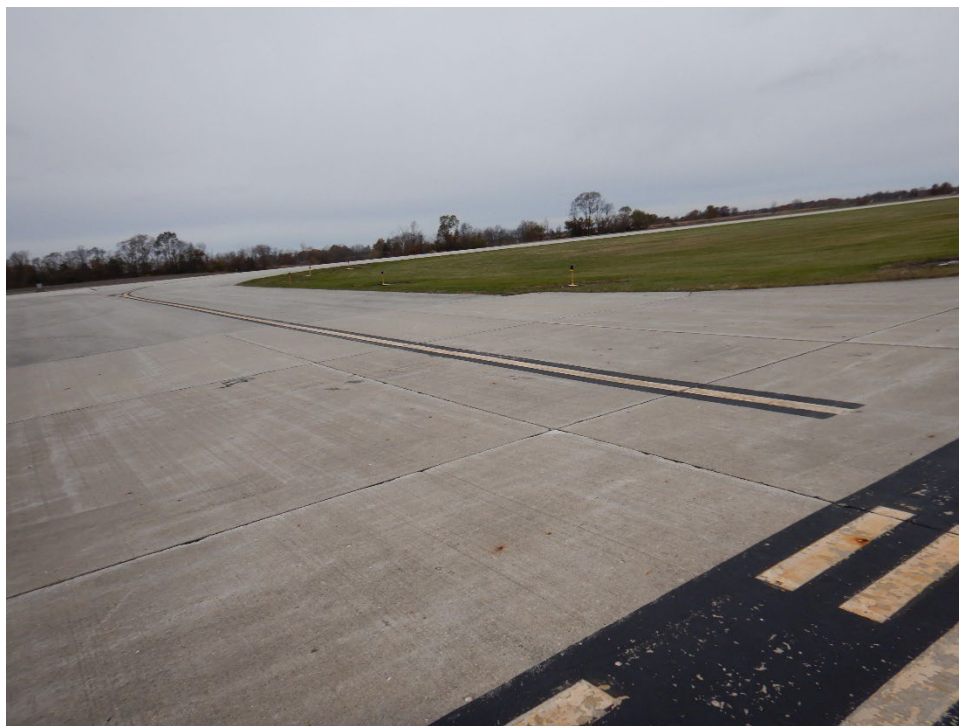
T02NE-01. Overview.

| Branch | Section | Surface Type | Section Area (sf) | LCD | 2021 PCI | % Distress Due to Load | % Distress Due to Climate/ Durability | % Distress Due to Other | Type of Distress |
|---|---|---|---|---|---|---|---|---|--|
| T02NE | 01 | PCC | 2,799 | 7/1/1989 | 75 | 13 | 39 | 48 | Corner Spalling, Faulting, Joint Seal Damage, LTD Cracking, Shrinkage Cracking |

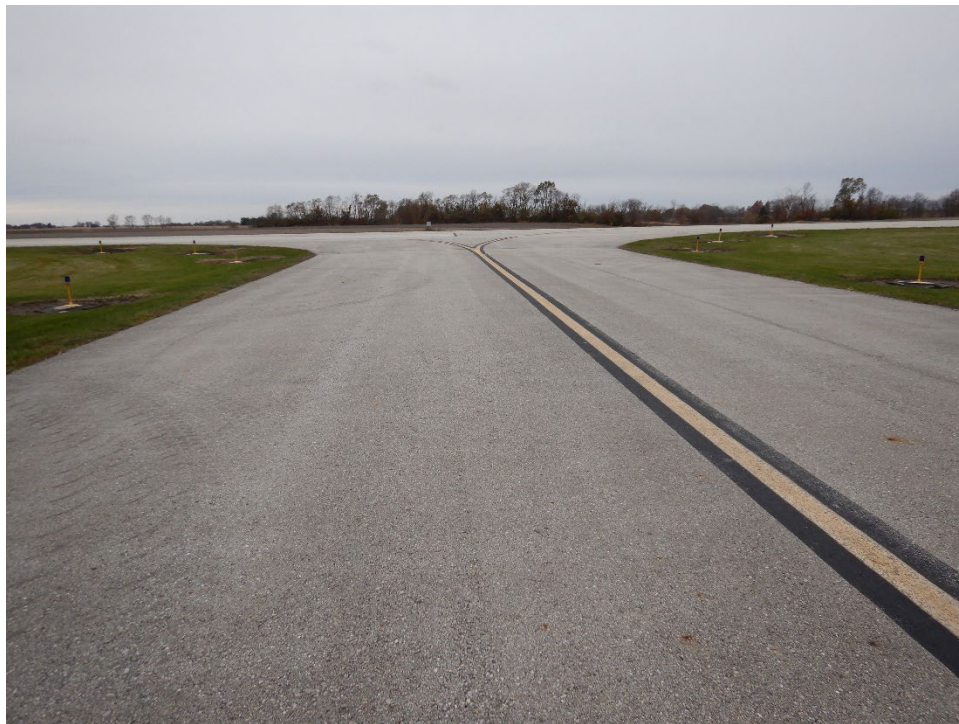
T02NE-02. Overview.

| Branch | Section | Surface Type | Section Area (sf) | LCD | 2021 PCI | % Distress Due to Load | % Distress Due to Climate/ Durability | % Distress Due to Other | Type of Distress |
|---|---|---|---|---|---|---|---|---|--|
| T02NE | 02 | AAC | 6,629 | 4/1/2010 | 75 | 0 | 100 | 0 | L&T Cracking, Weathering |

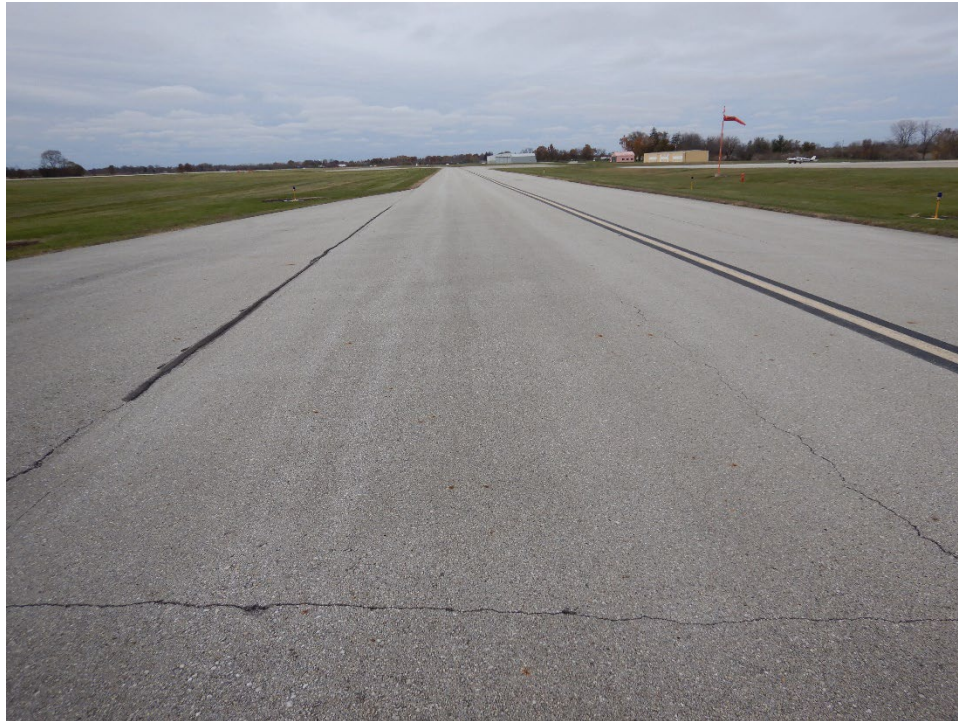
T03NE-01. Overview.

| Branch | Section | Surface Type | Section Area (sf) | LCD | 2021 PCI | % Distress Due to Load | % Distress Due to Climate/ Durability | % Distress Due to Other | Type of Distress |
|---|---|---|---|---|---|---|---|---|--|
| T03NE | 01 | AAC | 57,618 | 4/1/2010 | 74 | 0 | 100 | 0 | L&T Cracking, Weathering |

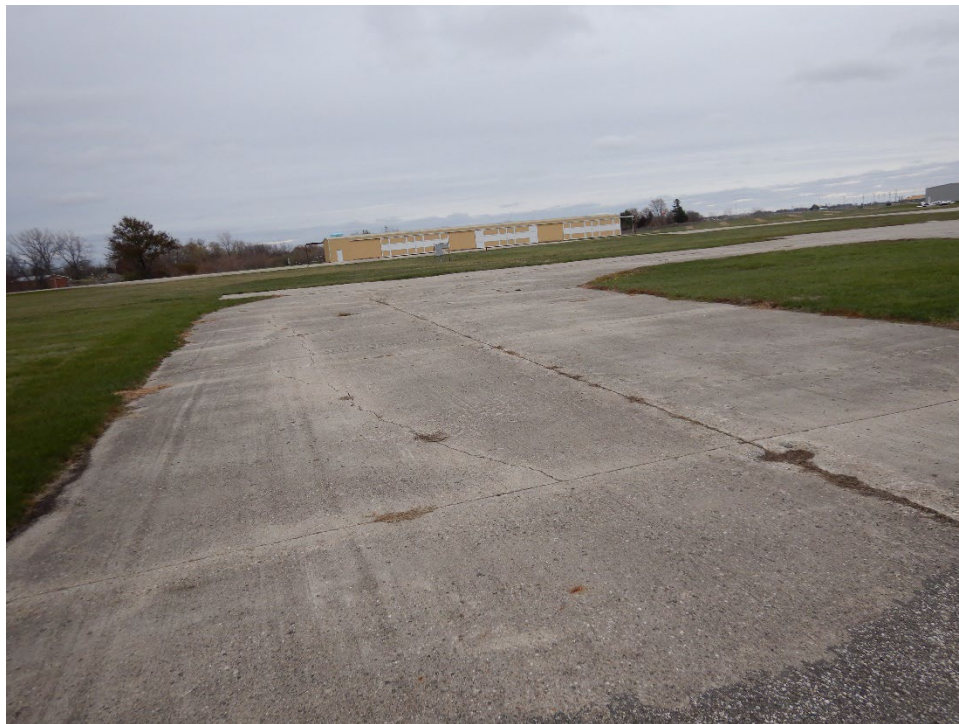
T04NE-01. Overview.

| Branch | Section | Surface Type | Section Area (sf) | LCD | 2021 PCI | % Distress Due to Load | % Distress Due to Climate/ Durability | % Distress Due to Other | Type of Distress |
|---|---|---|---|---|---|---|---|---|--|
| T04NE | 01 | PCC | 4,324 | 7/1/1955 | 5 | 53 | 6 | 41 | Corner Break, Corner Spalling, Joint Spalling, Joint Seal Damage, LTD Cracking, Popouts, Scaling, Shattered Slab |

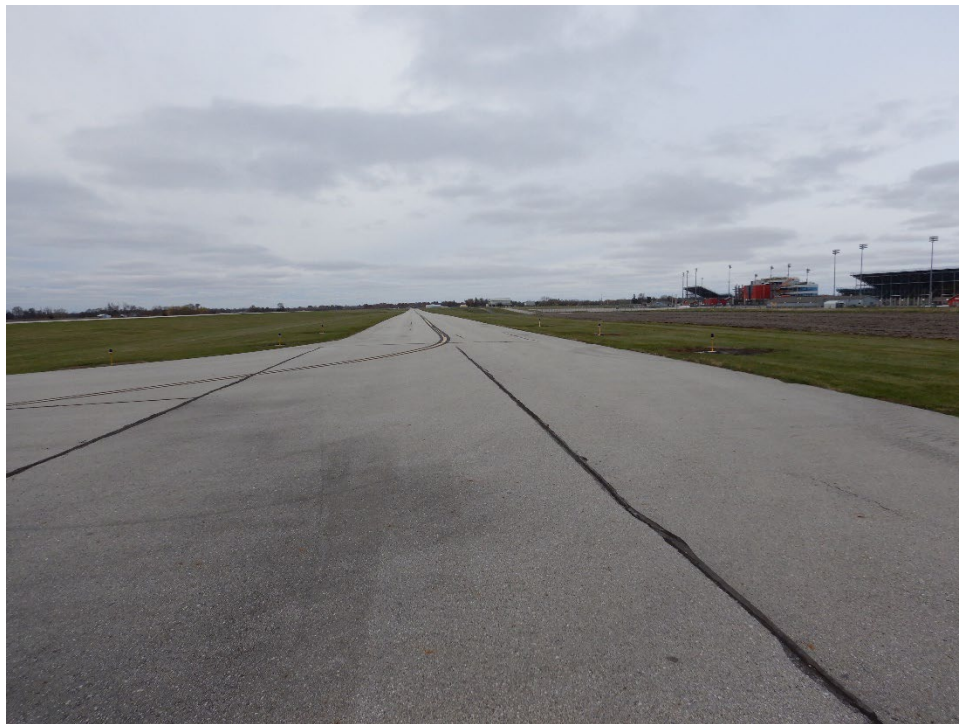
T05NE-01. Overview.

| Branch | Section | Surface Type | Section Area (sf) | LCD | 2021 PCI | % Distress Due to Load | % Distress Due to Climate/ Durability | % Distress Due to Other | Type of Distress |
|---|---|---|---|---|---|---|---|---|--|
| T05NE | 01 | AAC | 126,127 | 4/1/2010 | 75 | 0 | 100 | 0 | L&T Cracking, Weathering |

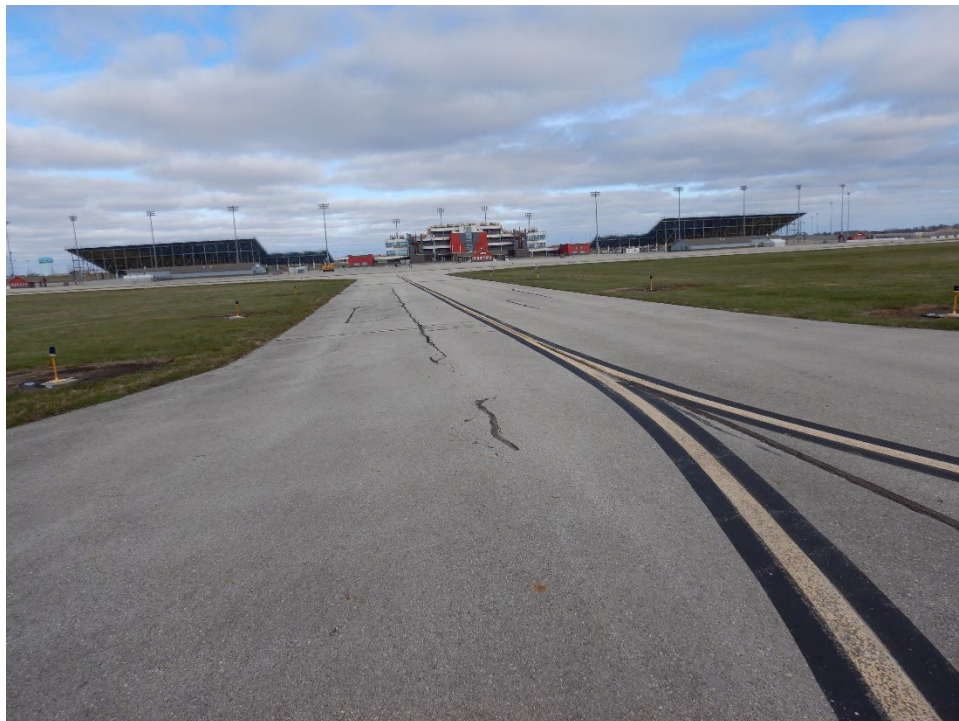
T06NE-01. Overview.

| Branch | Section | Surface Type | Section Area (sf) | LCD | 2021 PCI | % Distress Due to Load | % Distress Due to Climate/ Durability | % Distress Due to Other | Type of Distress |
|---|---|---|---|---|---|---|---|---|--|
| T06NE | 01 | AAC | 14,033 | 4/1/2010 | 69 | 0 | 100 | 0 | L&T Cracking, Weathering |

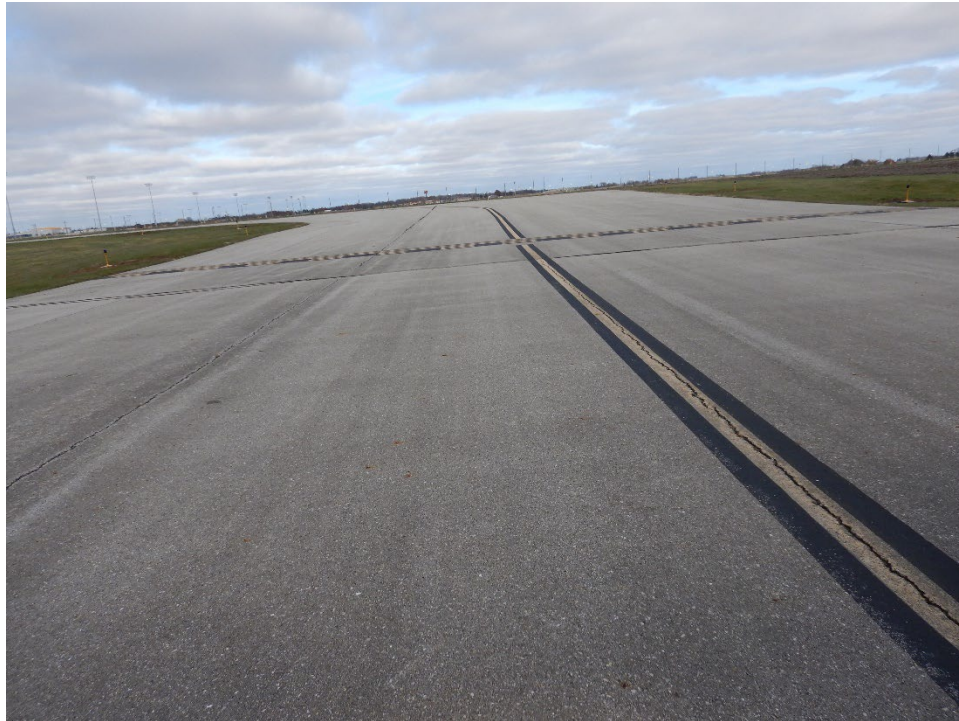
T07NE-01. Overview.

| Branch | Section | Surface Type | Section Area (sf) | LCD | 2021 PCI | % Distress Due to Load | % Distress Due to Climate/Durability | % Distress Due to Other | Type of Distress |
|---|---|---|---|---|---|---|---|---|---|
| T07NE | 01 | AAC | 13,745 | 4/1/2010 | 64 | 0 | 99 | 1 | Depression, L&T Cracking, Raveling, Weathering |

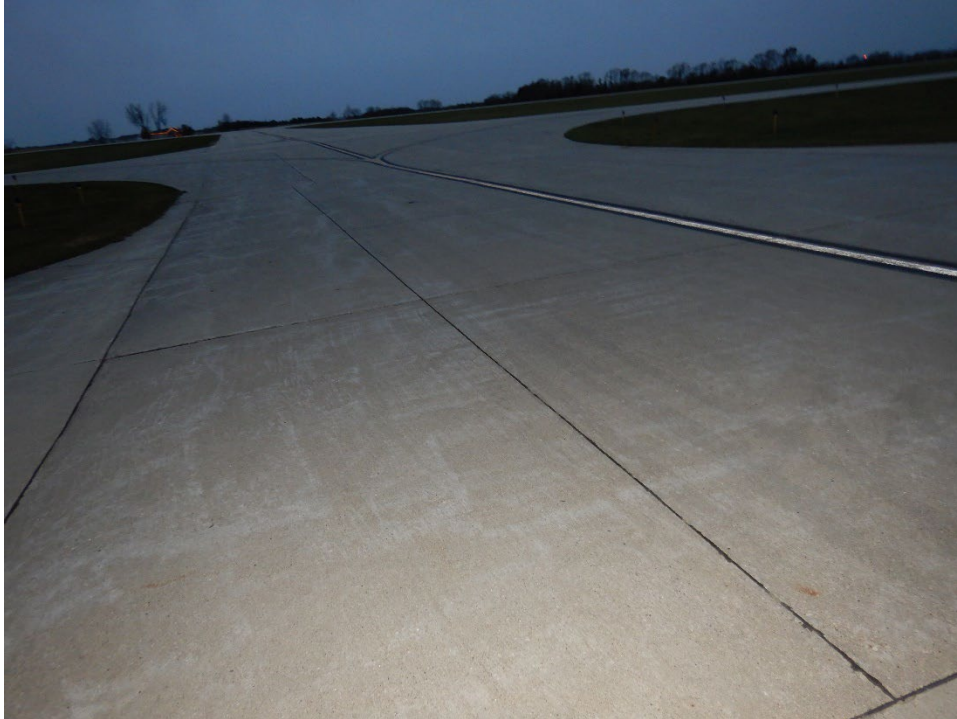
T08NE-01. Overview.

| Branch | Section | Surface Type | Section Area (sf) | LCD | 2021 PCI | % Distress Due to Load | % Distress Due to Climate/Durability | % Distress Due to Other | Type of Distress |
|---|---|---|---|---|---|---|---|---|---|
| T08NE | 01 | PCC | 2,465 | 6/1/2003 | 88 | 0 | 59 | 41 | Corner Spalling, Joint Seal Damage |

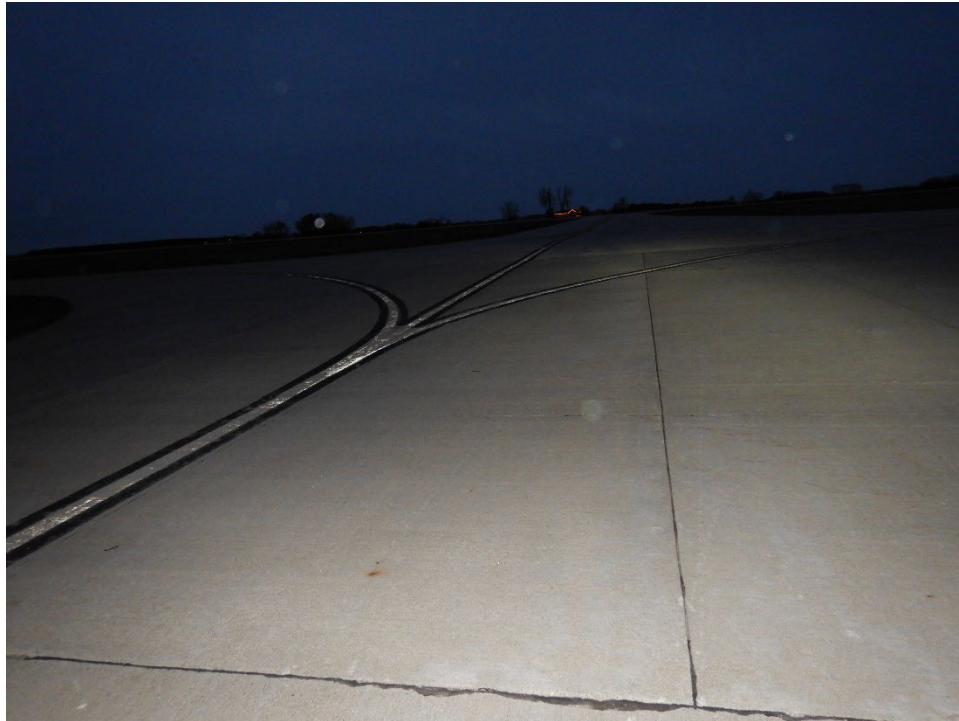
T08NE-02. Overview.

| Branch | Section | Surface Type | Section Area (sf) | LCD | 2021 PCI | % Distress Due to Load | % Distress Due to Climate/Durability | % Distress Due to Other | Type of Distress |
|---|---|---|---|---|---|---|---|---|---|
| T08NE | 02 | PCC | 6,461 | 4/3/2010 | 93 | 0 | 100 | 0 | Joint Seal Damage |

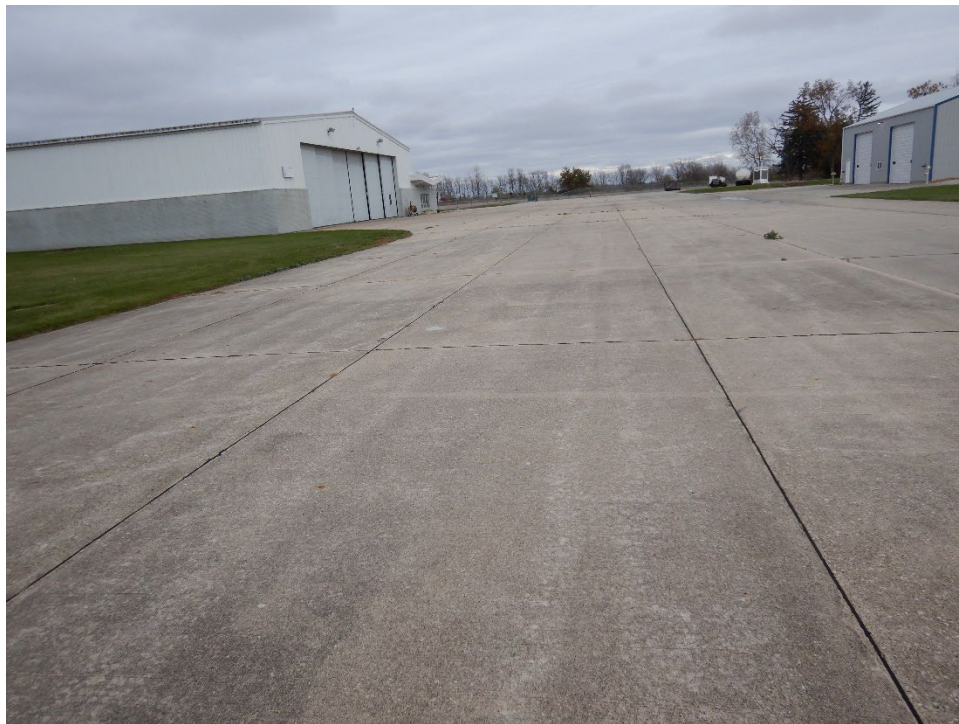
TH01NE-01. Overview.

| Branch | Section | Surface Type | Section Area (sf) | LCD | 2021 PCI | % Distress Due to Load | % Distress Due to Climate/Durability | % Distress Due to Other | Type of Distress |
|---|---|---|---|---|---|---|---|---|---|
| TH01NE | 01 | PCC | 13,225 | 1/1/1970 | 56 | 36 | 26 | 38 | ASR, Corner Spalling, Joint Spalling, Joint Seal Damage, LTD Cracking, Shrinkage Cracking |

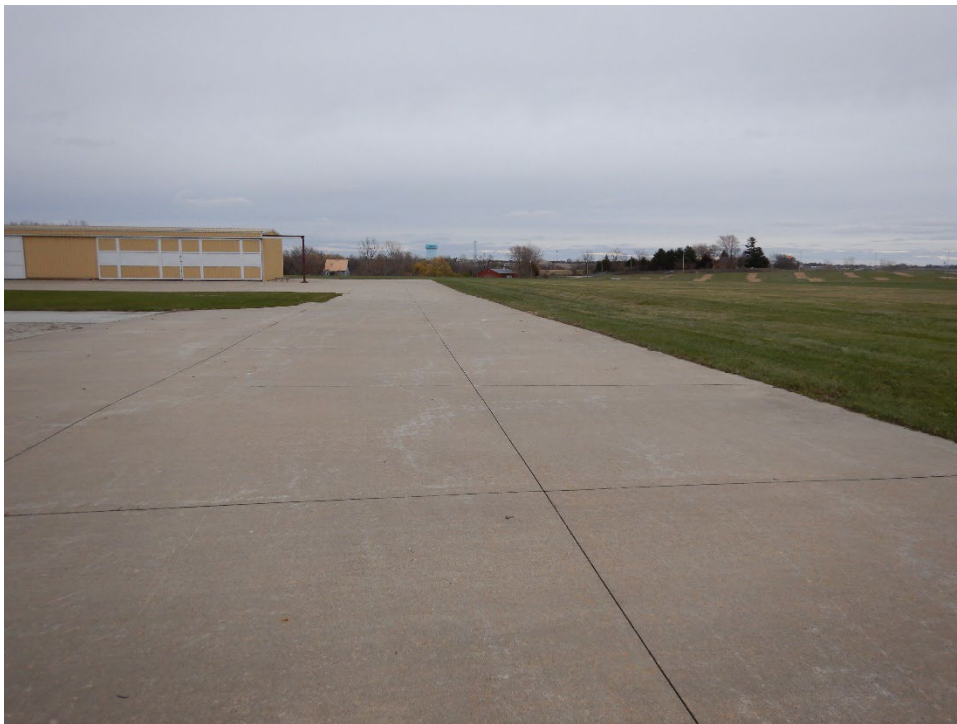
TH02NE-01. Overview.

| Branch | Section | Surface Type | Section Area (sf) | LCD | 2021 PCI | % Distress Due to Load | % Distress Due to Climate/Durability | % Distress Due to Other | Type of Distress |
|---|---|---|---|---|---|---|---|---|---|
| TH02NE | 01 | PCC | 18,201 | 7/3/2011 | 80 | 53 | 28 | 19 | Faulting, Joint Seal Damage, LTD Cracking, Shrinkage Cracking, Small Patch |

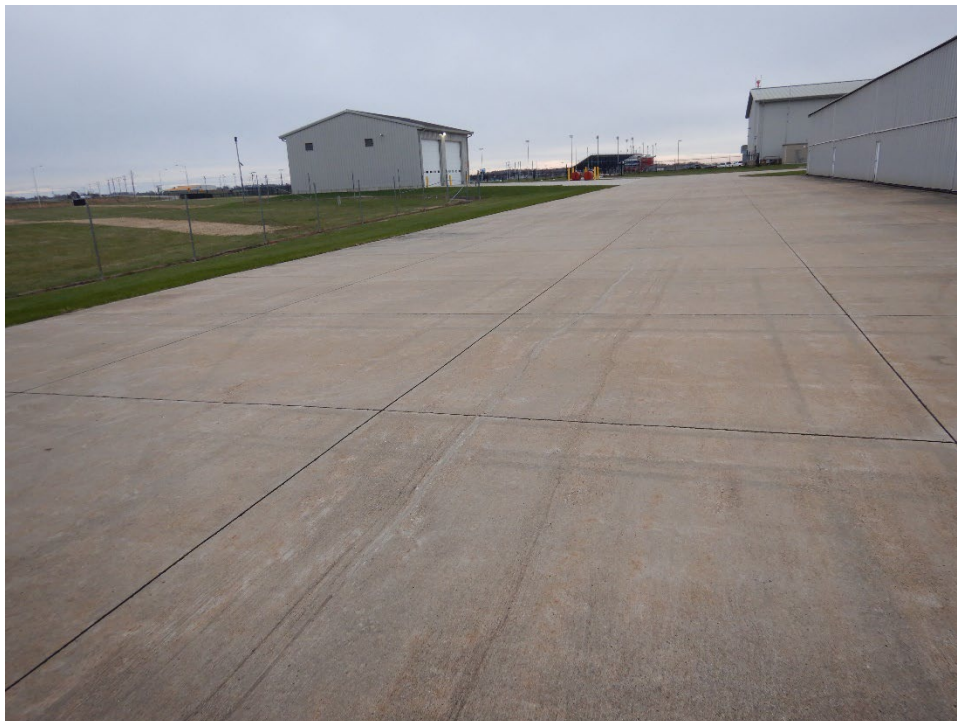
TH03NE-01. Overview.

| Branch | Section | Surface Type | Section Area (sf) | LCD | 2021 PCI | % Distress Due to Load | % Distress Due to Climate/Durability | % Distress Due to Other | Type of Distress |
|---|---|---|---|---|---|---|---|---|---|
| TH03NE | 01 | PCC | 22,244 | 5/3/2005 | 95 | 18 | 33 | 49 | Faulting, Joint Spalling, Joint Seal Damage, LTD Cracking, Shrinkage Cracking |
