Oelwein Municipal Airport

Pavement Management Report

JULY 2023

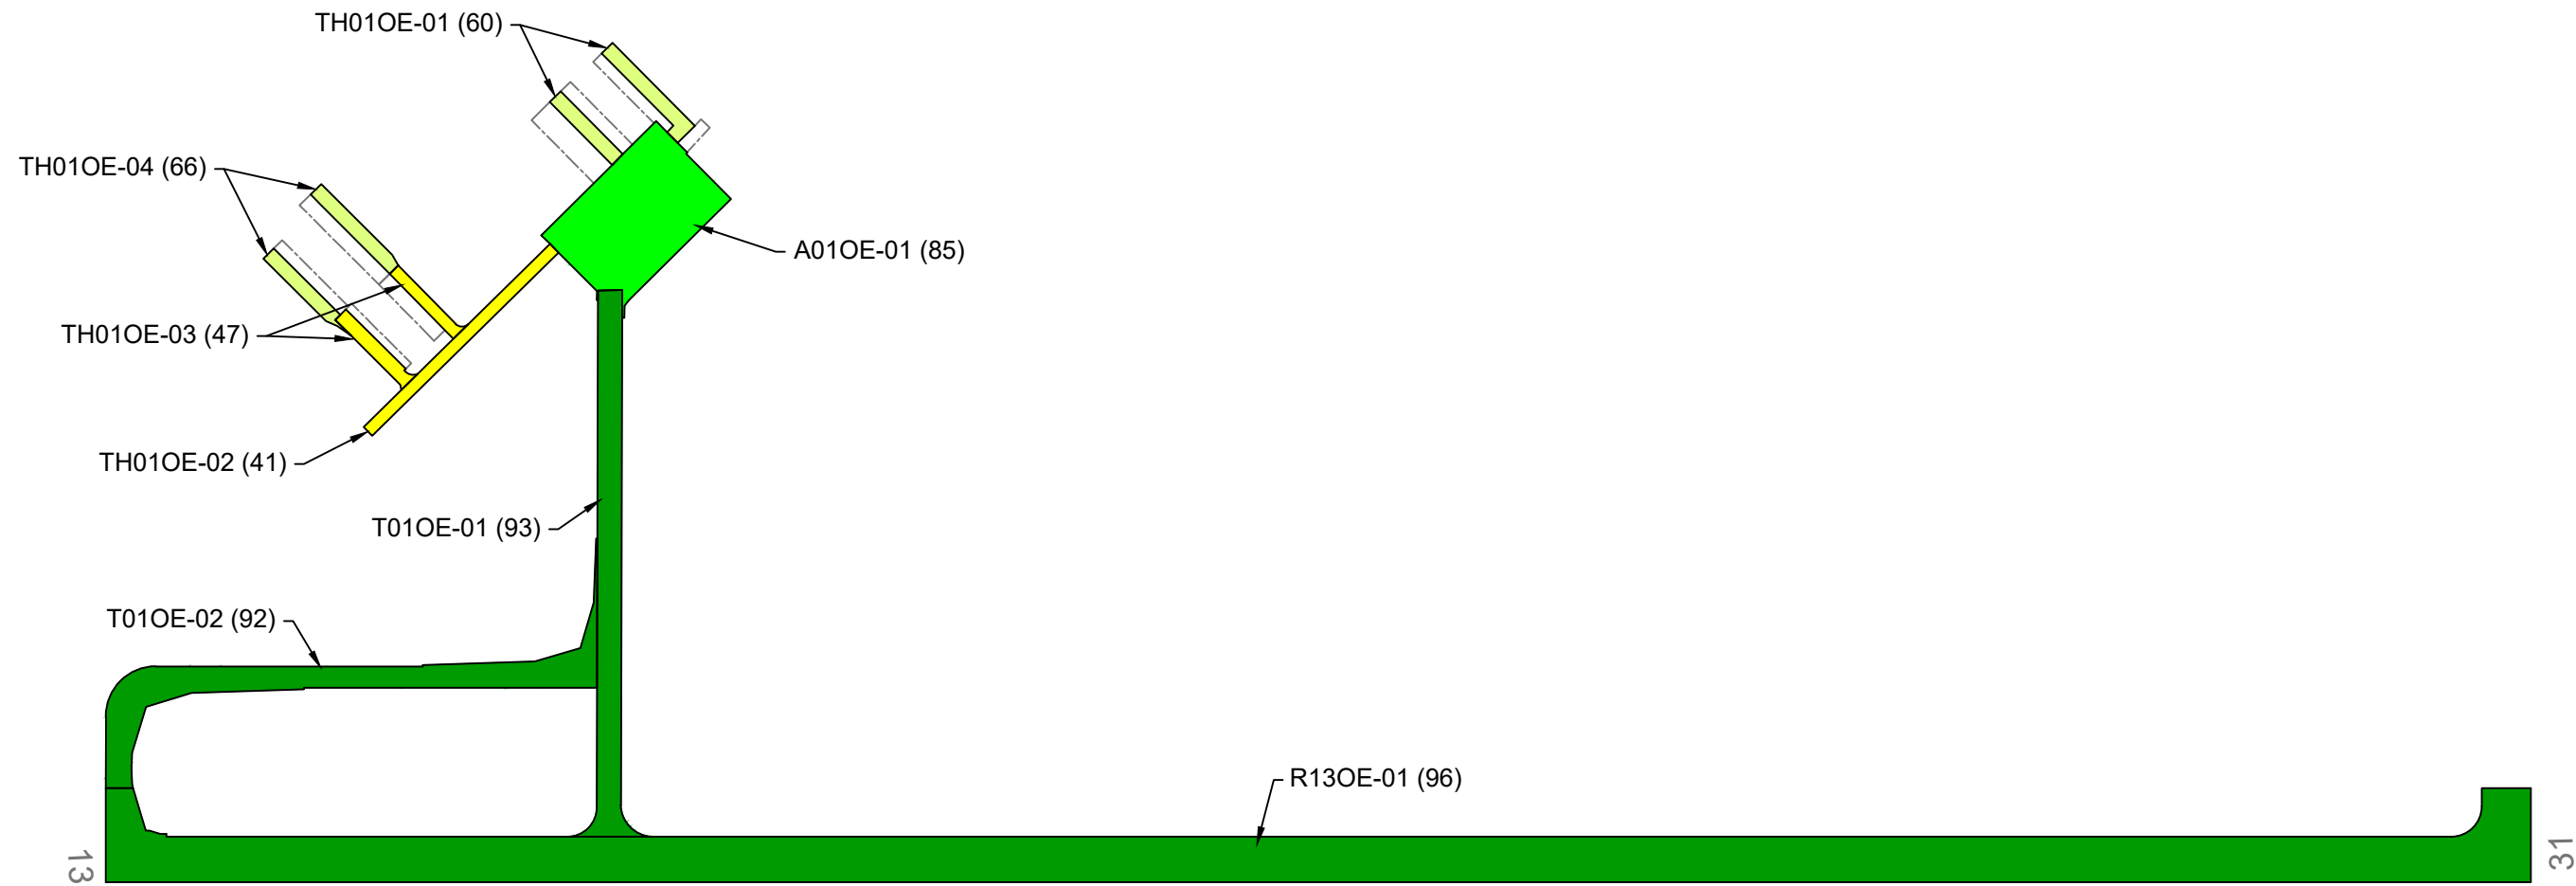
FIGURE 8. PCI MAP.

The pavements at Oelwein Municipal Airport were inspected in November 2022. The 2022 area-weighted condition of Oelwein Municipal Airport is 91, with conditions ranging from 41 to 96 (on a scale of 0 [failed] to 100 [excellent]). During the previous pavement inspection in 2019, the area-weighted PCI of the airport was 91.

Runway 13/31 contained one section. Section 01 was in excellent condition with low-severity corner spalling, faulting, joint spalling, large patching, and small patching noted during the inspection.
