# Osceola Municipal Airport

**PAVEMENT MANAGEMENT REPORT**

**AUGUST 2019**

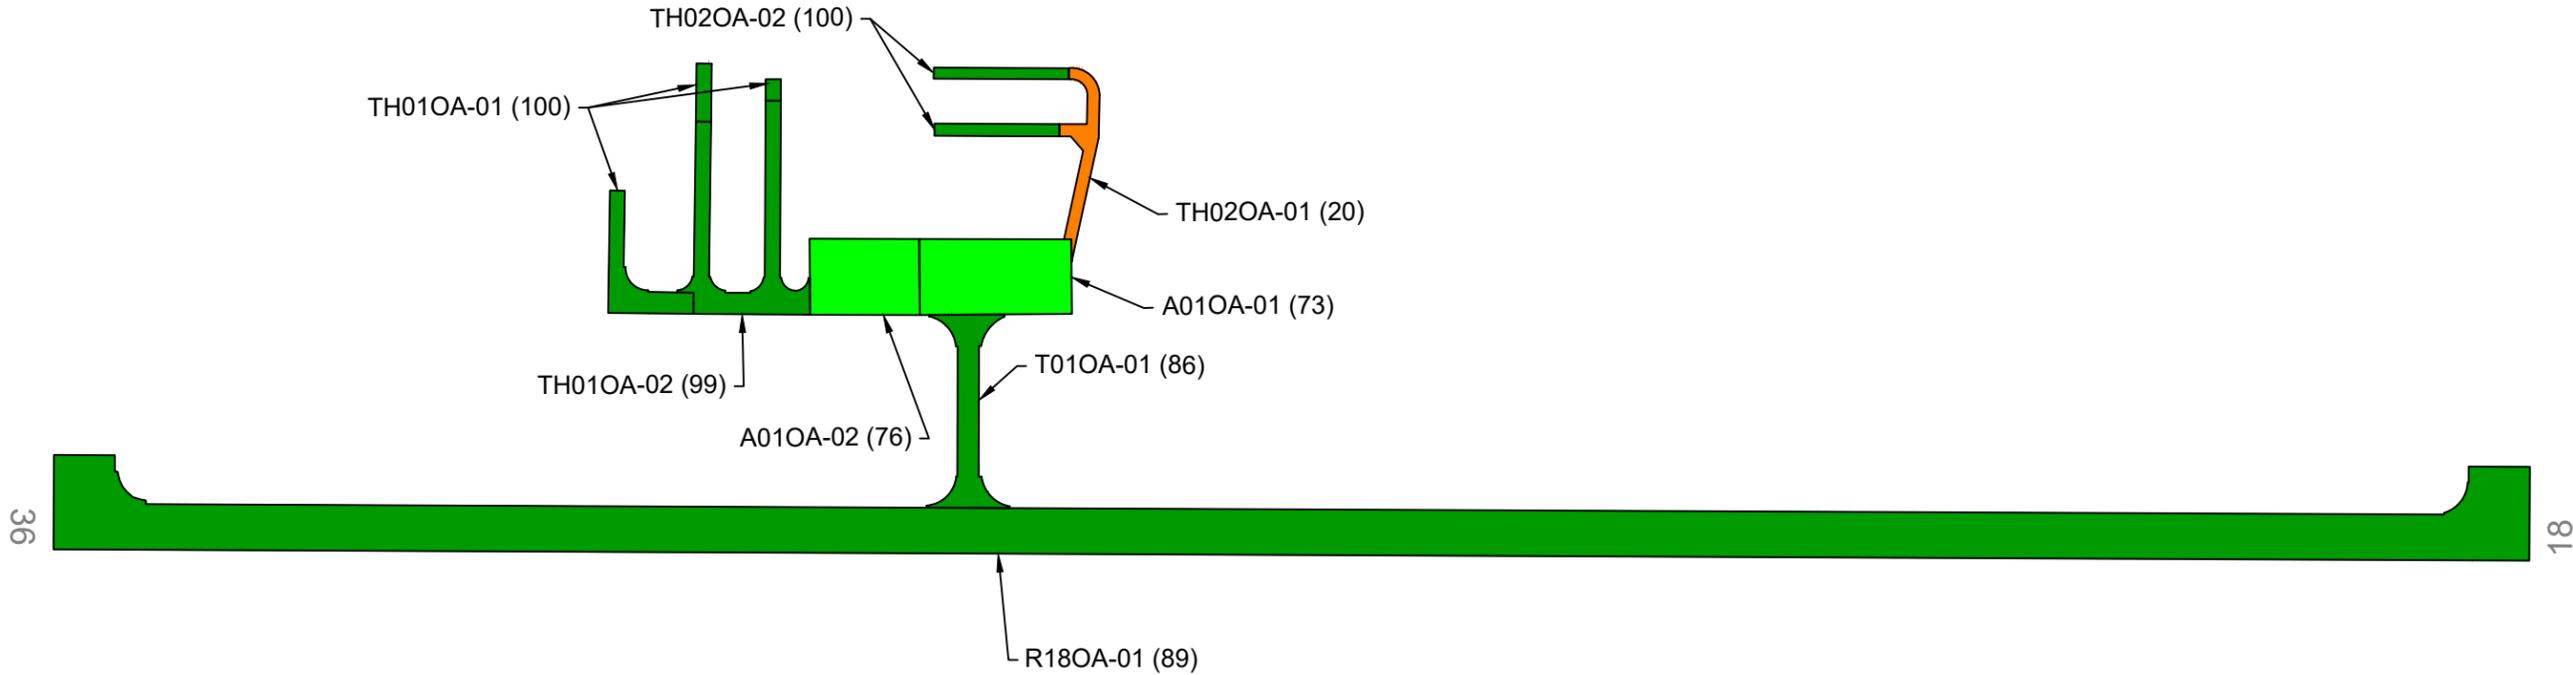
FIGURE 8. PCI MAP.

The pavements at Osceola Municipal Airport were inspected on December 2, 2018. The 2018 area-weighted condition of Osceola Municipal Airport is 87, with conditions ranging from 20 to 100 (on a scale of 0 [failed] to 100 [excellent]). During the previous pavement inspection in 2014, the area-weighted PCI of the airport was 93.

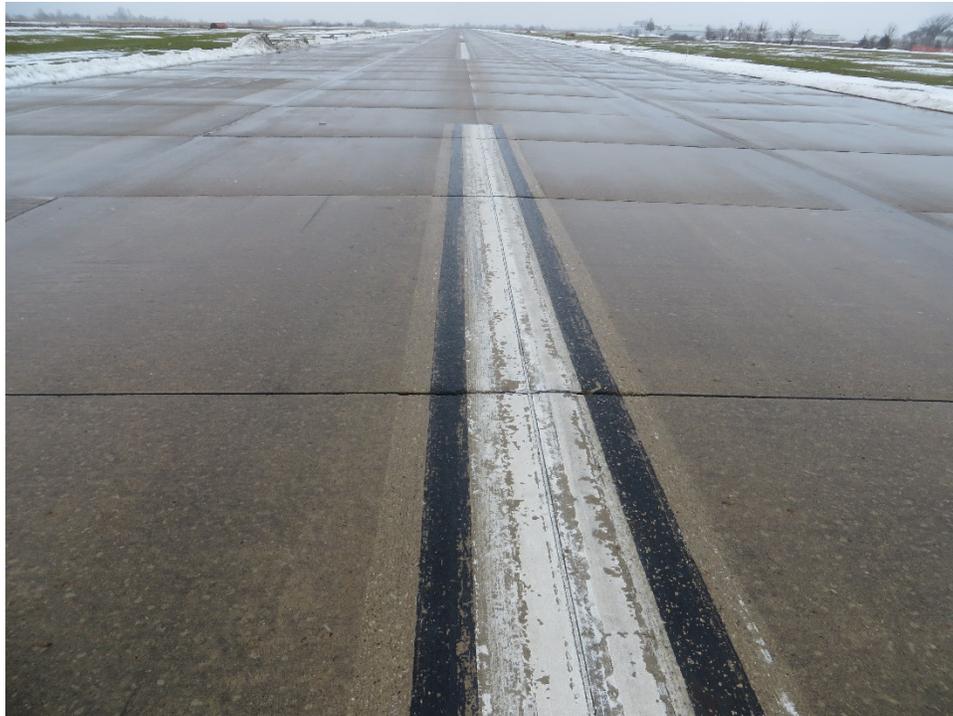
R180A-01. Overview.

Runway 18/36 consisted of one section. Medium- and high-severity corner spalling, low-severity faulting, low- and high-severity joint seal damage, shrinkage cracking, and medium-severity joint spalling and longitudinal, transverse, and diagonal (LTD) cracking were recorded in Section 01.

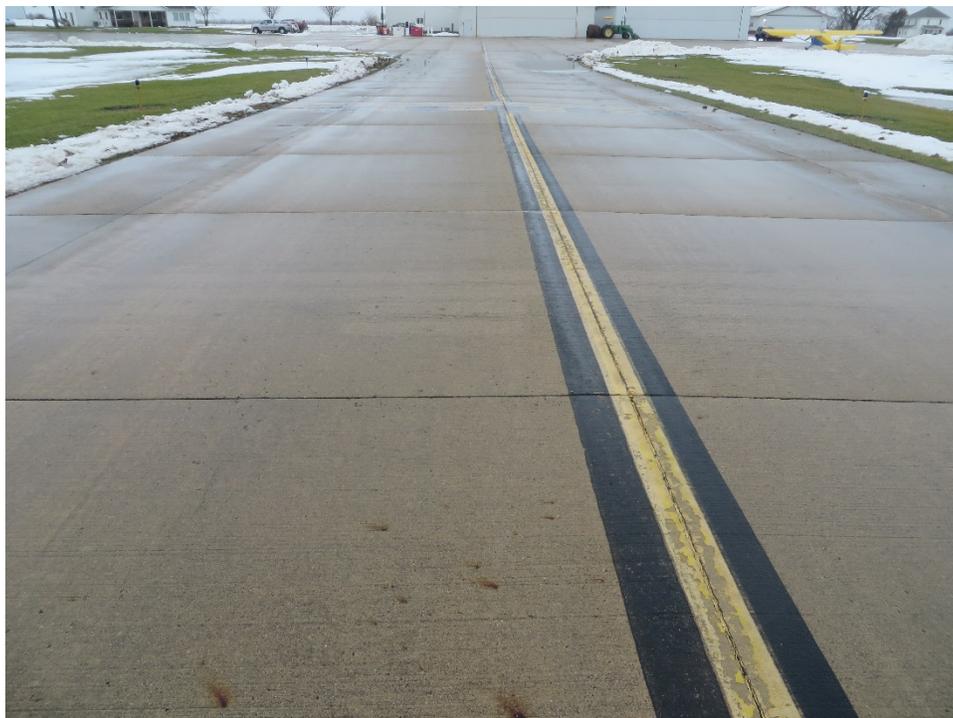
T010A-01. Overview.

Taxiway 01 was defined by one section that was located between the apron area and Runway 18/36. High-severity joint seal damage was identified throughout the section, along with isolated amounts of high-severity corner spalling and medium-severity joint spalling.
