Osceola Municipal Airport

PAVEMENT MANAGEMENT REPORT

JULY 2022

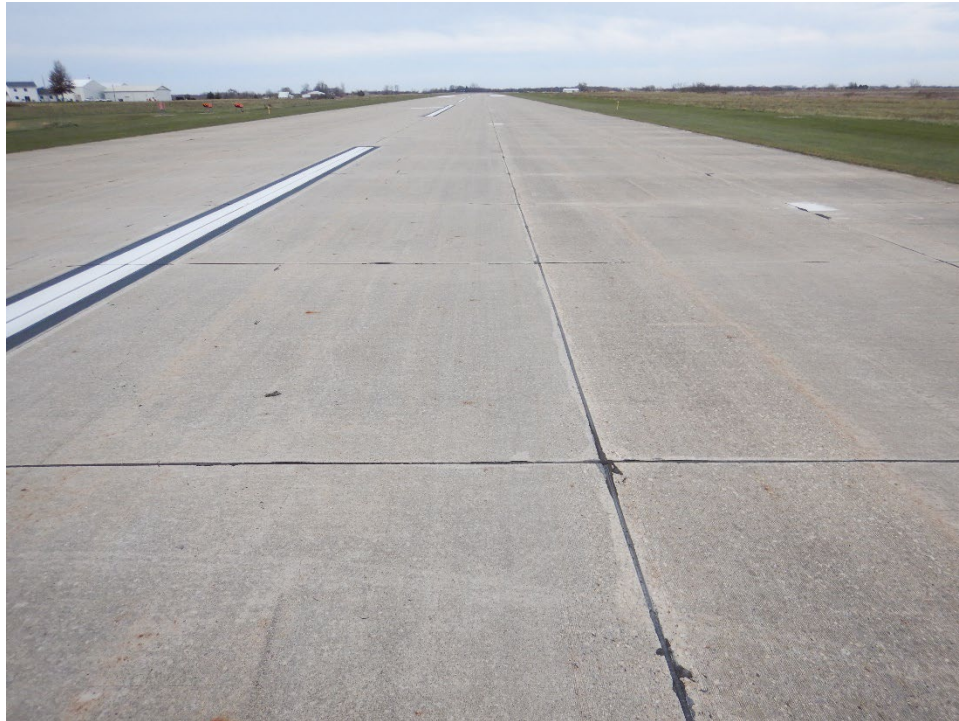
R18OA-01. Overview.

Runway 18/36 contained one section that had all severities of corner spalling; low- and medium-severity small patching and faulting; high-severity joint spalling; and low-severity ASR, corner break, and large patching.

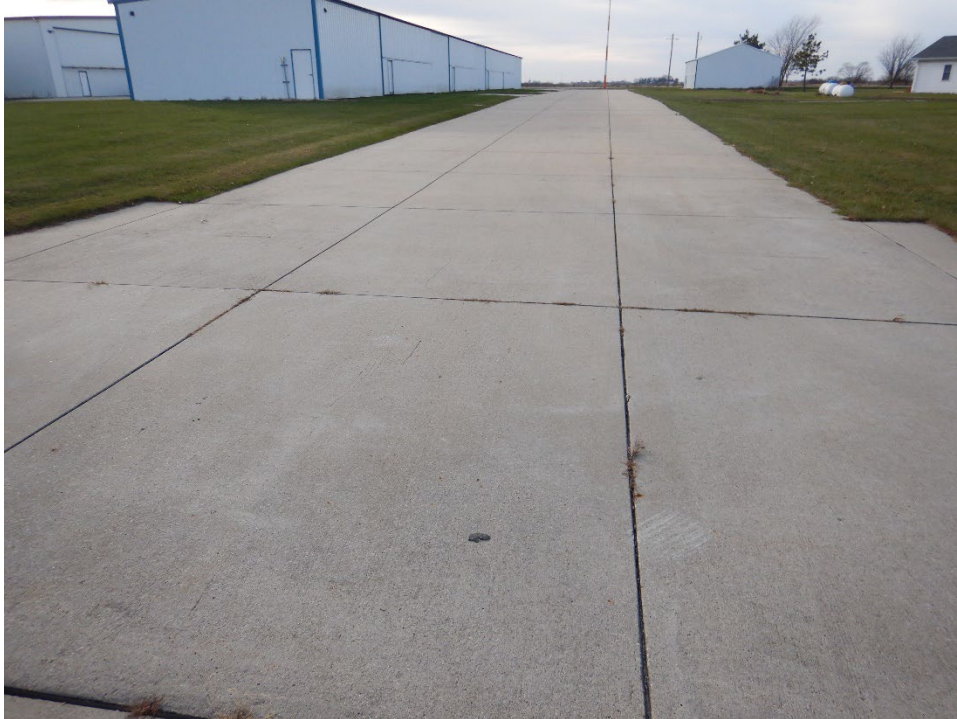
TH02OA-02. Overview.

TH02OA	02	PCC	8,098	4/5/2013	98	0	100	0	Joint Seal Damage
