Pella Municipal Airport

PAVEMENT MANAGEMENT REPORT

JULY 2022

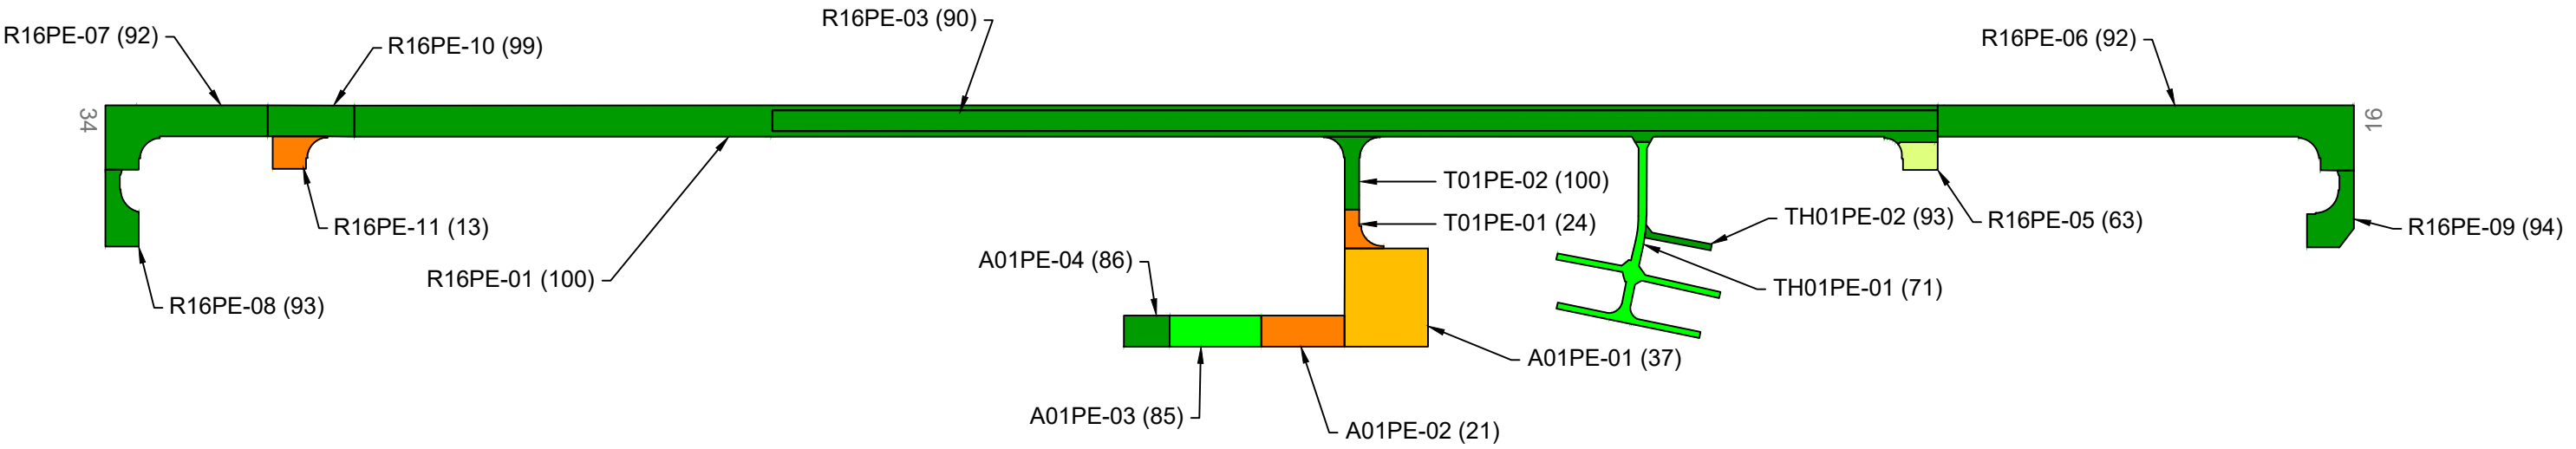
FIGURE 8. PCI MAP.

The pavements at Pella Municipal Airport were inspected in November 2021. The 2021 area-weighted condition of Pella Municipal Airport is 85, with conditions ranging from 13 to 100 (on a scale of 0 [failed] to 100 [excellent]). During the previous pavement inspection in 2018, the area-weighted PCI of the airport was 72.
