# Perry Municipal Airport

## PAVEMENT MANAGEMENT REPORT

**JULY 2021**

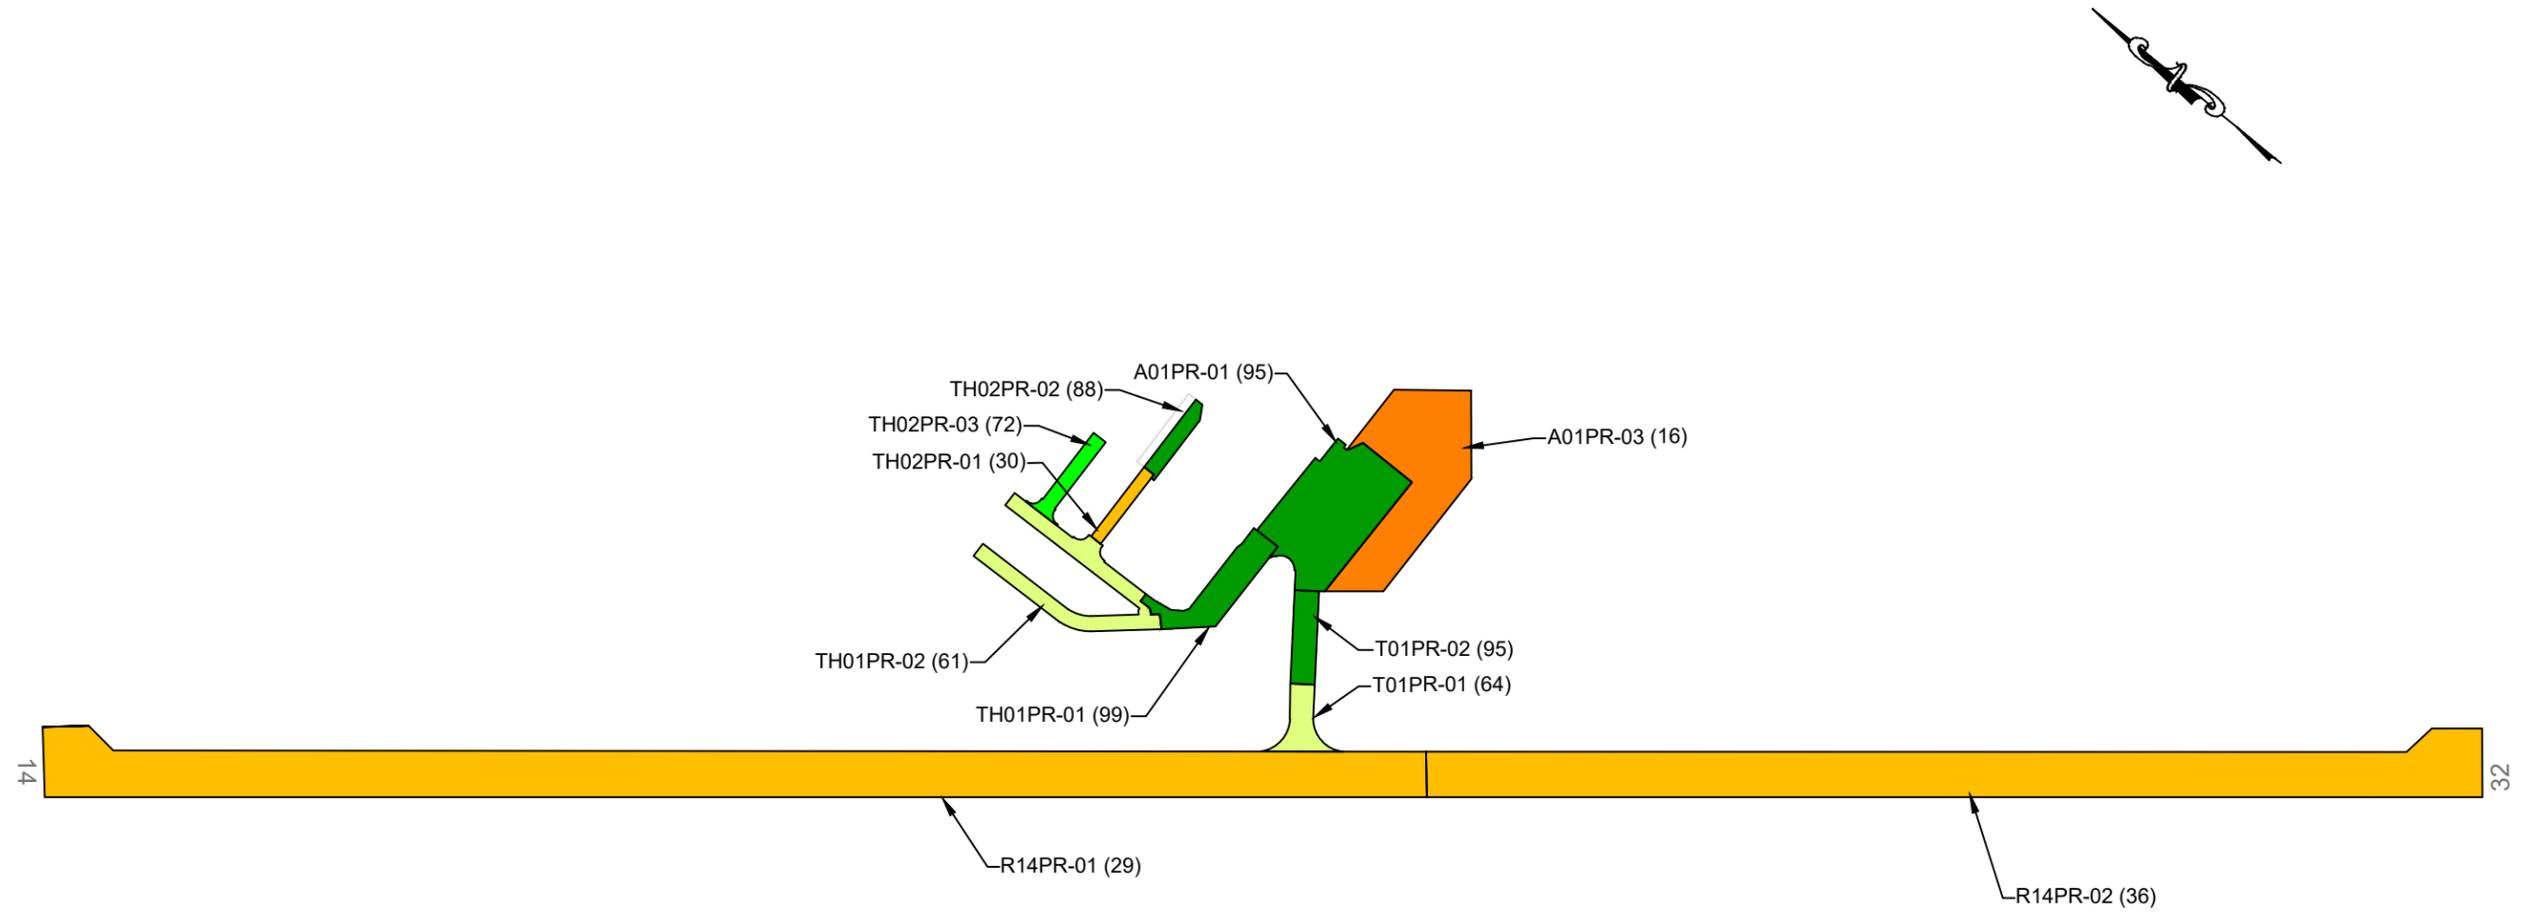
FIGURE 8. PCI MAP.

The pavements at Perry Municipal Airport were inspected in November 2020. The 2020 area-weighted condition of Perry Municipal Airport is 40, with conditions ranging from 16 to 99 (on a scale of 0 [failed] to 100 [excellent]). During the previous pavement inspection in 2017, the area-weighted PCI of the airport was 50.

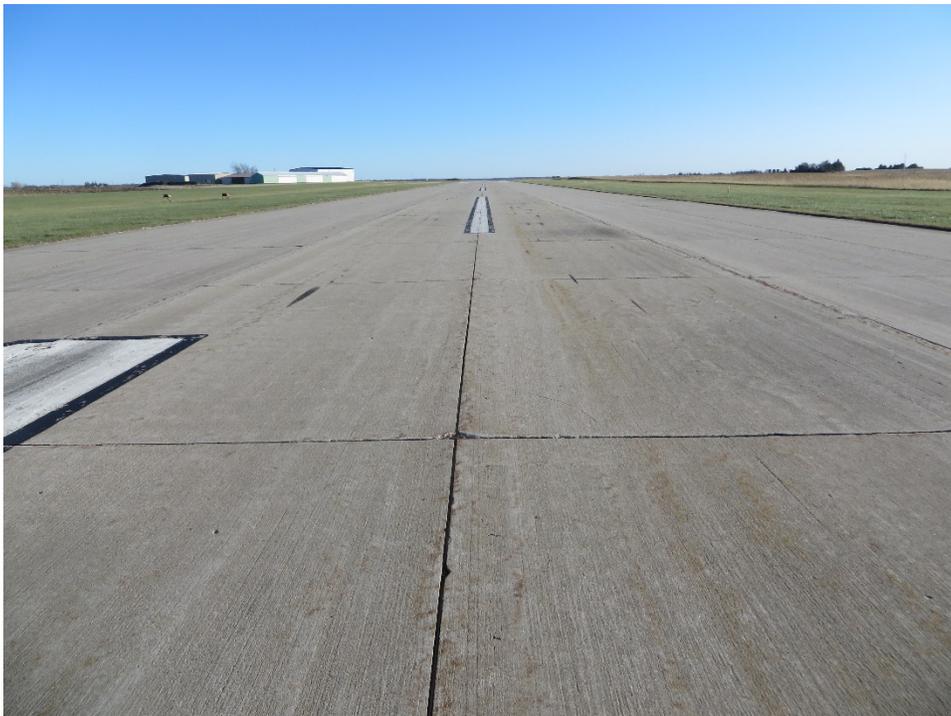
R14PR-01. Overview.

Runway 14/32 was defined by two sections in poor condition. Low-severity large patching; high-severity joint seal damage; low- and medium-severity corner break; medium- and high-severity shattered slab; shrinkage cracking; and all severities of ASR, corner spalling, faulting, joint spalling, small patching, and longitudinal, transverse, and diagonal (LTD) cracking were recorded in Section 01. Low-severity small patching and faulting; low- and medium-severity large patching and joint spalling; medium-severity corner break; medium- and high-severity LTD cracking; high-severity joint seal damage; popouts; shrinkage cracking; and all severities of corner spalling and ASR were identified in Section 02.

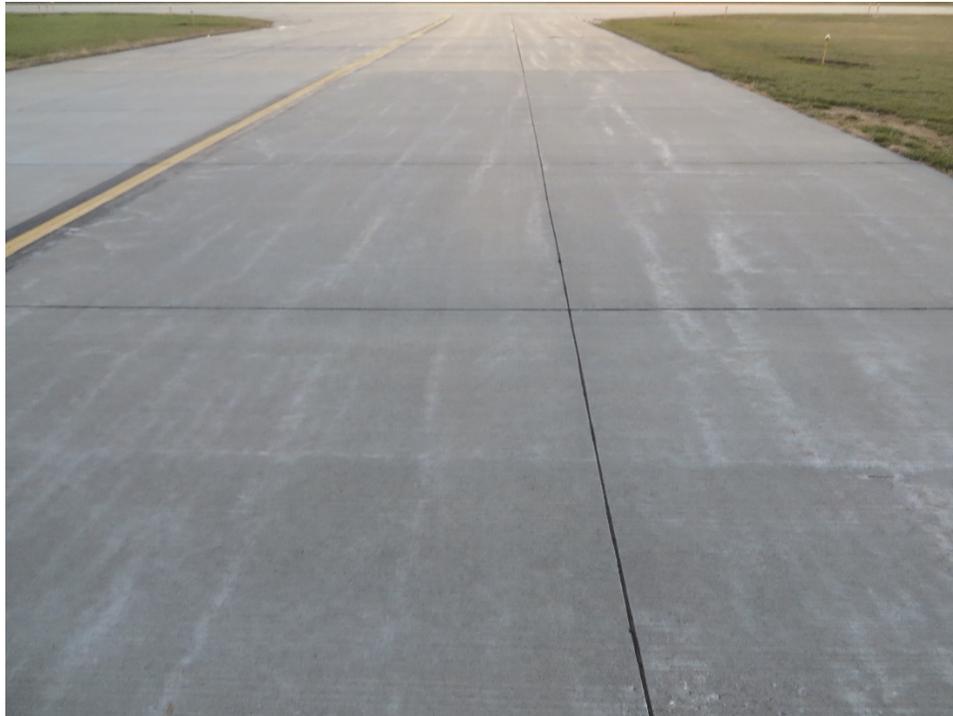
T01PR-02. Overview.

T01PR	02	PCC	6,124	1/3/2016	95	0	40	60	Corner Spalling, Joint Seal Damage, Joint Spalling
TH01PR	01	PCC	11,352	2/3/2019	99	0	0	100	Corner Spalling, Joint Spalling
TH01PR	02	PCC	16,332	1/21/2009	61	74	11	15	Corner Break, Corner Spalling, Faulting, Joint Seal Damage, Joint Spalling, LTD Cracking, Shattered Slab, Shrinkage Cracking
TH02PR	01	PCC	2,860	6/1/1991	30	66	11	23	Corner Break, Corner Spalling, Faulting, Joint Seal Damage, Joint Spalling, LTD Cracking
TH02PR	02	PCC	3,519	2/1/2013	88	0	100	0	Joint Seal Damage

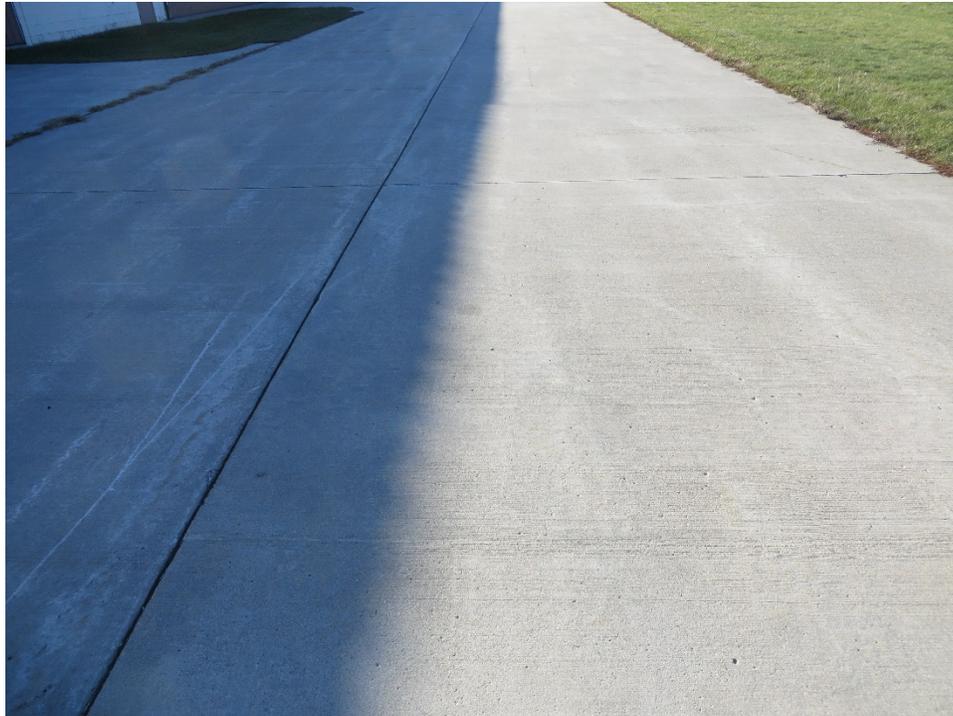
TH02PR-03. Overview.

Branch	Section	Surface Type	Section Area (sf)	LCD	2020 PCI	% Distress Due to Load	% Distress Due to Climate/Durability	% Distress Due to Other	Type of Distresses
TH02PR	03	PCC	4,173	9/1/2009	72	77	23	0	Joint Seal Damage, LTD Cracking
