Pocahontas Municipal Airport

Pavement Management Report

JULY 2023

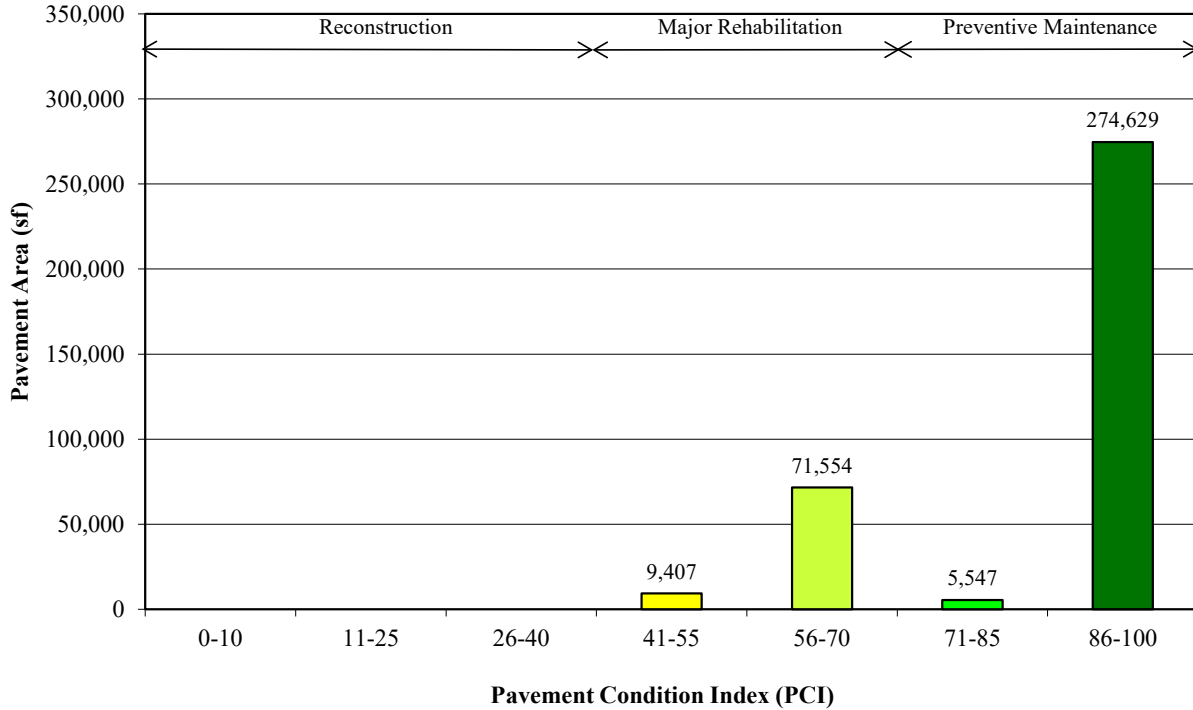
Figure 6. Pavement area by PCI range at Pocahontas Municipal Airport.

The pavements at Pocahontas Municipal Airport were inspected in November 2022. The 2022 area-weighted condition of Pocahontas Municipal Airport is 87, with conditions ranging from 42 to 100 (on a scale of 0 [failed] to 100 [excellent]). During the previous pavement inspection in 2019, the area-weighted PCI of the airport was 92.

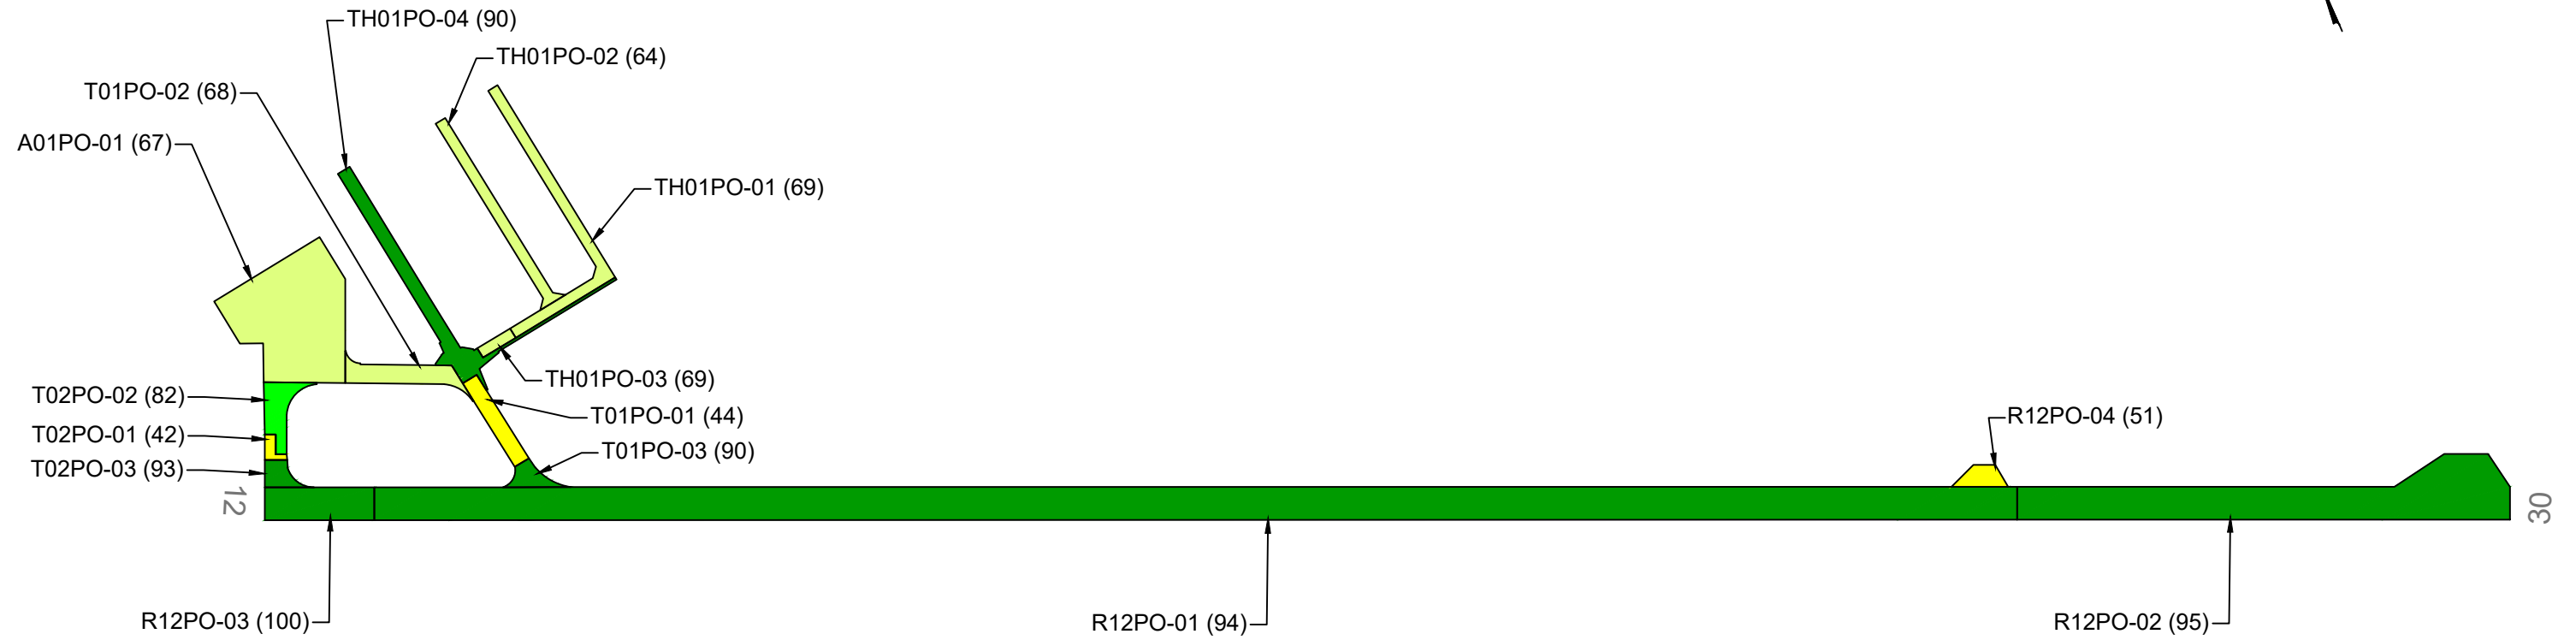
FIGURE 8. PCI MAP.

Figure 6 summarizes the overall condition of the pavements at Pocahontas Municipal Airport, and Figure 7 presents area-weighted condition (average PCI adjusted to account for the relative size of the pavement sections) by branch use. Figure 8 is a map that displays the condition of the evaluated pavements. Table 1 summarizes the results of the pavement evaluation. Appendix B presents photographs taken during the PCI inspection, and Appendix C contains detailed information on the distress types observed during the visual survey. Appendix D includes detailed work history information that was collected during the record review process.
