Red Oak Municipal Airport

PAVEMENT MANAGEMENT REPORT

JULY 2022

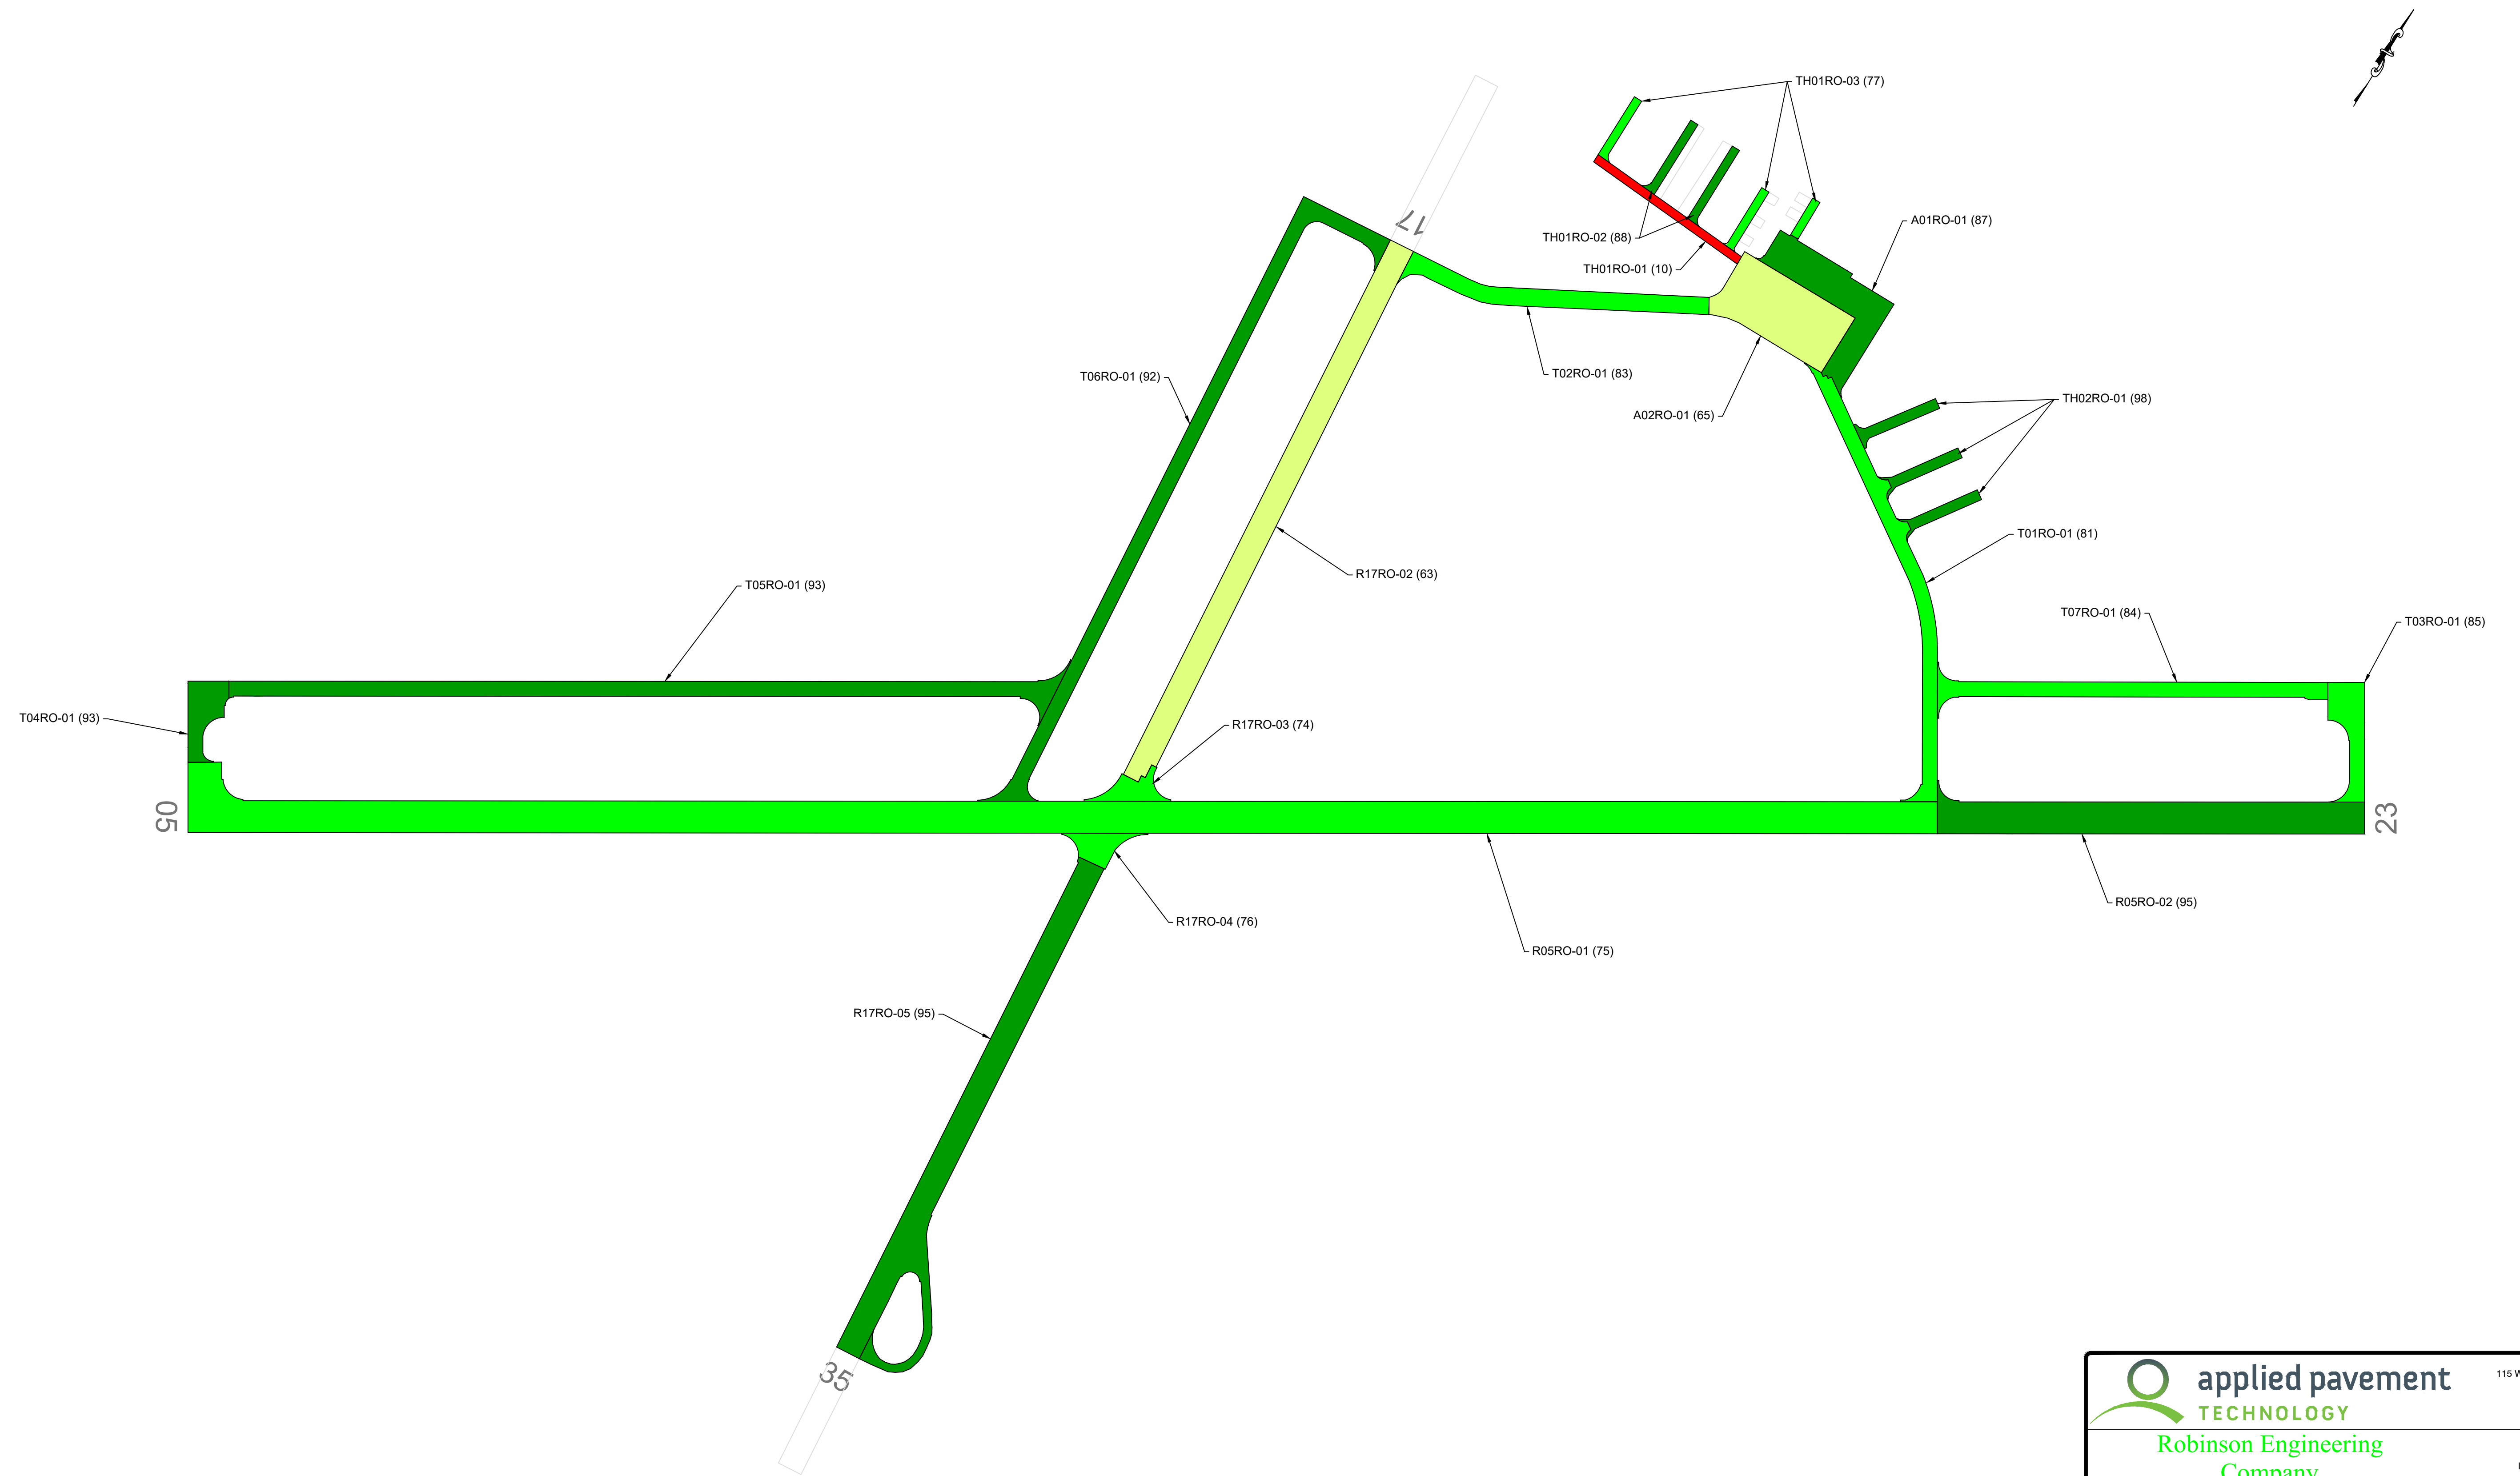
FIGURE 8. PCI MAP.

The pavements at Red Oak Municipal Airport were inspected in November 2021. The 2021 area-weighted condition of Red Oak Municipal Airport is 81, with conditions ranging from 10 to 98 (on a scale of 0 [failed] to 100 [excellent]). During the previous pavement inspection in 2018, the area-weighted PCI of the airport was 80.

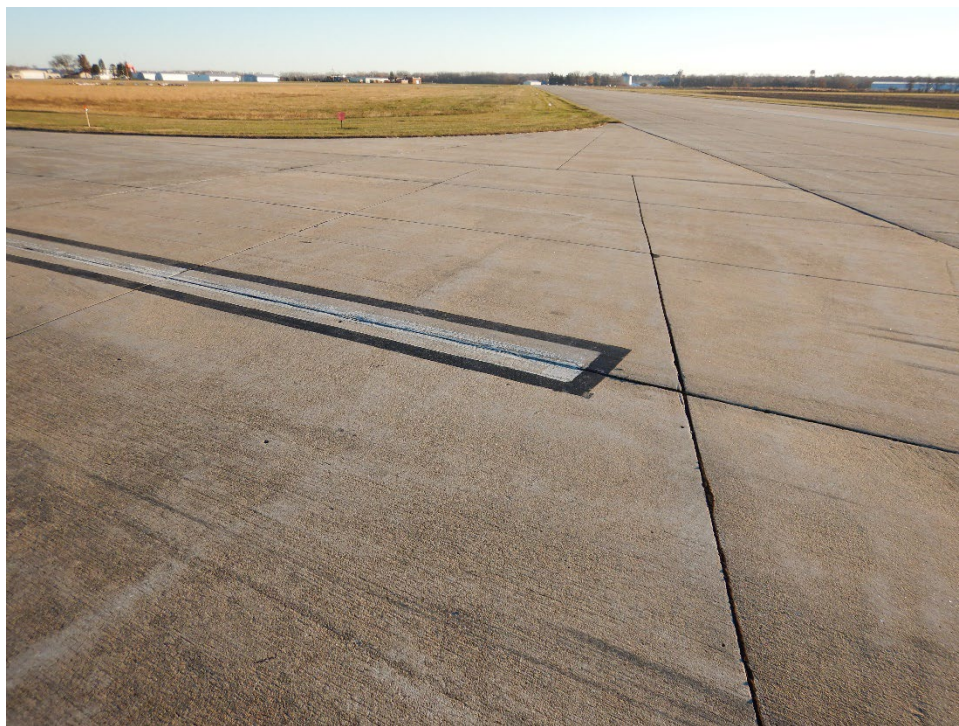
R17RO-03. Overview.

R17RO	03	PCC	7,080	6/3/1988	74	29	21	50	Corner Break, Corner Spalling, Faulting, Joint Spalling, Joint Seal Damage, Large Patch, LTD Cracking, Shrinkage Cracking
R17RO	04	PCC	7,410	6/3/1988	76	4	23	73	ASR, Corner Break, Faulting, Joint Spalling, Joint Seal Damage, Shrinkage Cracking
R17RO	05	PCC	88,305	6/3/1966	95	0	34	66	Corner Spalling, Joint Spalling, Joint Seal Damage, Shrinkage Cracking, Small Patch

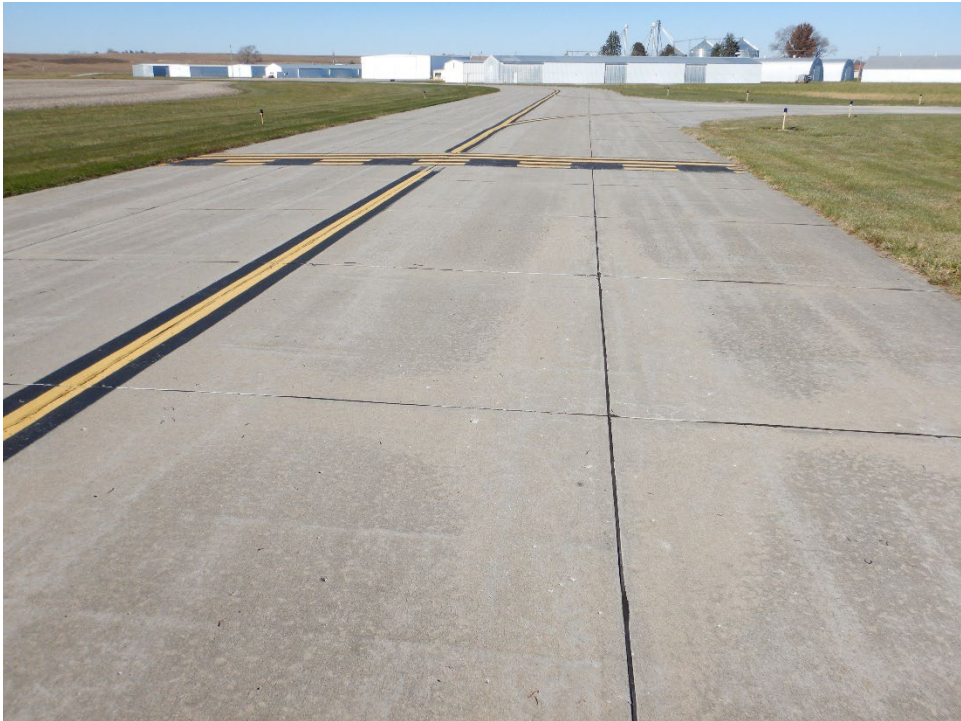
T01RO-01. Overview.

Taxiway 01 connected Runway 05/23 with the apron area and contained one section. Low- and medium-severity corner spalling and low-severity faulting, ASR, and joint seal damage were recorded in Section 01.
