# Rockwell City Municipal Airport

## PAVEMENT MANAGEMENT REPORT

**JULY 2021**

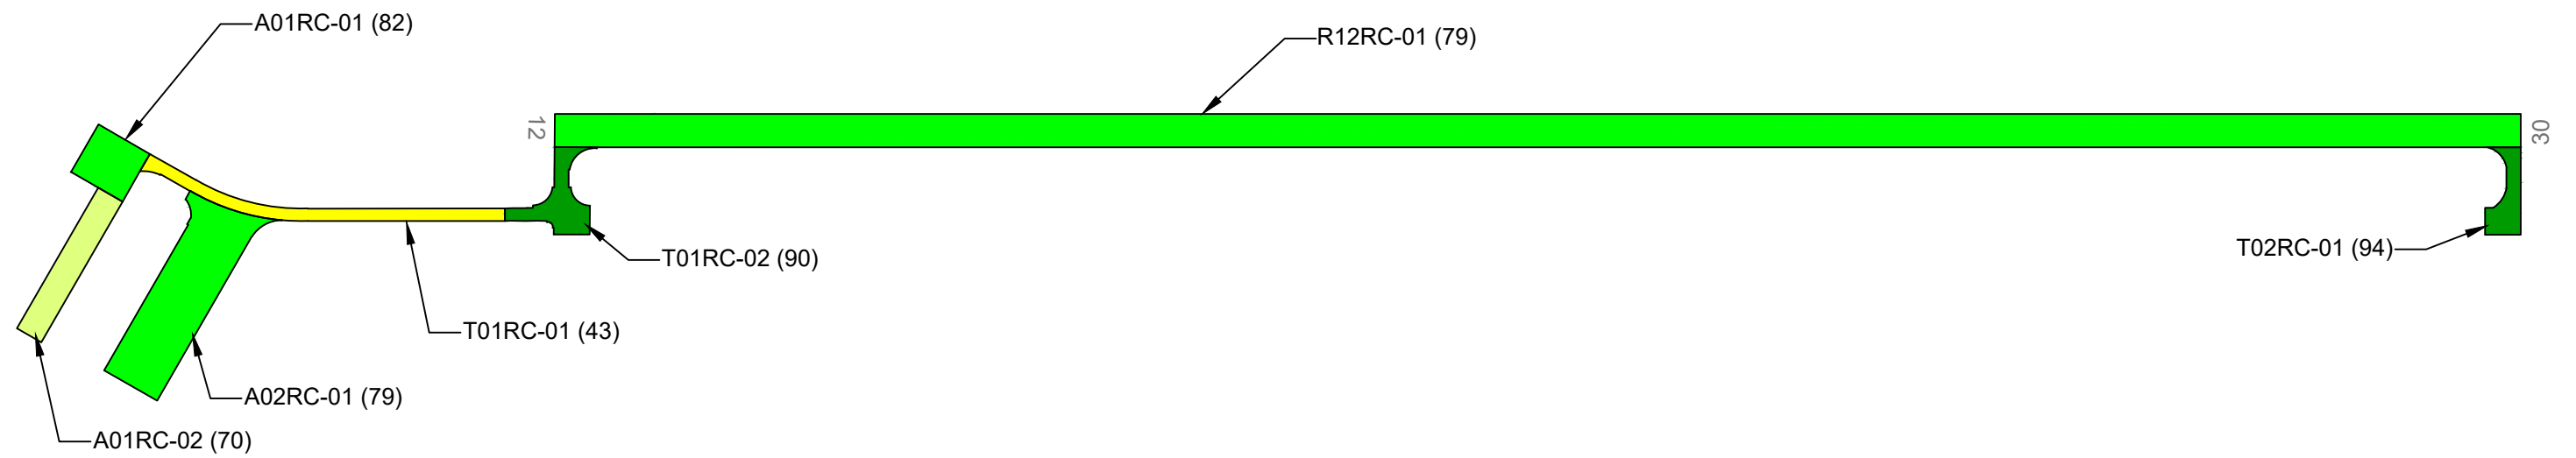
FIGURE 8. PCI MAP.

The pavements at Rockwell City Municipal Airport were inspected in November 2020. The 2020 area-weighted condition of Rockwell City Municipal Airport is 78, with conditions ranging from 43 to 94 (on a scale of 0 [failed] to 100 [excellent]). During the previous pavement inspection in 2017, the area-weighted PCI of the airport was 76.

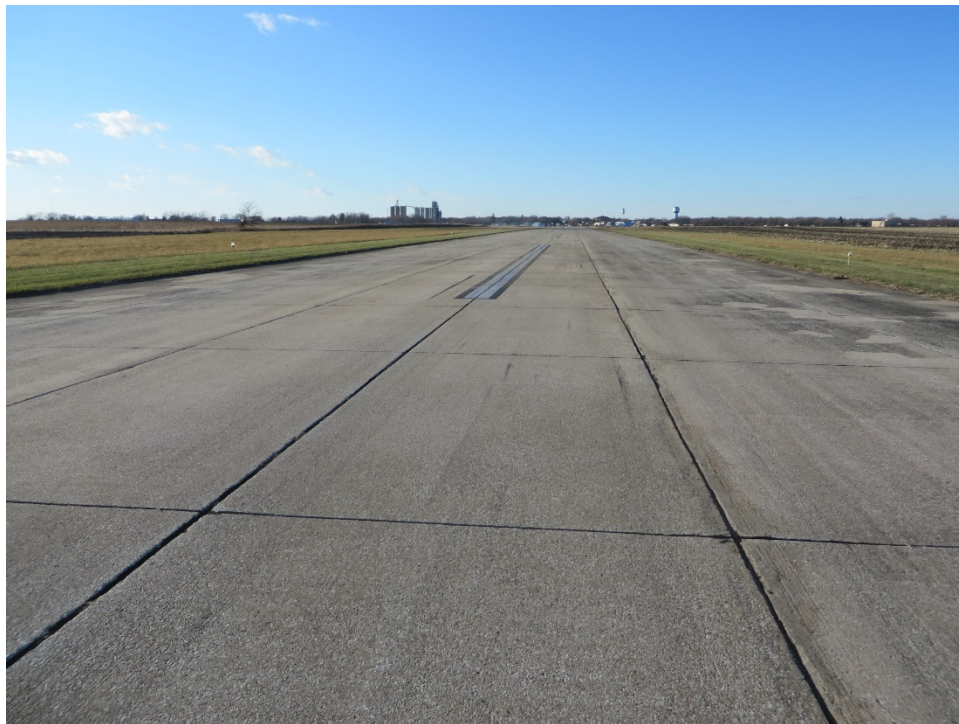
R12RC-01. Overview.

Runway 12/30 was defined by one section. Section 01 had low-severity corner spalling, joint seal damage, and small patching and low- and medium-severity corner break, faulting, joint spalling, shattered slab, and longitudinal, transverse, and diagonal (LTD) cracking recorded during the inspection.

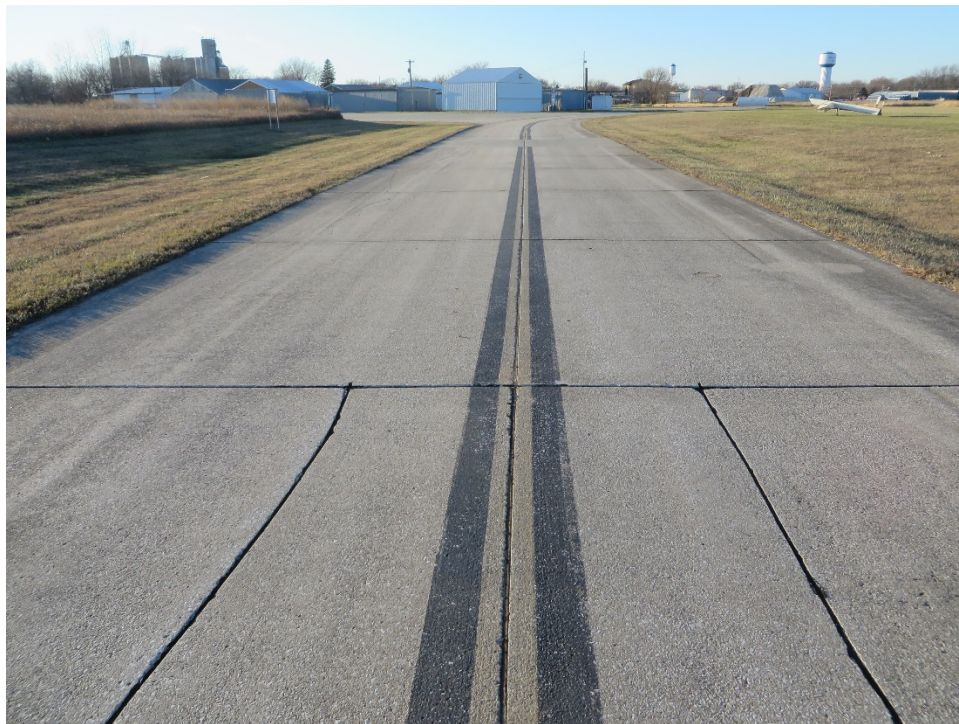
T01RC-01. Overview.

Taxiway 01 consisted of two sections. Low-severity corner break and large patching; low- and medium-severity corner spalling, faulting, joint seal damage, joint spalling, LTD cracking, and shattered slab; and shrinkage cracking were identified in Section 01. Section 02 had areas of low-severity LTD cracking and joint seal damage; low- and medium-severity corner break; and medium-severity joint spalling recorded at the time of the inspection.

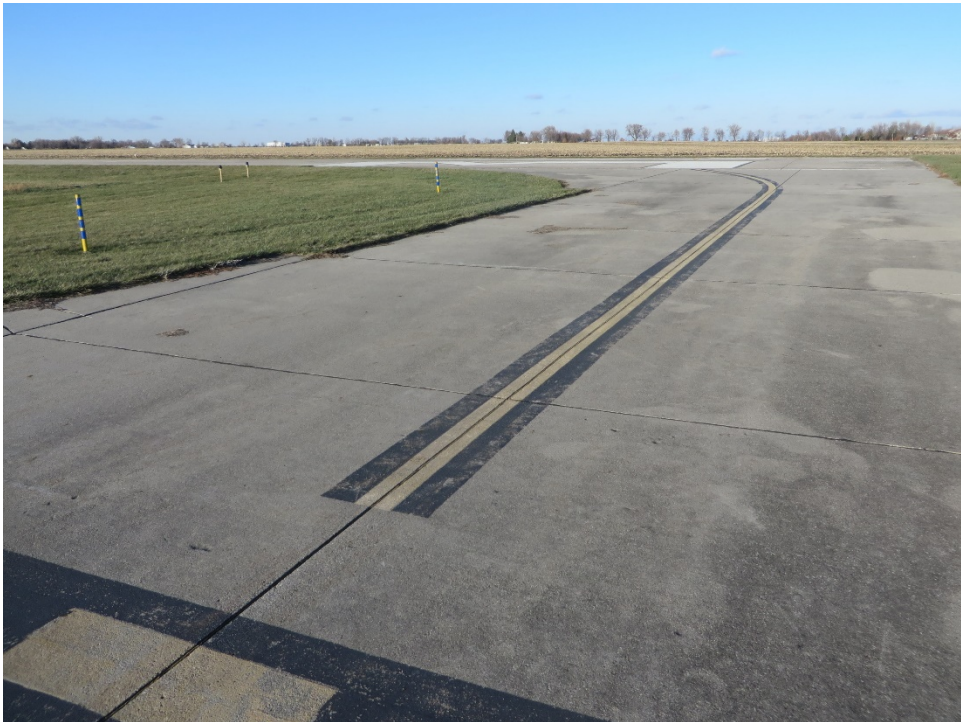
T02RC-01. Overview.

T02RC	01	PCC	6,473	6/1/2007	94	0	33	67	Faulting, Joint Seal Damage

Taxiway 02 contained one section. Low-severity faulting and joint seal damage were observed in Section 01.
