# Rockwell City Municipal Airport

## Pavement Management Report

**JULY 2024**

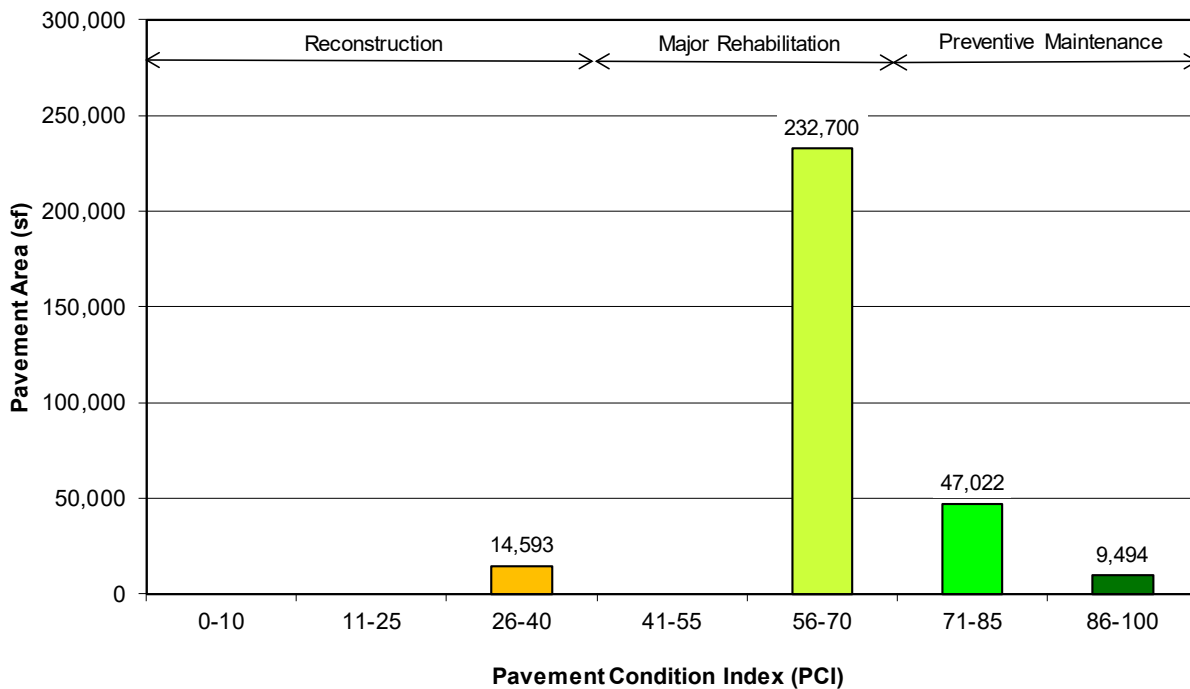
Figure 6. Pavement area by PCI range at Rockwell City Municipal Airport.

The pavements at Rockwell City Municipal Airport were inspected in November 2023. The 2023 area-weighted condition of Rockwell City Municipal Airport is 69, with conditions ranging from 38 to 86 (on a scale of 0 [failed] to 100 [excellent]). During the previous pavement inspection in 2020, the area-weighted PCI of the airport was 78.

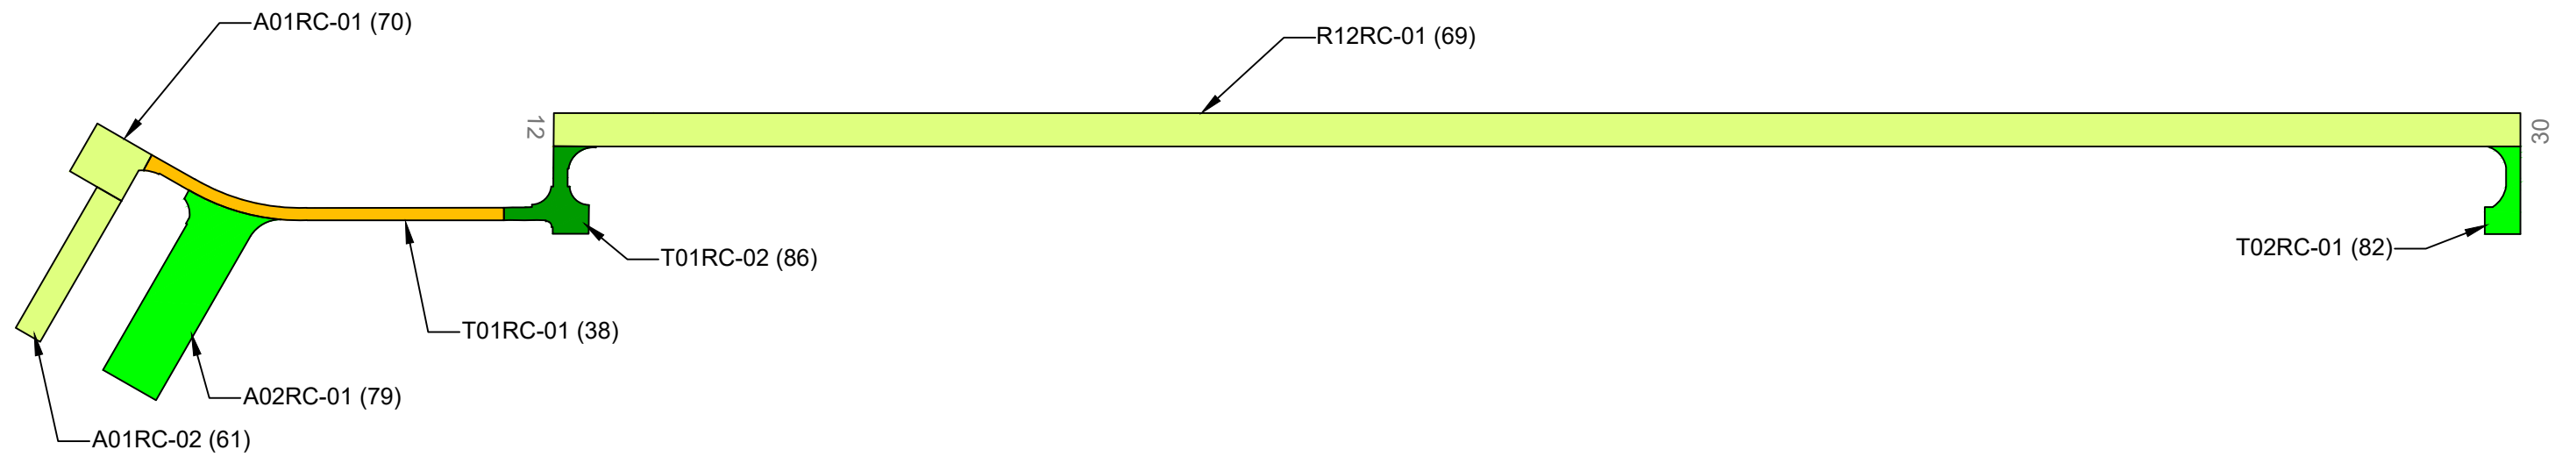
FIGURE 8. PCI MAP.

Figure 6 summarizes the overall condition of the pavements at Rockwell City Municipal Airport, and Figure 7 presents area-weighted condition (average PCI adjusted to account for the relative size of the pavement sections) by branch use. Figure 8 is a map that displays the condition of the evaluated pavements. Table 1 summarizes the results of the pavement evaluation. Appendix B presents photographs taken during the PCI inspection, and Appendix C contains detailed information on the distress types observed during the visual survey. Appendix D includes detailed work history information that was collected during the record review process.
