# Sibley Municipal Airport

**PAVEMENT MANAGEMENT REPORT**

**AUGUST 2019**

**IOWA DEPARTMENT OF TRANSPORTATION  
AVIATION BUREAU**

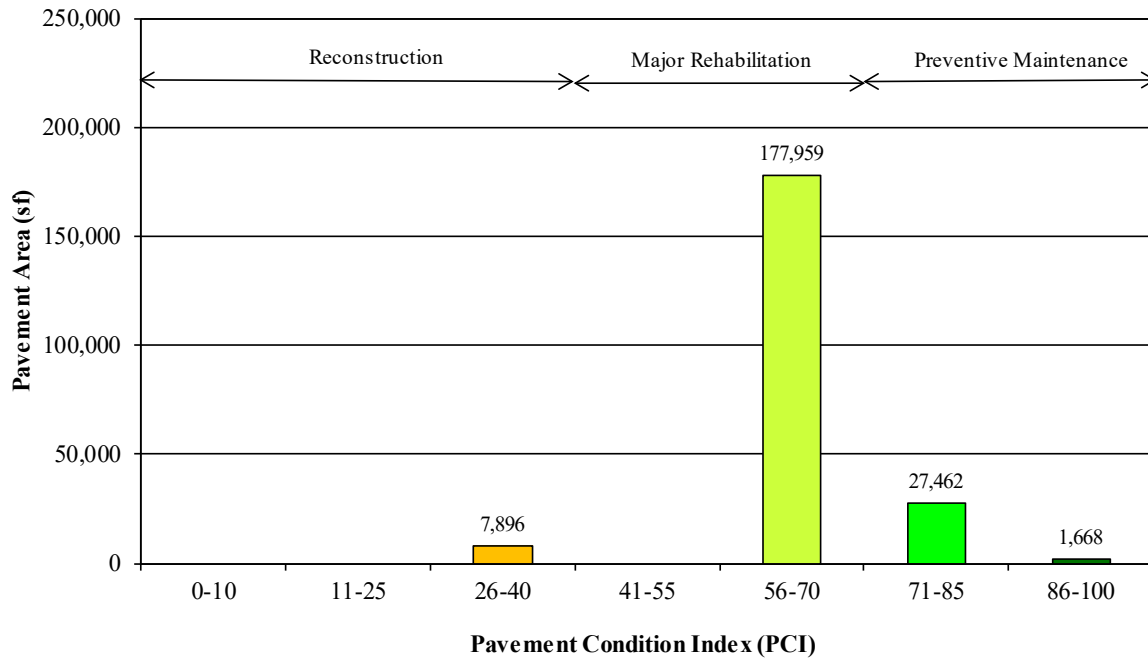
Figure 6. Pavement area by PCI range at Sibley Municipal Airport.

The pavements at Sibley Municipal Airport were inspected on November 17, 2018. The 2018 area-weighted condition of Sibley Municipal Airport is 62, with conditions ranging from 35 to 92 (on a scale of 0 [failed] to 100 [excellent]). During the previous pavement inspection in 2014, the area-weighted PCI of the airport was 70.
