Tipton – Mathews Memorial Airport

PAVEMENT MANAGEMENT REPORT

JULY 2021

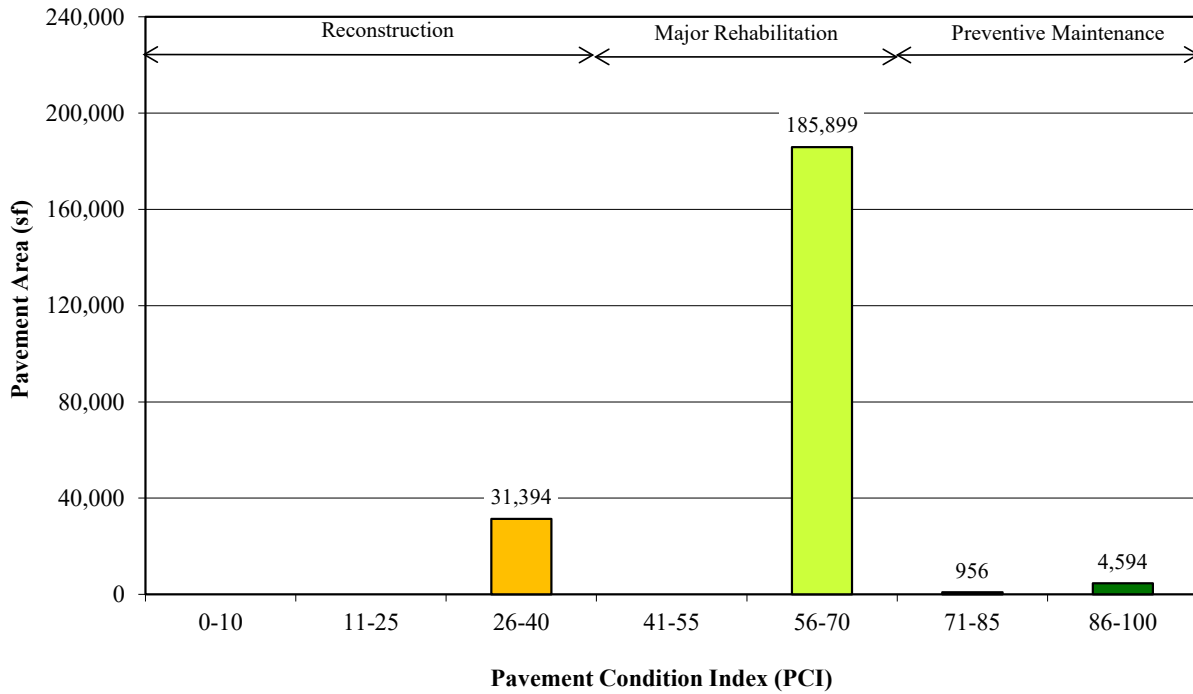
Figure 6. Pavement area by PCI range at Tipton - Mathews Memorial Airport.

The pavements at Tipton - Mathews Memorial Airport were inspected in November 2020. The 2020 area-weighted condition of Tipton - Mathews Memorial Airport is 56, with conditions ranging from 29 to 93 (on a scale of 0 [failed] to 100 [excellent]). During the previous pavement inspection in 2017, the area-weighted PCI of the airport was 67.

Figure 6 summarizes the overall condition of the pavements at Tipton - Mathews Memorial Airport, and Figure 7 presents area-weighted condition (average PCI adjusted to account for the relative size of the pavement sections) by branch use. Figure 8 is a map that displays the condition of the evaluated pavements. Table 1 summarizes the results of the pavement evaluation. Appendix B presents photographs taken during the PCI inspection, and Appendix C contains detailed information on the distresses observed during the visual survey. Appendix D includes detailed work history information that was collected during the record review process.
