# West Union – George L. Scott Airport

## PAVEMENT MANAGEMENT REPORT

**JULY 2021**

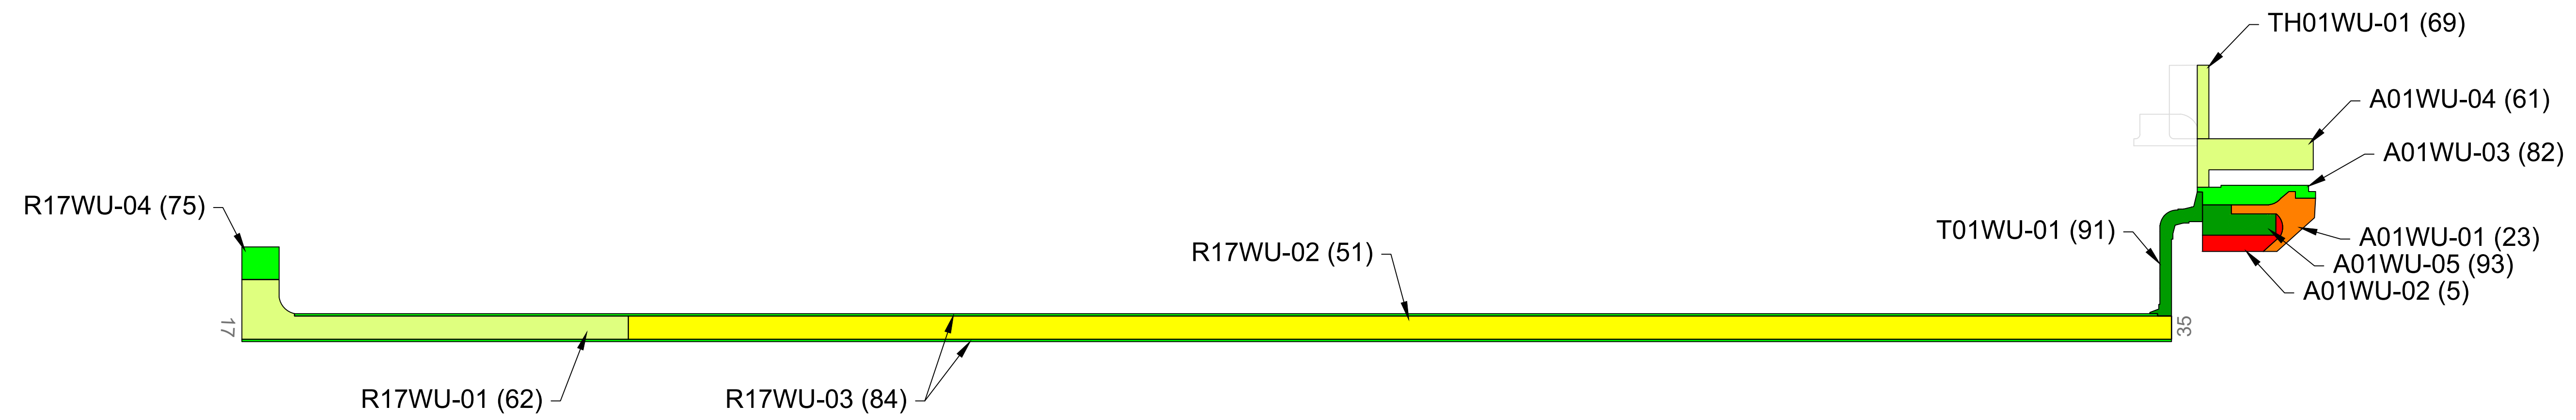
FIGURE 8. PCI MAP.

The pavements at West Union - George L. Scott Airport were inspected in November 2020. The 2020 area-weighted condition of West Union - George L. Scott Airport is 59, with conditions ranging from 5 to 93 (on a scale of 0 [failed] to 100 [excellent]). During the previous pavement inspection in 2017, the area-weighted PCI of the airport was 67.

Figure 6 summarizes the overall condition of the pavements at West Union - George L. Scott Airport, and Figure 7 presents area-weighted condition (average PCI adjusted to account for the relative size of the pavement sections) by branch use. Figure 8 is a map that displays the condition of the evaluated pavements. Table 1 summarizes the results of the pavement evaluation. Appendix B presents photographs taken during the PCI inspection, and Appendix C contains detailed information on the distresses observed during the visual survey. Appendix D includes detailed work history information that was collected during the record review process.
