West Union-George L Scott Municipal Airport

Pavement Management Report

JULY 2024

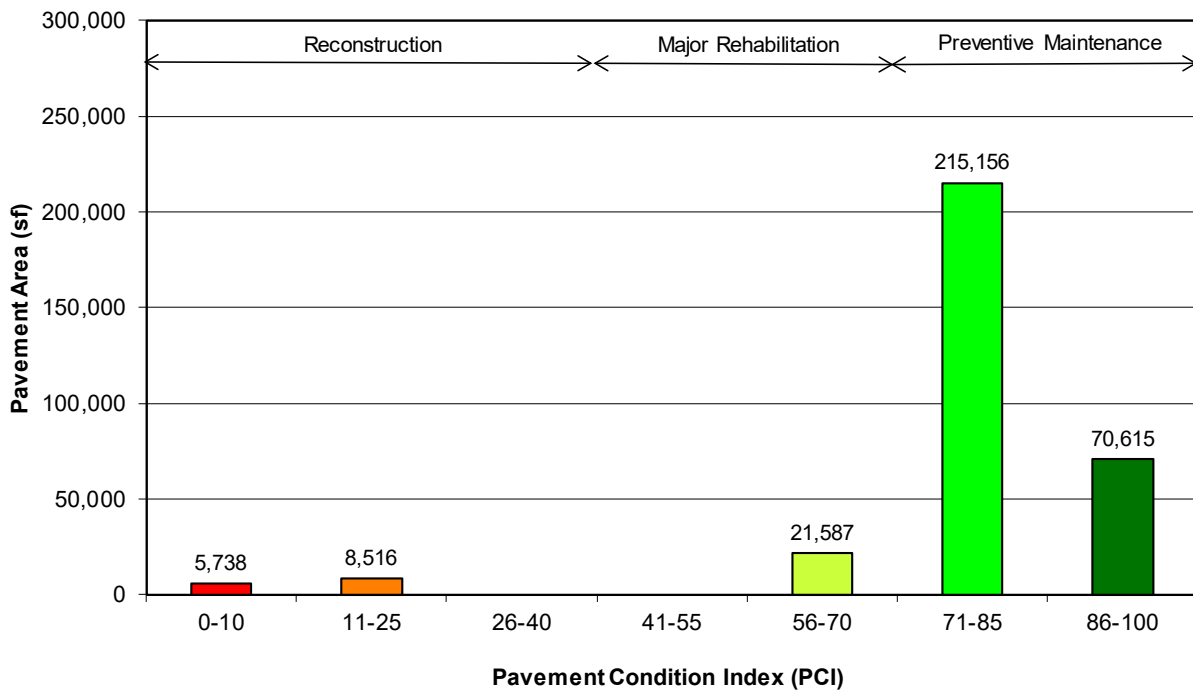
Figure 6. Pavement area by PCI range at West Union-George L Scott Municipal Airport.

The pavements at West Union-George L Scott Municipal Airport were inspected in November 2023. The 2023 area-weighted condition of West Union-George L Scott Municipal Airport is 80, with conditions ranging from 0 to 99 (on a scale of 0 [failed] to 100 [excellent]). During the previous pavement inspection in 2020, the area-weighted PCI of the airport was 59.

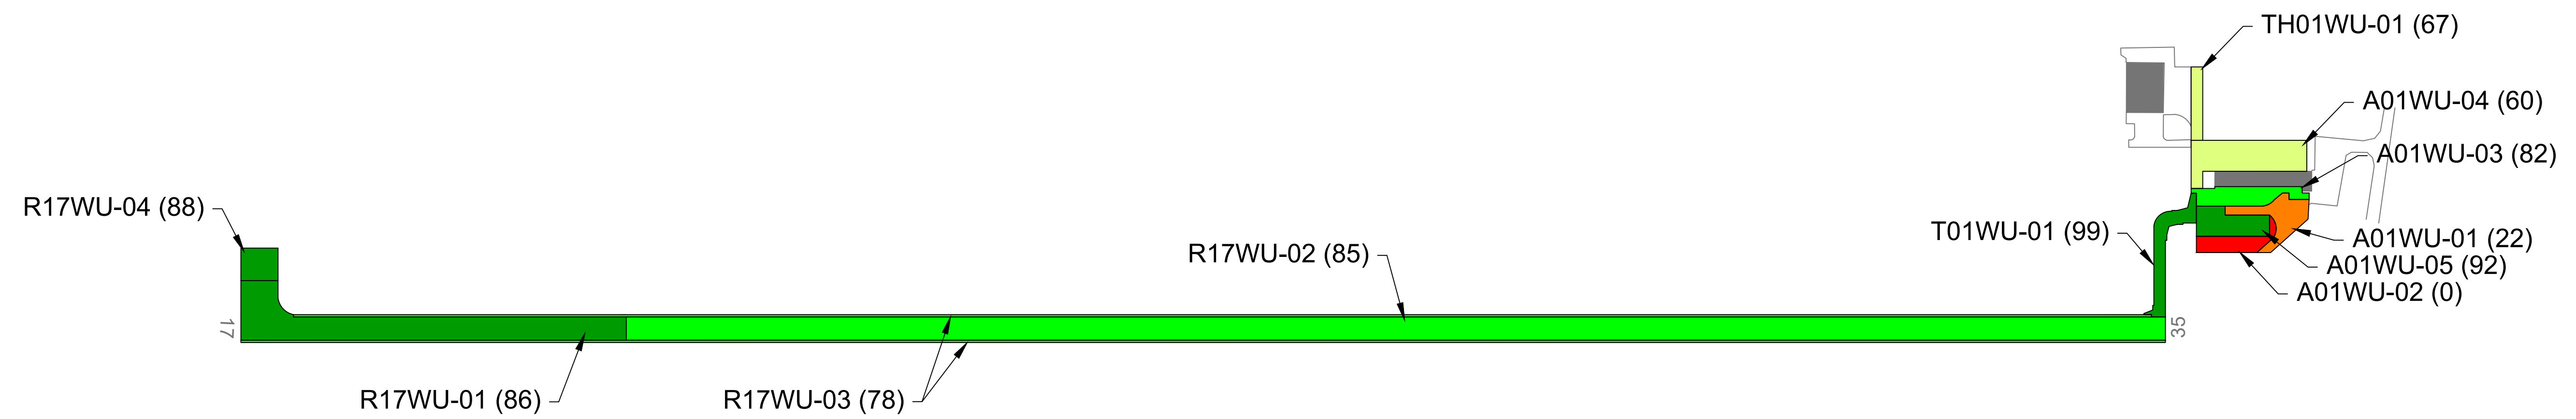
FIGURE 8. PCI MAP.

Branch	Section	Surface Type	Section Area (sf)	LCD	2023 PCI	% Distress Due to Load	% Distress Due to Climate/Durability	% Distress Due to Other	Type of Distress
A01WU	01	PCC	8,516	6/1/1975	22	53	9	38	Corner Break, Corner Spalling, Faulting, Joint Spalling, Joint Seal Damage, LTD Cracking, Shattered Slab
A01WU	02	PCC	5,738	6/1/1977	0	93	7	0	Corner Break, Joint Seal Damage, LTD Cracking, Shattered Slab
A01WU	03	PCC	8,527	7/1/1991	82	36	54	10	Corner Break, Joint Spalling, Joint Seal Damage, LTD Cracking
A01WU	04	PCC	17,637	1/1/1996	60	61	23	16	Corner Break, Corner Spalling, Joint Spalling, Joint Seal Damage, LTD Cracking, Scaling
A01WU	05	PCC	8,395	6/3/2017	92	0	86	14	Corner Spalling, Joint Spalling, Joint Seal Damage
R17WU	01	PCC	48,287	6/1/1988	86	13	0	87	ASR, Large Patch, LTD Cracking, Small Patch
R17WU	02	PCC	165,863	6/1/1975	85	69	0	31	Corner Break, Corner Spalling, Joint Spalling, Large Patch, LTD Cracking, Shrinkage Cracking, Small Patch

R17WU	03	PCC	40,766	6/3/2007	78	4	0	96	ASR, Large Patch, LTD Cracking, Small Patch
R17WU	04	PCC	5,600	6/3/2007	88	20	0	80	Faulting, Joint Spalling, LTD Cracking, Small Patch
T01WU	01	PCC	8,333	6/3/2015	99	100	0	0	Corner Break
TH01WU	01	PCC	3,950	10/1/2008	67	66	29	5	Joint Seal Damage, LTD Cracking, Scaling, Shrinkage Cracking
