Winterset Municipal Airport

PAVEMENT MANAGEMENT REPORT

JUNE 2018

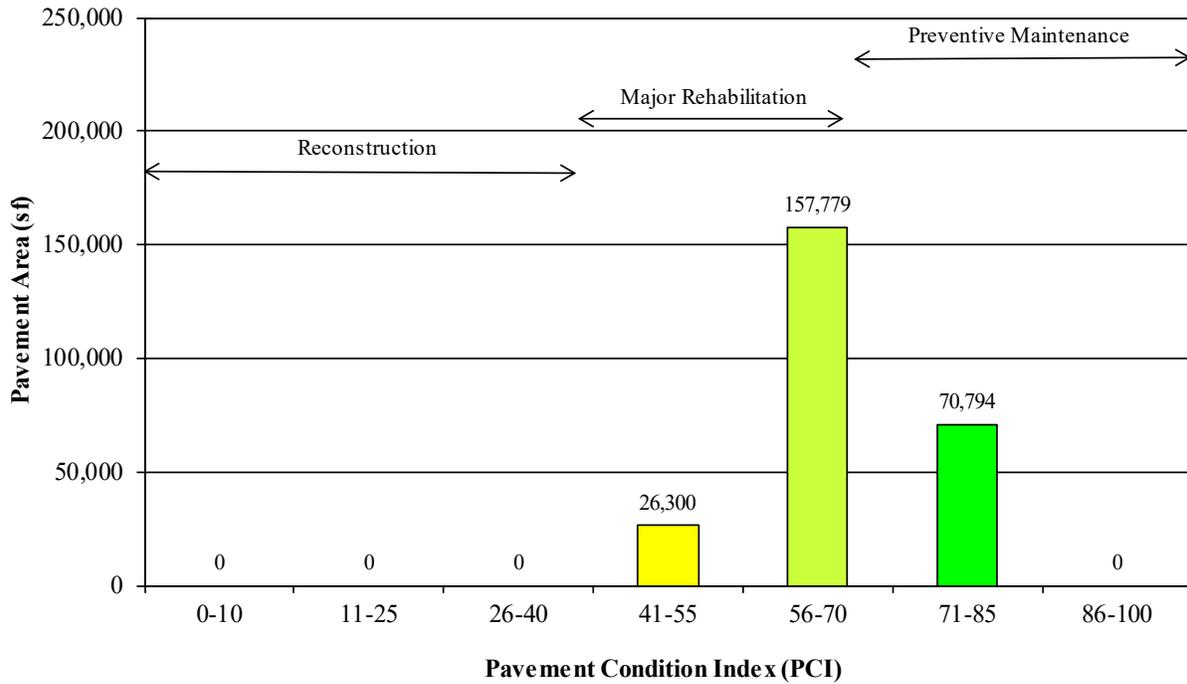
Figure 6. Pavement area by PCI range at Winterset Municipal Airport.

The pavements at Winterset Municipal Airport were inspected on December 5, 2017. The 2017 area-weighted condition of Winterset Municipal Airport is 66, with conditions ranging from 53 to 82 (on a scale of 0 [failed] to 100 [excellent]). During the previous pavement inspection in 2014, the area-weighted PCI of the airport was 89.

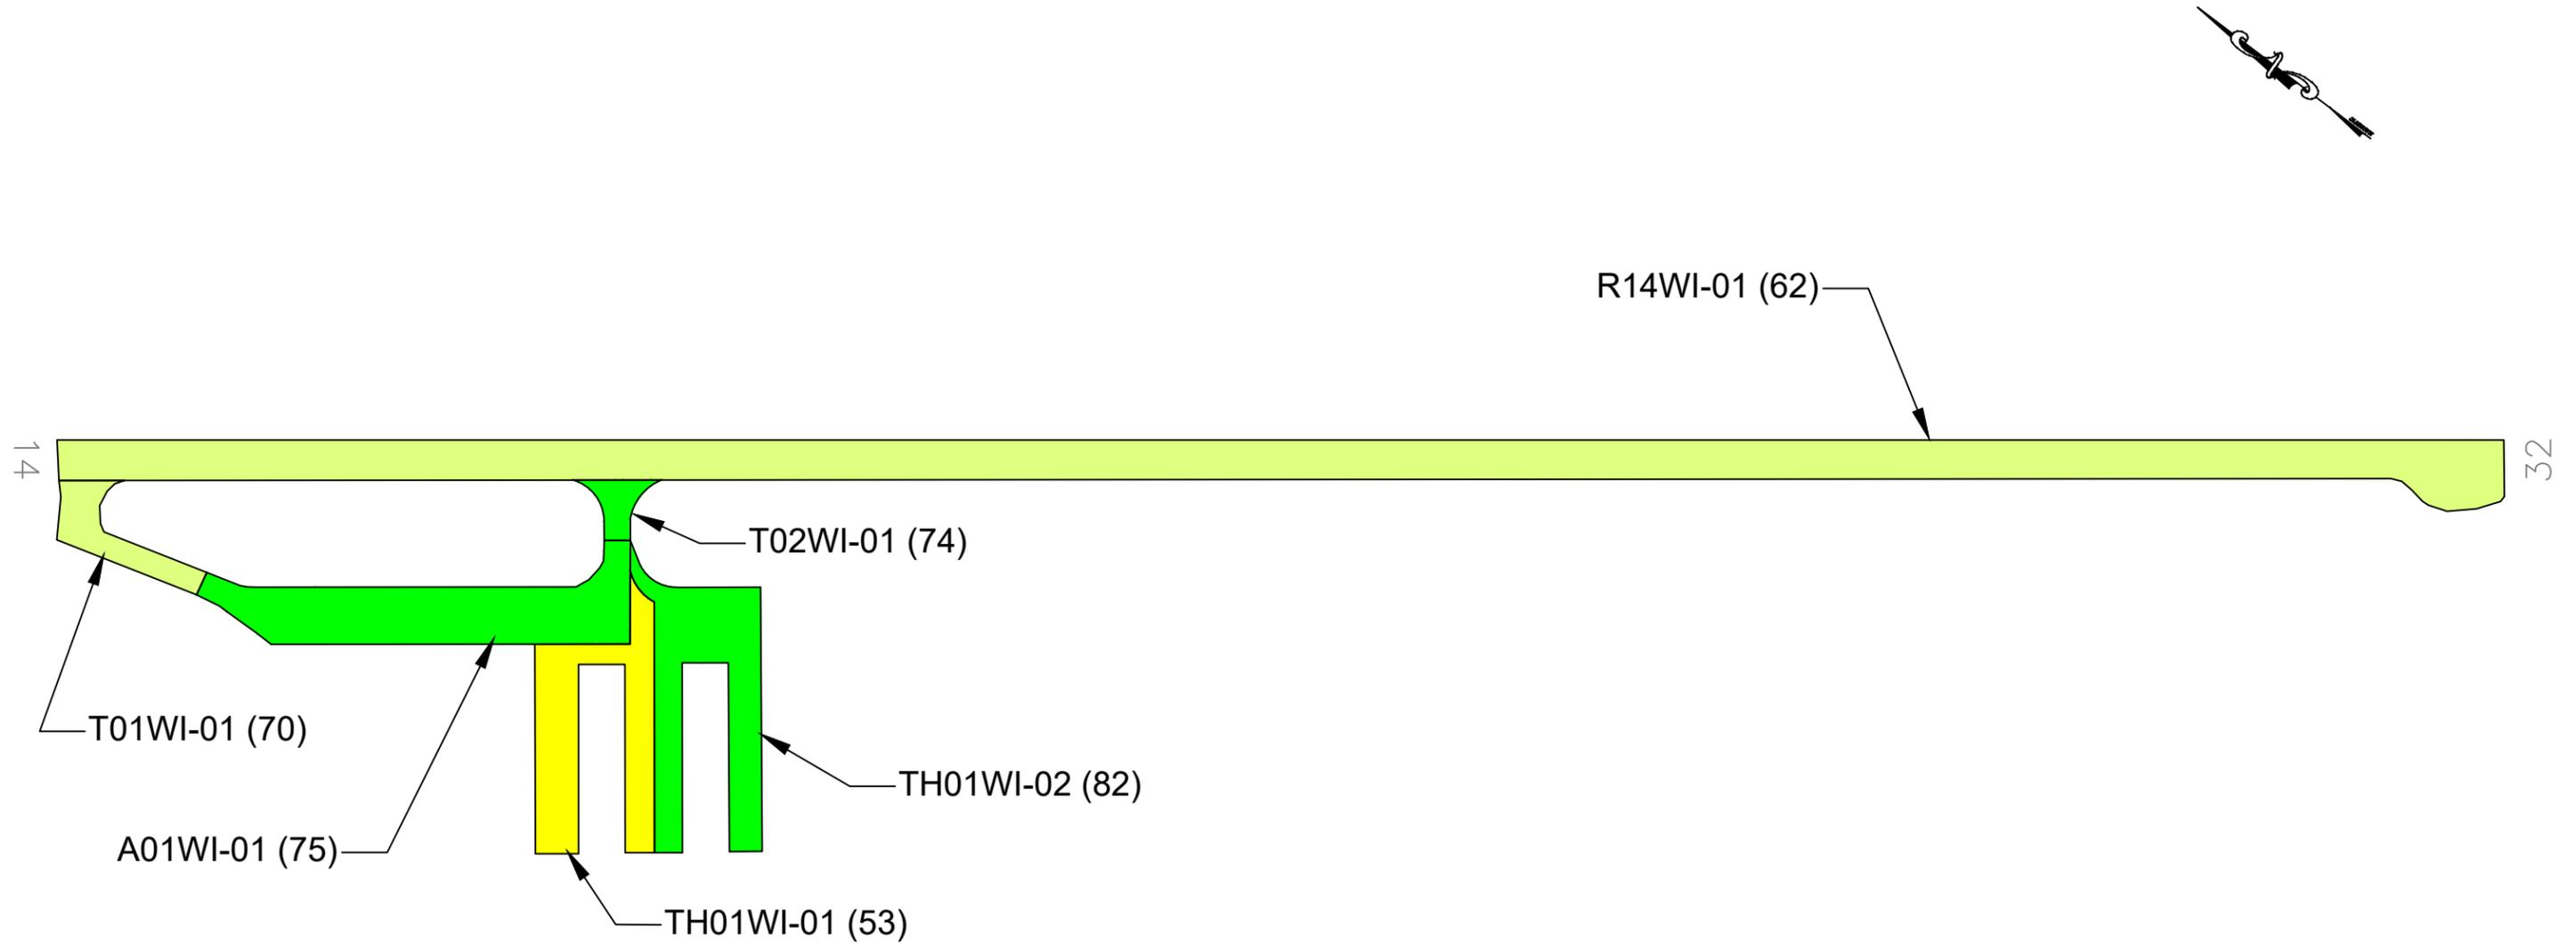
FIGURE 8. PCI MAP.

| Branch ¹ | Section ¹ | Surface Type ² | Section Area (sf) | LCD ³ | 2017 PCI | % Distress due to Load ⁴ | % Distress due to Climate/Durability ⁵ | % Distress due to Other ⁶ | Type of Distresses ⁷ |
|---|---|---|---|---|---|---|---|---|---|
| A01WI | 01 | AC | 37,013 | 6/4/2009 | 75 | 0 | 100 | 0 | L&T Cracking, Raveling, Weathering |
| R14WI | 01 | AAC | 149,219 | 6/1/2005 | 62 | 60 | 38 | 2 | Alligator Cracking, L&T Cracking, Swelling, Weathering |
| T01WI | 01 | AAC | 8,560 | 6/1/2009 | 70 | 31 | 55 | 14 | Alligator Cracking, L&T Cracking, Swelling, Weathering |
| T02WI | 01 | AAC | 3,487 | 6/1/2009 | 74 | 43 | 57 | 0 | Alligator Cracking, L&T Cracking, Weathering |
| TH01WI | 01 | AC | 26,300 | 1/1/2003 | 53 | 33 | 63 | 4 | Alligator Cracking, Depression, L&T Cracking, Raveling, Rutting, Swelling, Weathering |
| TH01WI | 02 | AC | 30,294 | 1/1/2013 | 82 | 0 | 74 | 26 | L&T Cracking, Swelling, Weathering |
