Winterset Municipal Airport

Pavement Management Report

JULY 2024

WINTERSET MUNICIPAL AIRPORT PAVEMENT MANAGEMENT REPORT

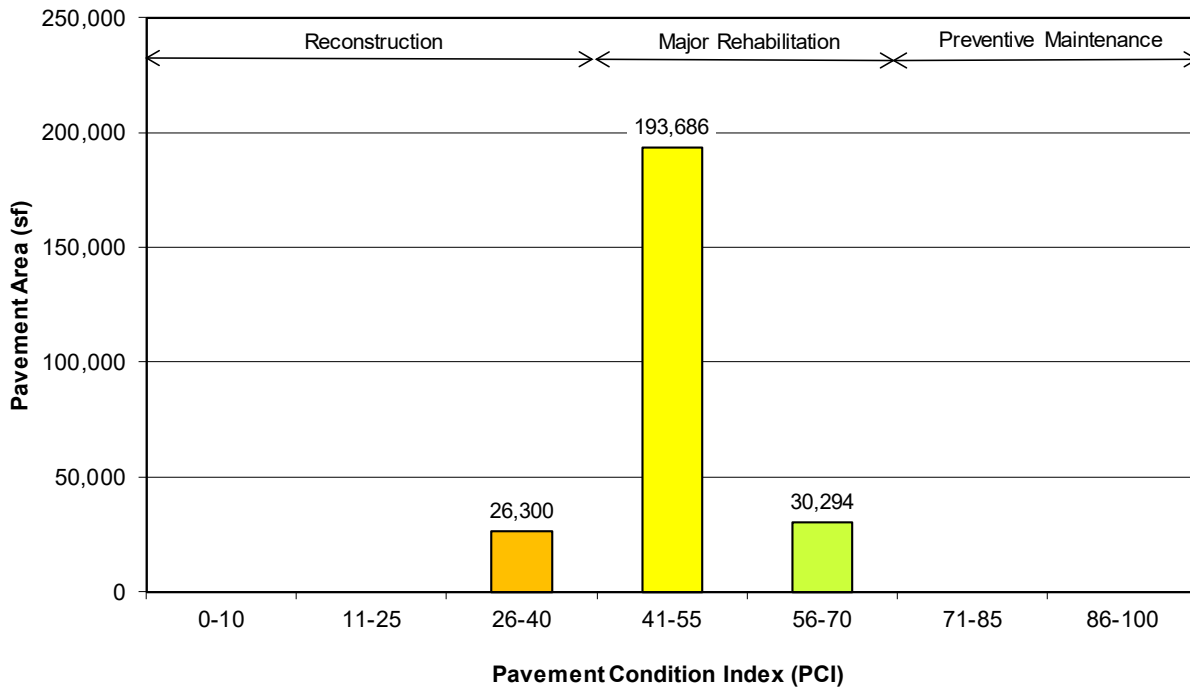
Figure 6. Pavement area by PCI range at Winterset Municipal Airport.

The pavements at Winterset Municipal Airport were inspected in November 2023. The 2023 area-weighted condition of Winterset Municipal Airport is 51, with conditions ranging from 38 to 61 (on a scale of 0 [failed] to 100 [excellent]). During the previous pavement inspection in 2020, the area-weighted PCI of the airport was 57.

Figure 6 summarizes the overall condition of the pavements at Winterset Municipal Airport, and Figure 7 presents area-weighted condition (average PCI adjusted to account for the relative size of the pavement sections) by branch use. Figure 8 is a map that displays the condition of the evaluated pavements. Table 1 summarizes the results of the pavement evaluation. Appendix B presents photographs taken during the PCI inspection, and Appendix C contains detailed information on the distress types observed during the visual survey. Appendix D includes detailed work history information that was collected during the record review process.
