# EVALUATION OF A STEEL GIRDER BRIDGE STRENGTHENED USING FRP PLATES

CTRE Project

**Final Report • November 2005**

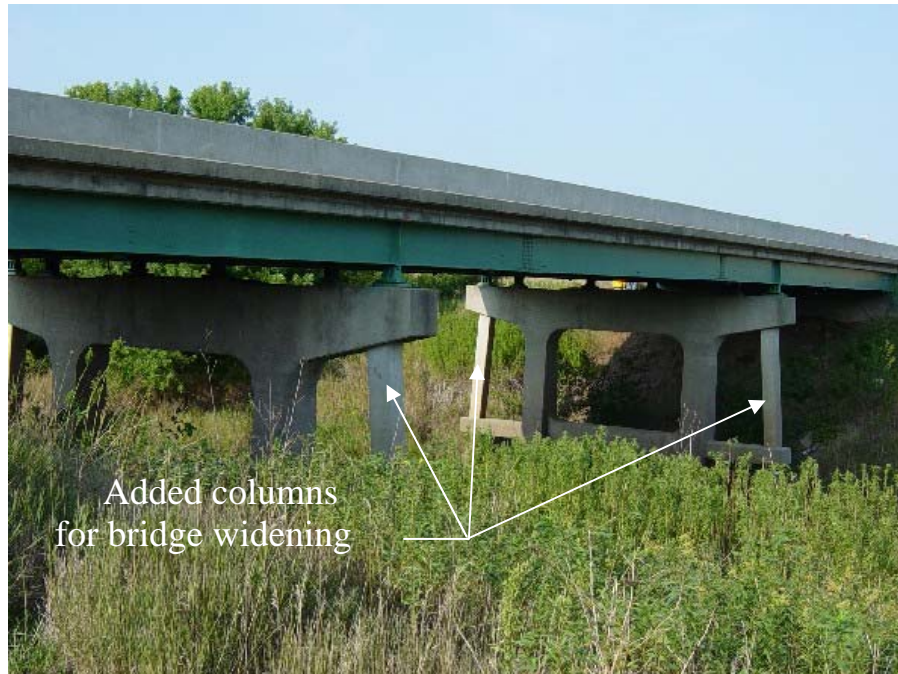
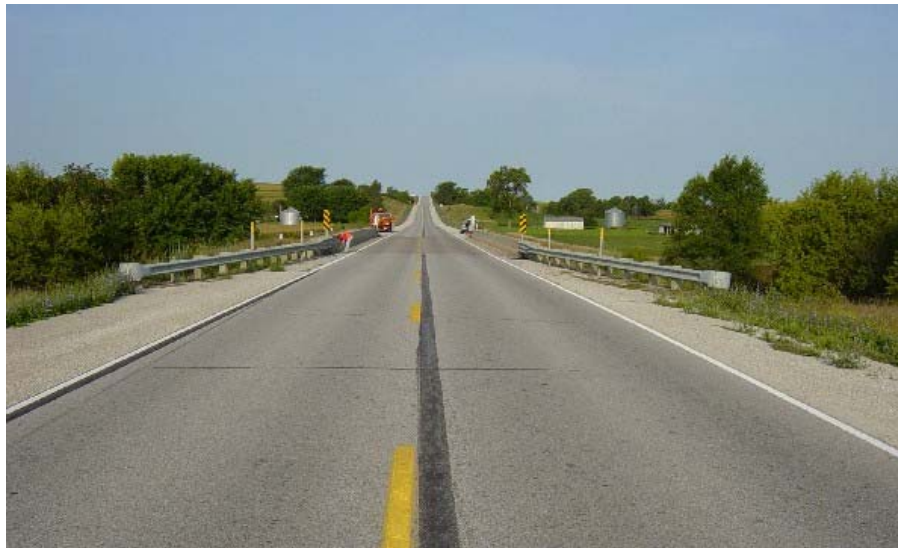
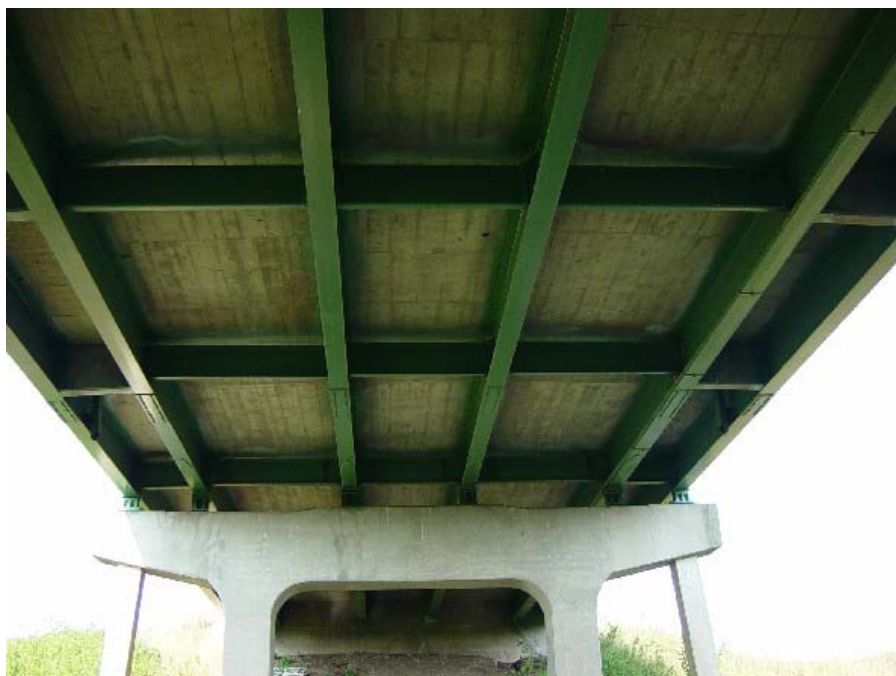
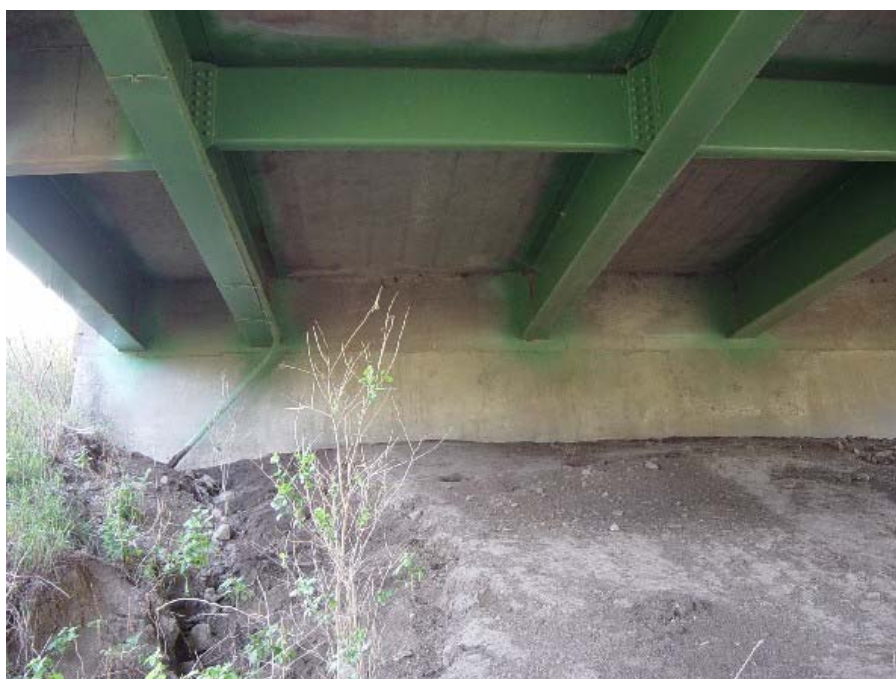
The bridge (Number 7838.5S092) selected for strengthening is a 150 ft x 30 ft three-span continuous I-girder bridge shown in Fig. 1. The bridge is located in southwest Iowa in Pottawattamie County carrying State Highway IA 92 over Walnut Creek. The bridge has two 45 ft - 6 in. end spans and a 59-ft center span. The original non-composite bridge was built in 1938 and was widened on both sides in 1967 by the addition of exterior girders that were constructed composite with the deck. The original bridge deck is a nominal 6.5-in. thick cast-in-place, reinforced concrete slab. The current average deck thickness is approximately 11 in. with 4 - 1/8 in. of crown from the edge of the roadway to the center of the roadway. The bridge deck is supported by two W27x84 exterior girders and four interior girders (two W27x91s and two W27x98s). Girder spacing, diaphragm location, etc., are as shown in Fig. 2. Note that full depth 8-in. thick concrete diaphragms were installed between the W27x91 interior and W27x84 exterior girders when the bridge was widened in 1967. The bridge has no skew. Both abutments are integral concrete supported on treated wood friction piling, and the original piers are open-two-column concrete supported on untreated wood friction wood piling. The piers were also widened on both sides with the addition of a concrete pile at each end in 1967 (see Fig. 1a).

There are a few random vertical and horizontal hairline cracks in both abutments and the east abutment footing has a delaminated area at the top of a construction joint. Several hairline, narrow transverse cracks and a few small delaminated areas exist in the top and bottom surfaces of the deck. Both curbs show moderate hairline cracks. The top of the deck has Portland Cement (PC) patches at several locations, and a few small spalls and delaminated areas along the construction joints.

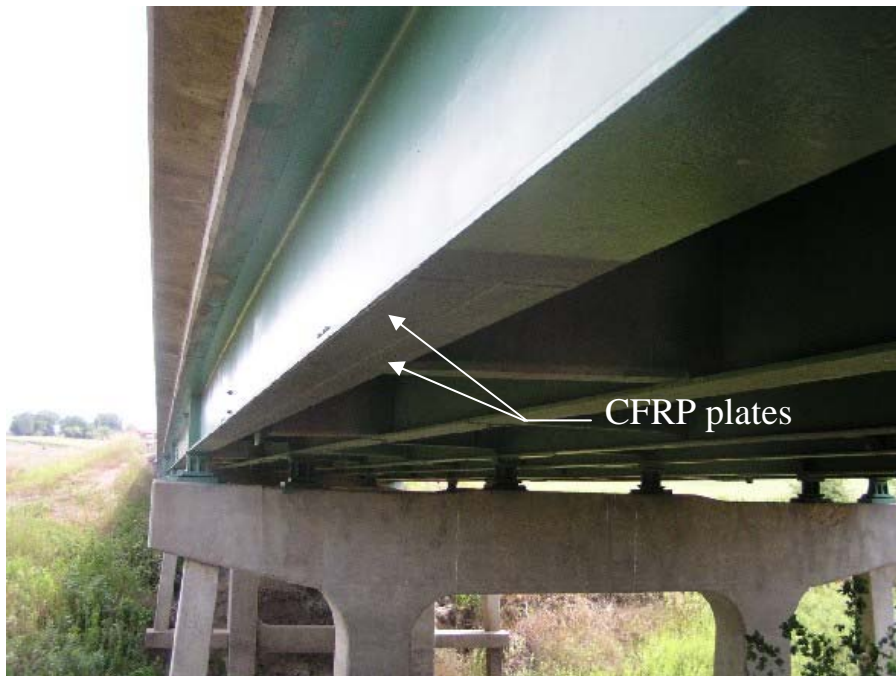
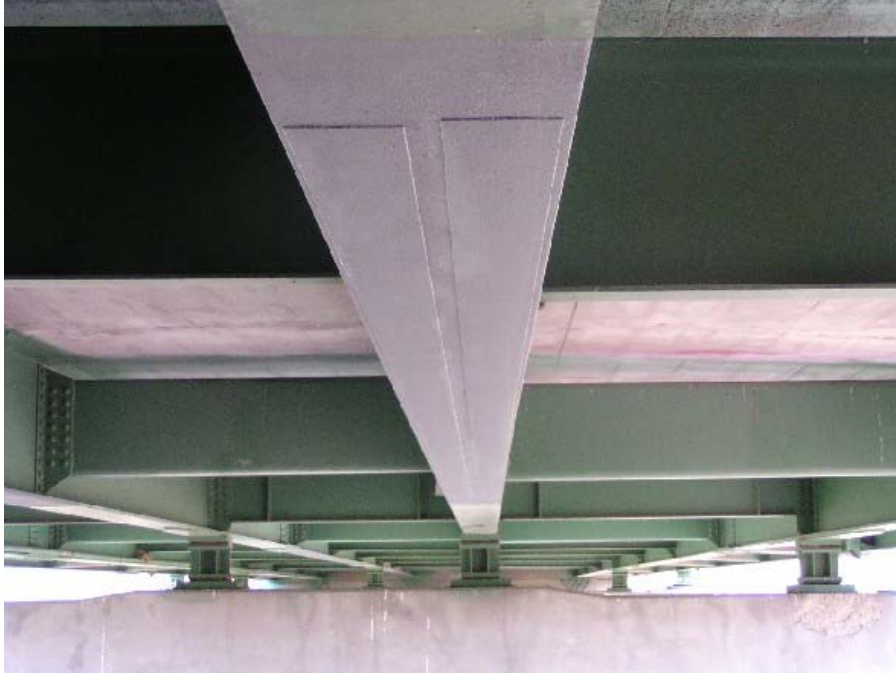
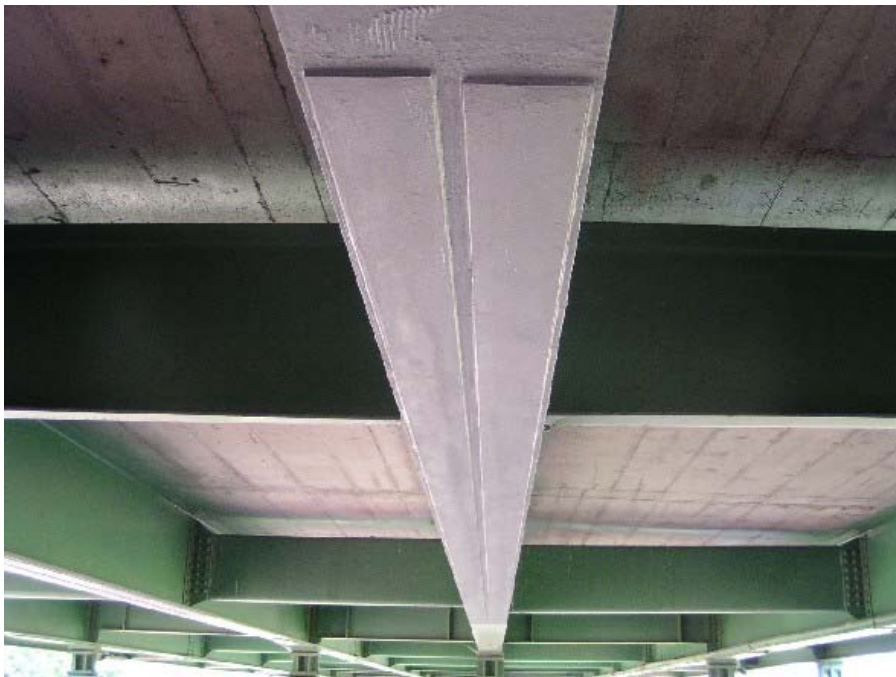
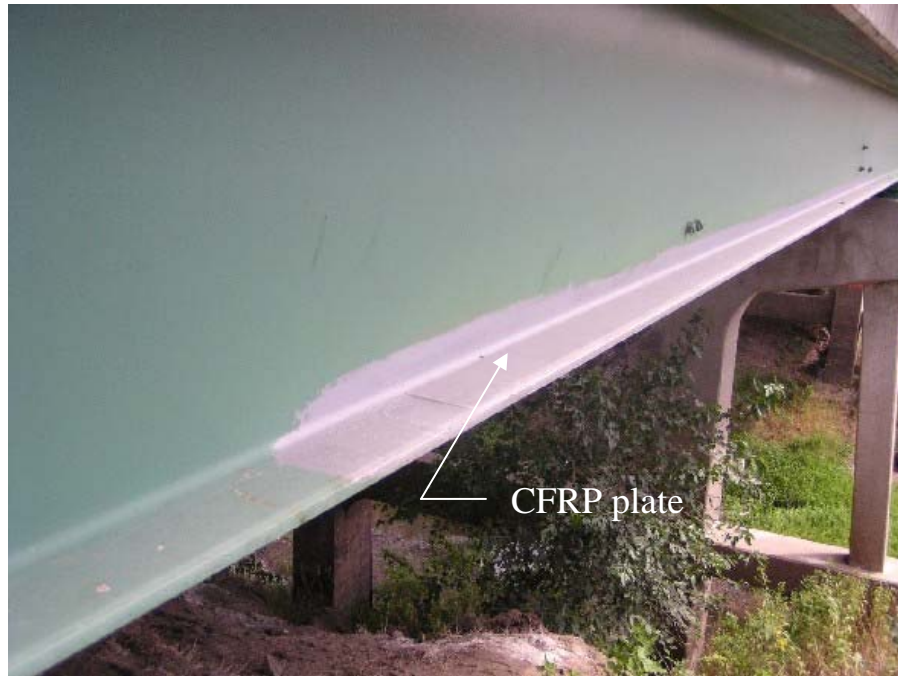
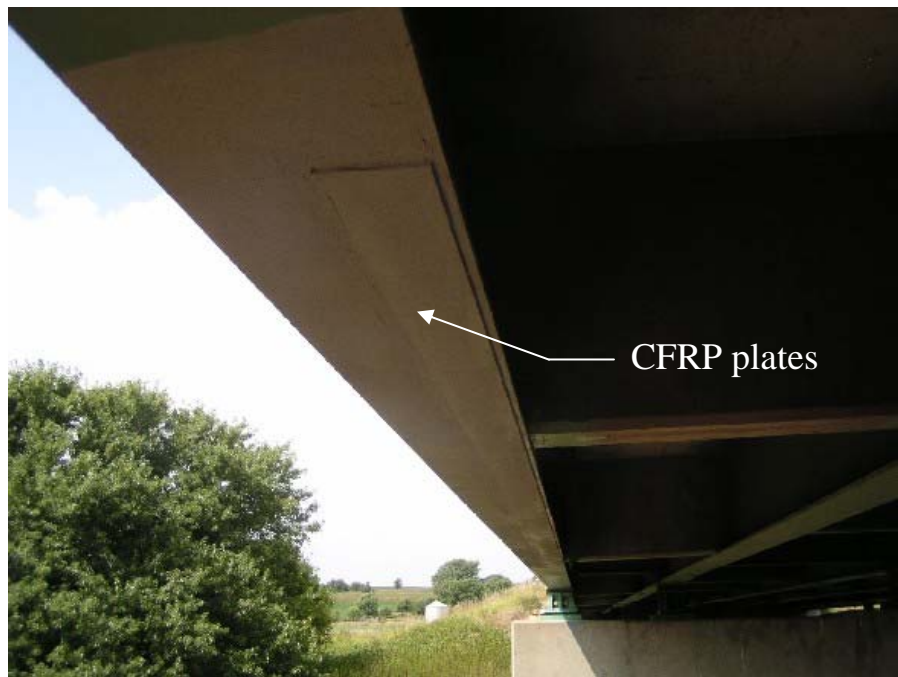
**Figure 21. Photographs of the completed installation.**

As illustrated in Fig. 9, temporary scaffolding was constructed underneath the bridge in both end spans to provide easy access to the girders. Access to the center span was accomplished using a snooper truck. Proper preparation of the bonding surfaces of the plates and girders is critical to achieving a good bond between the girder and plate. The steel girder surfaces to which the CFRP plates were to be bonded were roughened to a coarse sandpaper texture by sandblasting to remove any paint and unsound material. As can be seen in Fig. 10, the work area was covered with a layer of plastic sheeting during sandblasting to contain the paint debris. The resulting sandblasted girder surface can be seen in Fig. 11. After sandblasting, the girder surface was cleaned (see Fig. 12) with a clean rag wetted with acetone. The bonding surfaces of the CFRP plates were also cleaned (see Fig. 13) with acetone to remove all dirt and debris. After the bonding surfaces were dry, the prepared girder surface was treated with a thin layer of FRS Primer (see Fig. 14) to prevent corrosion induced by a galvanic reaction – which occurs when two dissimilar materials are coupled with a corrosive electrolyte [8] – between the girder and carbon fibers. Once the primer had set, a specially designed pneumatic caulking nozzle was used to mix the two-components of the ECS 104 structural epoxy (see Fig. 15). The structural epoxy was applied to both the pre-cut (see Fig. 16) CFRP plates (see Fig. 17a) and the girder surface (see Fig. 17b) using a 1/8 in. v-notched trowel. The plate was then carefully placed on the girder surface (see Fig. 18), starting at one end, taking special care to ensure a “straight” application. A smooth, hand roller was then used to apply pressure to the plate to evenly distribute the epoxy and to remove any trapped air (see Fig. 19). A smooth trowel was then used to remove any excess epoxy (see Fig. 20) from the edges of the CFRP plates. After all plates were installed, all surfaces were painted. Photographs of the completed installation are presented in Fig. 21.

The handling and installation of the CFRP plates was relatively labor intensive and required some training. At least a three-man crew was needed to install the system (one day per layer: three days for three layers). It is recommended that a periodic visual inspection be made at the bond line on each strengthened girder to investigate any bond failure or slip at the bonding surface; if any signs of delamination or bond failure are detected, appropriate actions should be taken since these types of failure would lead to a significant reduction in strength.
