1. Report No.	2. Government Accession No.	3. Recipient's Catalog No.	
4. Title and Subtitle Testing and Evaluation of the Iowa DOT FRP Temporary Bypass Bridge		5. Report Date March 2008

Testing and Evaluation of the Iowa DOT FRP Temporary Bypass Bridge

Bridge Engineering Center

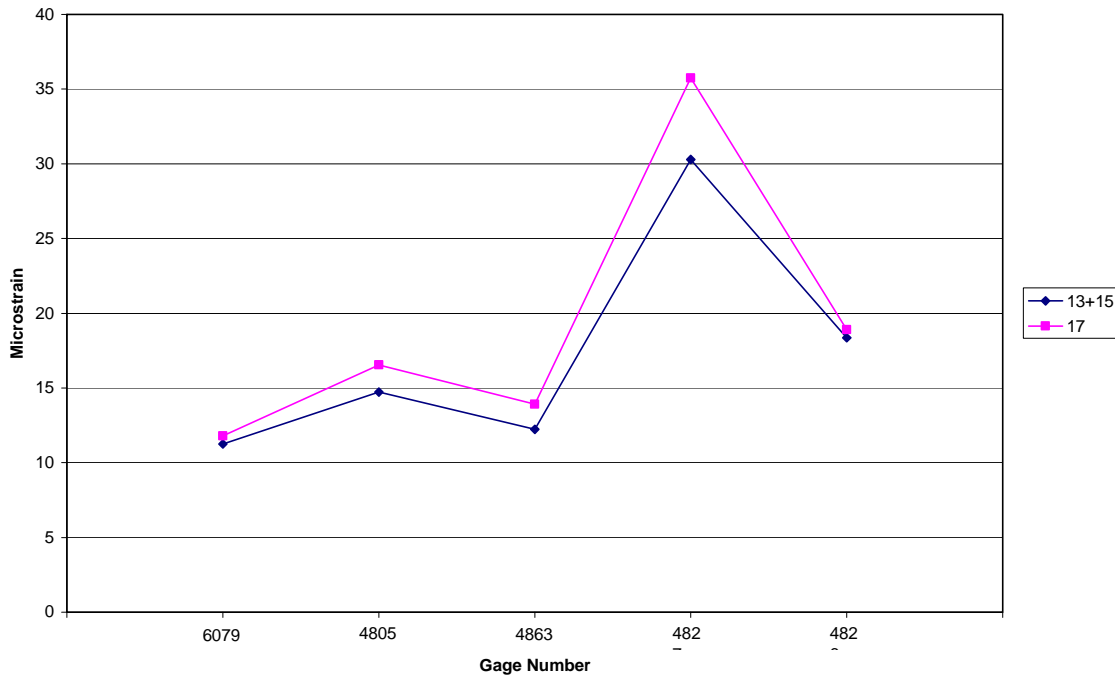
This preliminary testing was helpful in establishing a level of confidence in the performance of the bridge and test set-up. Illustrated in Fig. 19 are the midspan strains profiles for an individual deck panel loaded with two point loads simultaneously (load case 17) as well as the same two point loads loaded individually and then superimposed (load cases 13 and 15). Figure 19, and other data, confirms that the principle of superposition is applicable. Preliminary testing also confirmed that calculated maximum mid-span strains correlated well with maximum measured mid-span strain for a legal load truck.

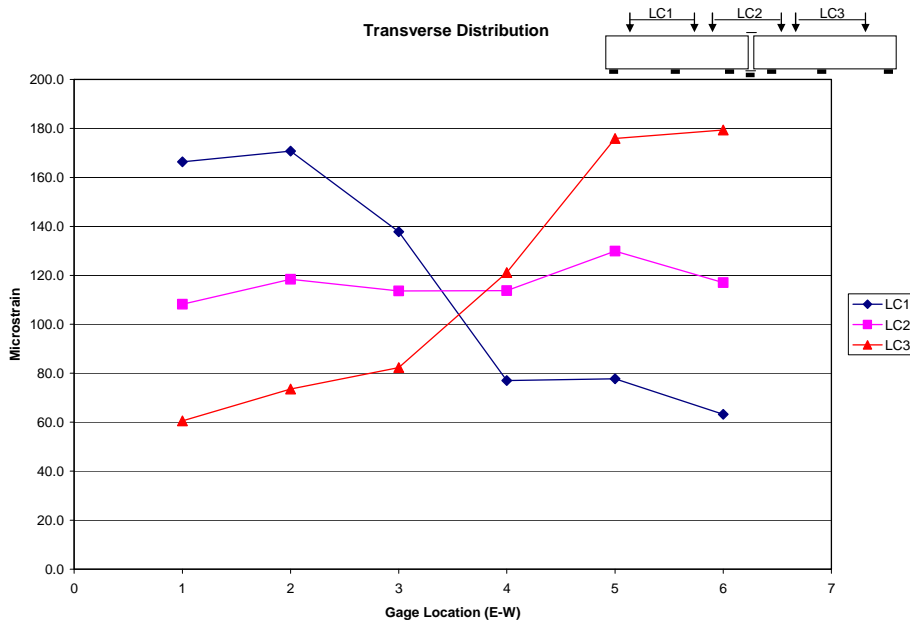
Figures 27 and 28 illustrate the transverse distribution of strain at mid-span for a single lane loaded and two lanes loaded, respectively (similar transverse distribution was calculated at quarter-span but is not shown here). The two lanes loaded case was approximated by superposition of LC 1 and 3. As shown, it is evident that the distribution of strain is relatively symmetric about the longitudinal centerline of the bridge, which suggests adequate load transfer from panel to panel by the steel connection plates. Note that SG7 strain data are not shown in Fig. 27 or 28; these data represent the strain on the steel connection plates. Generally, the strains measured in the steel connection plates were smaller in magnitude than those in the FRP, possibly the result of slip occurring between the connection plate and the panels as well as other factors.

Figure 27. Transverse load distribution at mid-span for all three load cases.

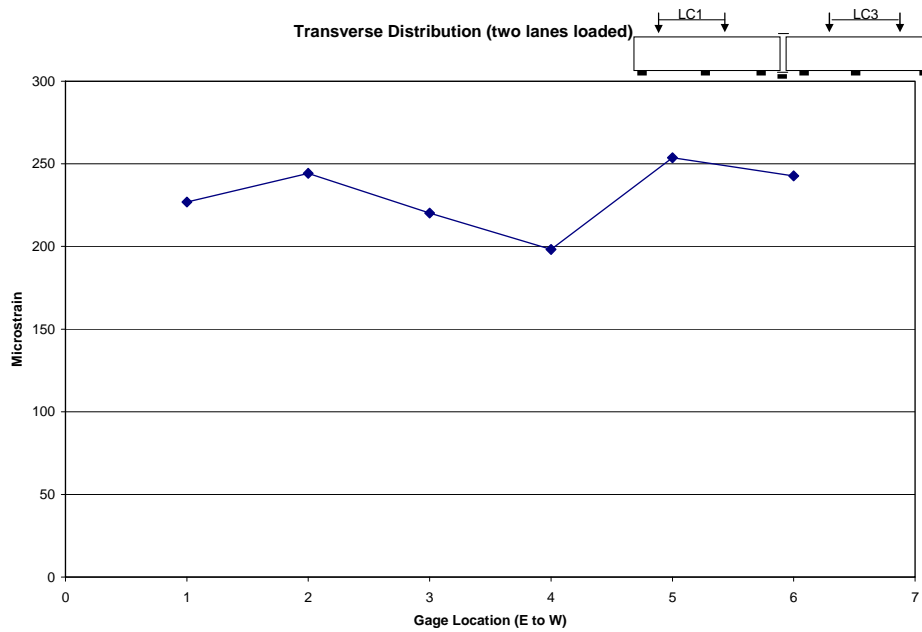
Figure 28. Transverse load distribution at mid-span, two lanes loaded.

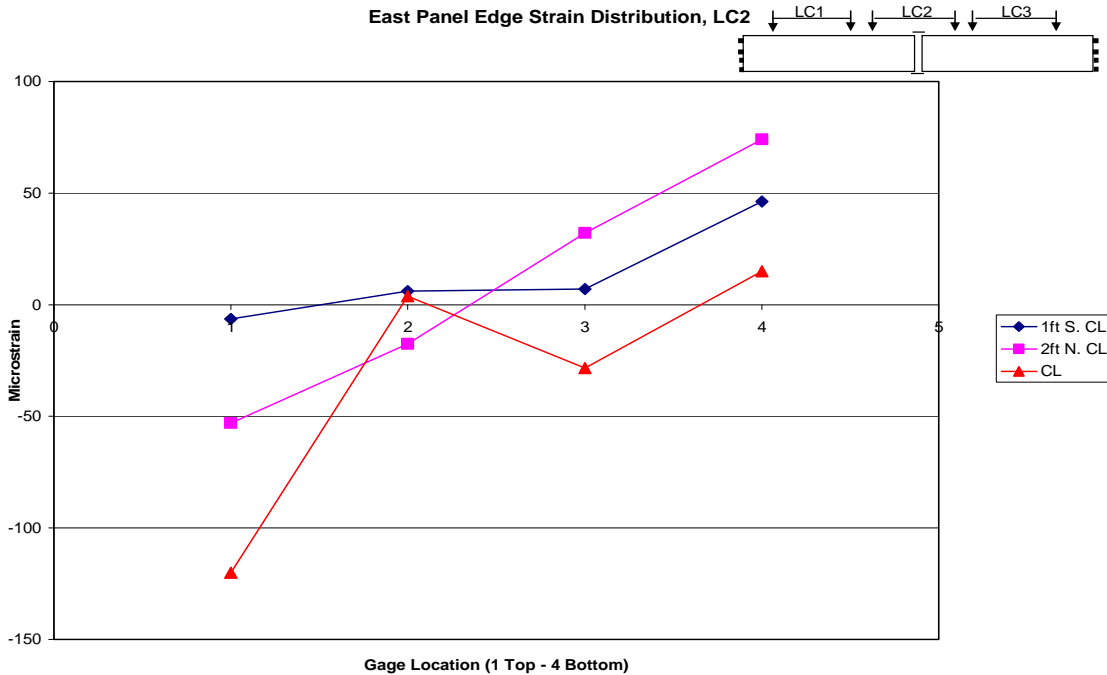
For testing, three vertical cross-sections were instrumented on both the East and West side of the bridge (1ft south of centerline, centerline, and 2 ft north of centerline, see Fig. 29), with four gages placed throughout each cross-section. Figures 30 and 31 illustrate the vertical strain distribution at each location for the East and West sides, respectively, for LC2 which is representative of all load cases. Figures 30 and 31 suggest that there are differences in the neutral axis location from cross section to cross section on the sides of the panels; additionally, Figure 24 also illustrates that the neutral axis may vary across the width of the panel. The reasons for the variability in neutral axis from cross section to cross section are unknown.

Figure 30. Side panel strain distribution, East side, LC2.

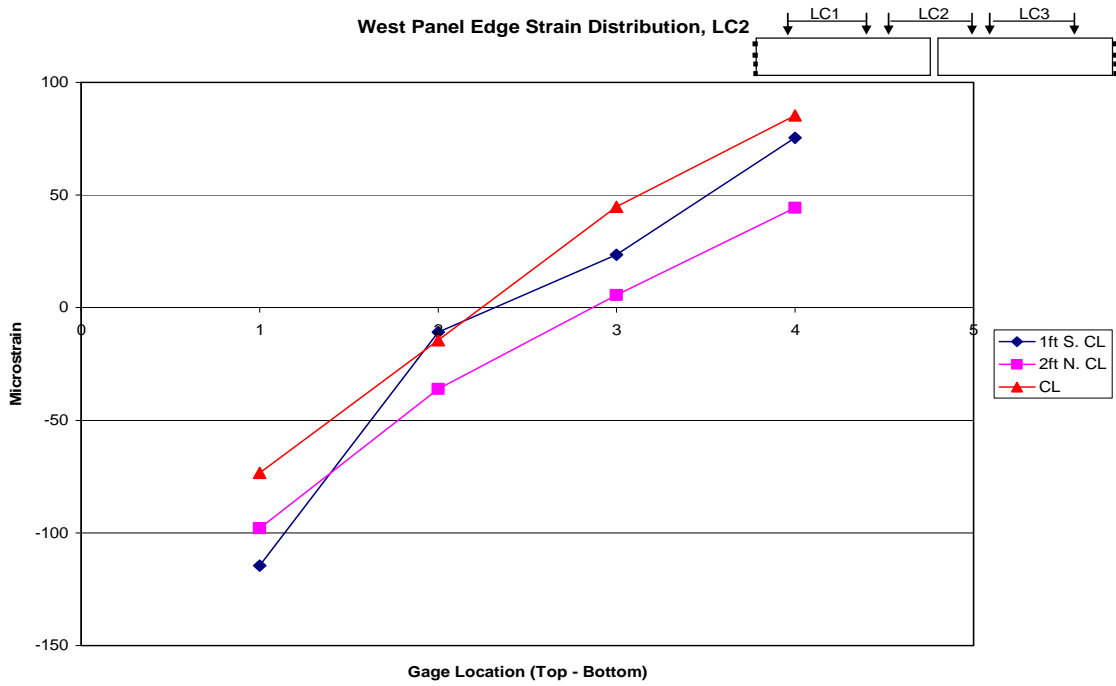
Figure 31. Side panel strain distribution, West side, LC2.

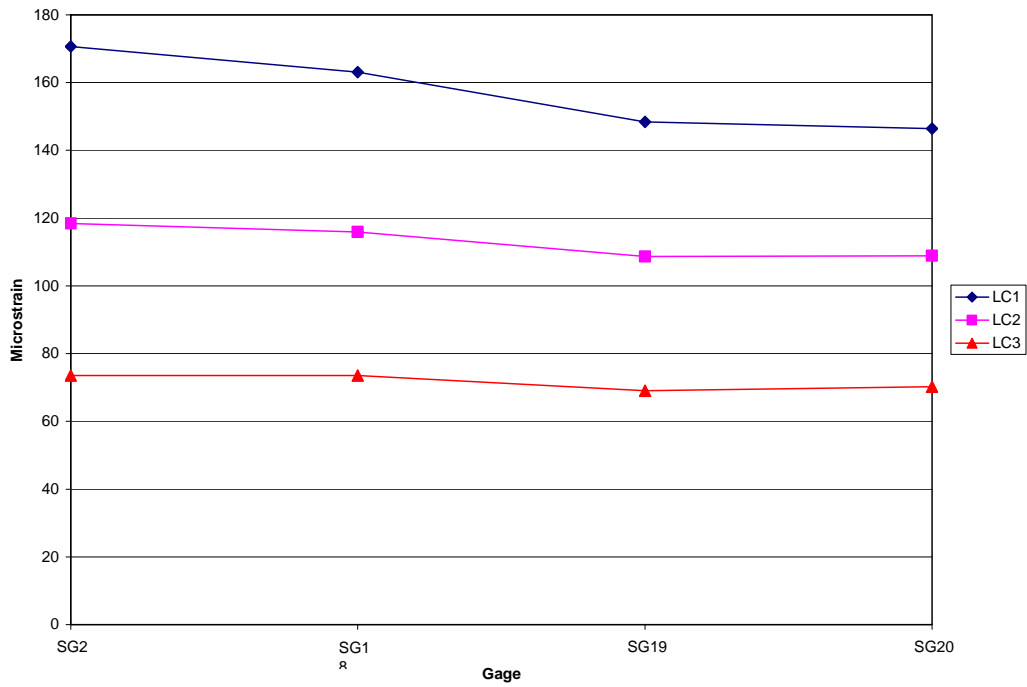
Figure 32 illustrates the strain profile for gages SG2, SG18, SG19 and SG20, on the bottom of the deck for all three load cases. It is evident from Fig. 32, that transverse distribution of load from bottle to bottle is adequate and relatively constant regardless of load position.

Figure 32. Transverse strain distribution from bottle to bottle.
