EVALUATION OF THE BETTENDORF BRIDGE, IOWA

**Final Report
July 2006**

A report from
Center for Transportation Research and Education

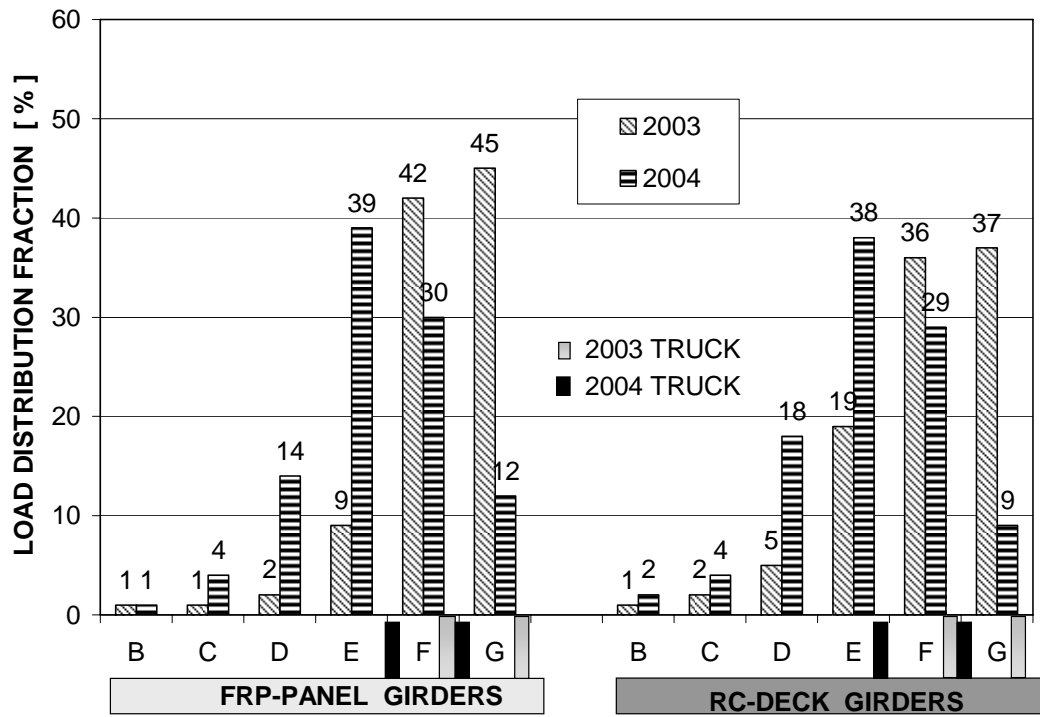
Figure 40. Path Y3 LDF

The Path Y2 LDF, shown in Figure 39, illustrates the same pattern between the two tests with only minimal differences. Although Path Y3 and Path Y4 were not coincident during the two-year study, it was observed that the LDFs for both were lower than 47% (Figure 40 and Figure 41).

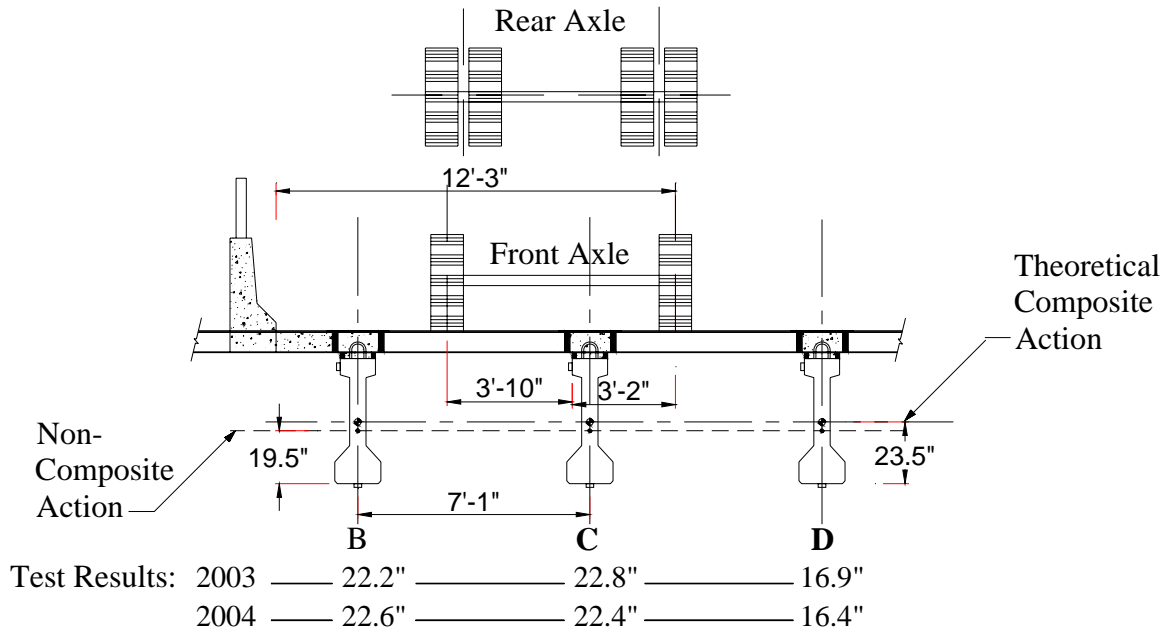
Figure 46. Neutral Axis: 2003 and 2004 Tests - FRP-deck span – Path Y1

The experimental neutral axis locations were determined for all transverse load positions. Figure 46 shows the neutral axis results for Path Y1 measured from the bottom flange over the most heavily loaded girders. As can be observed, the neutral axis locations did not significantly change over time. For Girders B and C, the values obtained show that composite action was likely achieved. For Girder D, the measured neutral axis location was below even the non-composite action (girder's neutral axis location, 19.4 in.). This can likely be attributed to a weak shear connection and the possibility of torsion effects of the truck loading typically ignored during design. This observation is validated later.

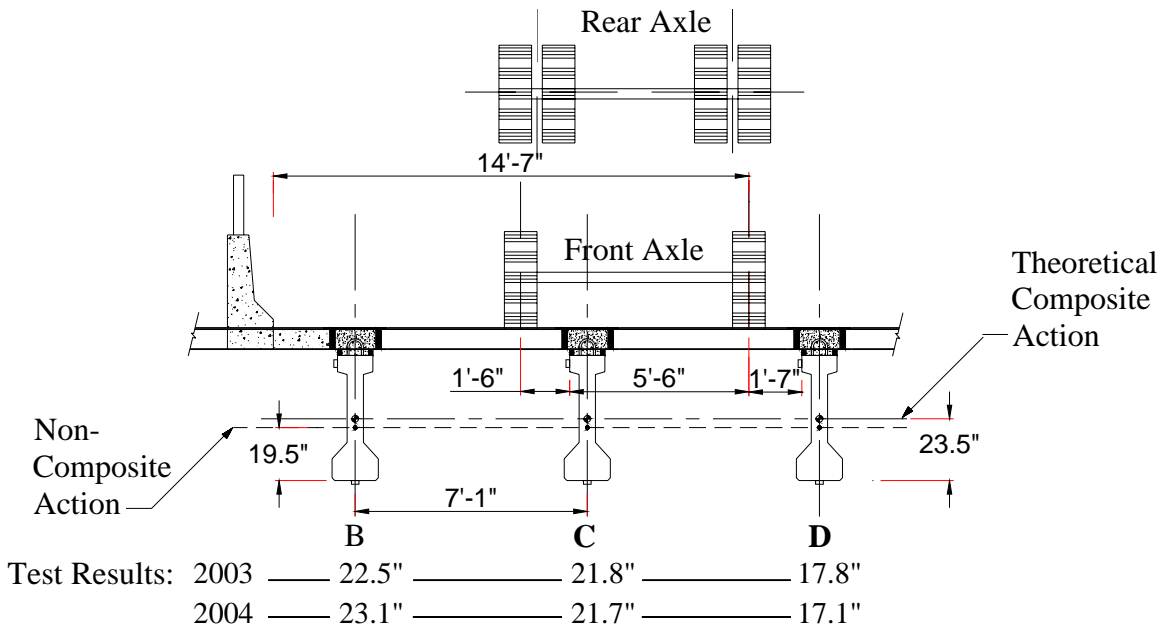
Figure 47. Neutral Axis: 2003 and 2004 Tests - FRP-deck span – Path Y2

For Path Y2, Girders B, C and D were the most heavily loaded. Figure 47 shows the wheel positions relative to Girders C and D and the resulting neutral axis locations for both tests. Girder D's measurements again indicated a neutral axis position below the neutral axis of the girder alone.

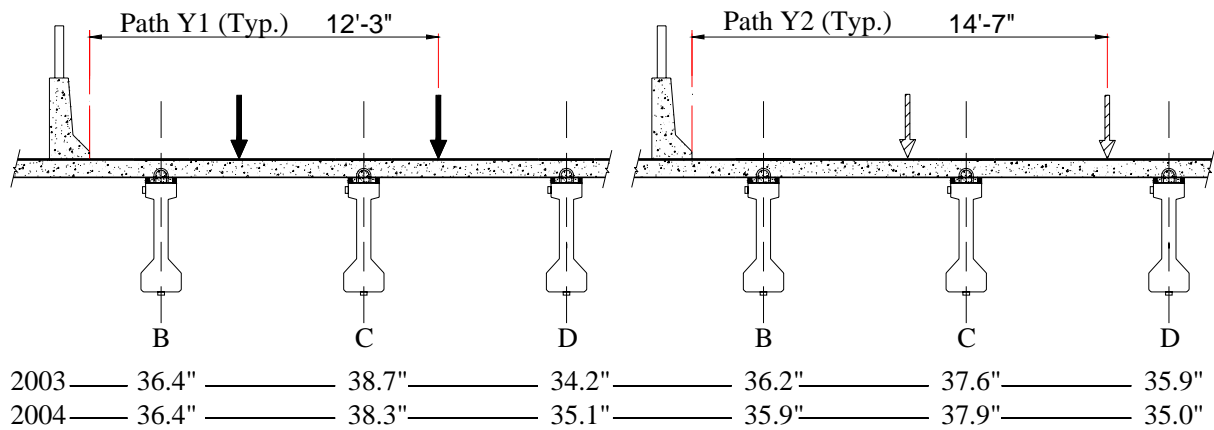
Figure 48. Neutral Axis: 2003 and 2004 Tests - RC Deck Span Comparison

Figure 48 shows the location of the neutral axis in the RC deck span for the two tests. The values were similar between the two tests and indicated that a high degree of composite action was likely achieved (design neutral axis of 38.0 in).

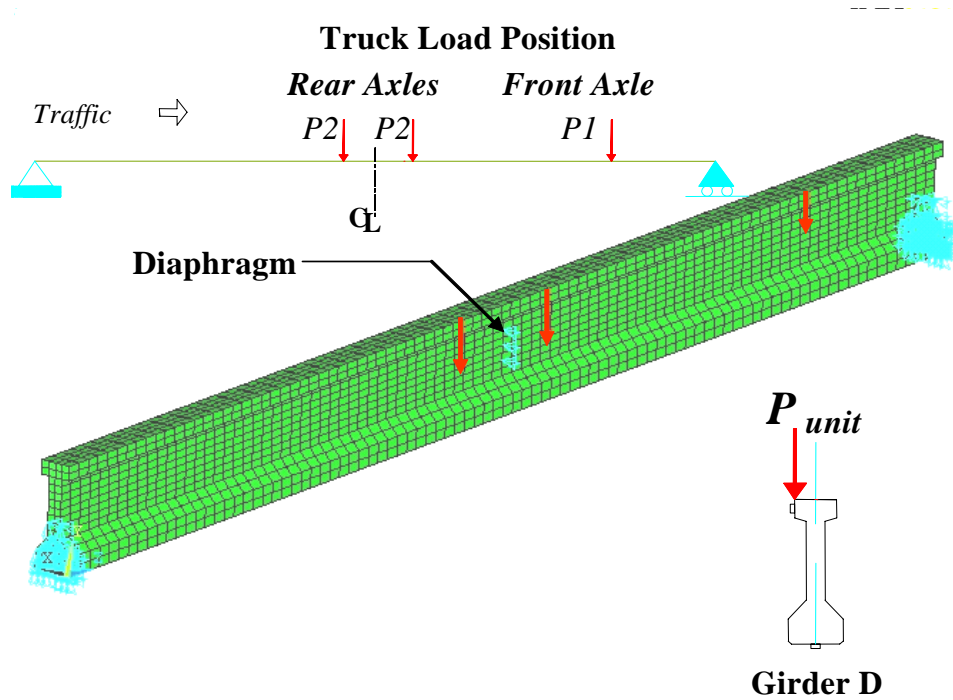
Figure 49. Analysis of Eccentric Load on Interior Girder D

To evaluate the impact of torsion in either Girder D or E, a single prestressed girder was modeled using a commercial finite element program. In this modeling, a three-dimensional element with simply supported ends and an intermediate diaphragm was used. The specific geometric and material properties used in the Bettendorf bridge were modeled. As shown in Figure 49, loads were placed at a position causing high live load bending stresses. Two specific cases were studied. In one case, the loading consisted of applying eccentric unit loads to cause torsion and bending in the girder. The other case considered centered loads applied on the girder which only caused bending.

The results of the torsional loading analysis showed that the absolute strains on the top flange were larger than the strains on the bottom flange, contrary to the results found for the flexural only loading analysis. It should be noted that for both loading cases, the same strain levels were obtained on the bottom flange. This can be explained as follows: without restraint (mid-span condition) the flange can warp and bend about the minor axis of the girder (Figure 50). Thus, the gage on the top flange captured two effects: pure bending and warping due to torsion. For the bottom flange, warping stresses are zero at the location when the strain transducers were placed. Thereby, when the neutral axis location was computed based on the gage positions and strains, similar to the field neutral axis computation, the increased top strain shifted the neutral axis down. For the torsional loading analysis, the obtained neutral axis was approximately 17 in., measured from the bottom flange, and was approximately 20 in. for the flexural loading analysis.

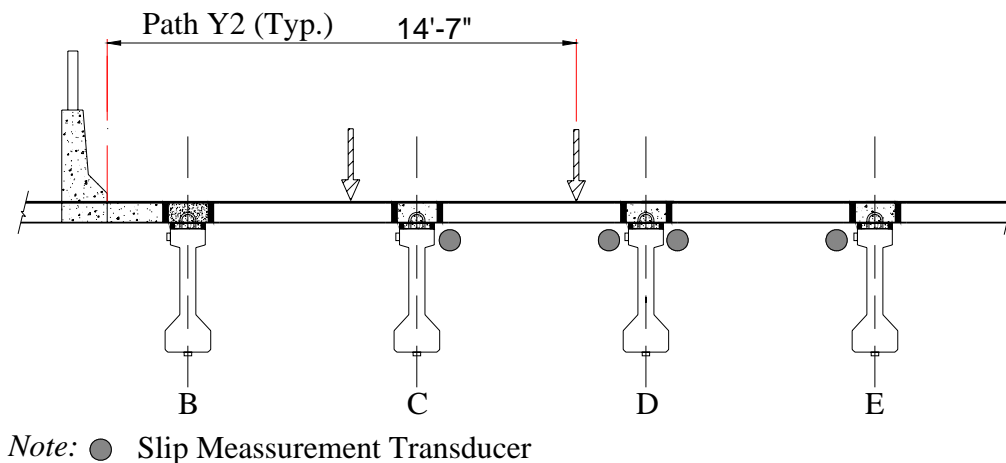
Figure 51. Location of Slip Instrumentation with Respect Path Y2

Figure 51 shows the location of four slip-measurement transducers installed underneath the FRP panel on the top flange of Girders C, D and E. As expected, the differential horizontal displacement (slip) between the concrete girder and the FRP deck was found to be greatest when the truck was in the immediate vicinity of the instrumentation locations. The most critical case for these specific girders corresponded to Path Y2.

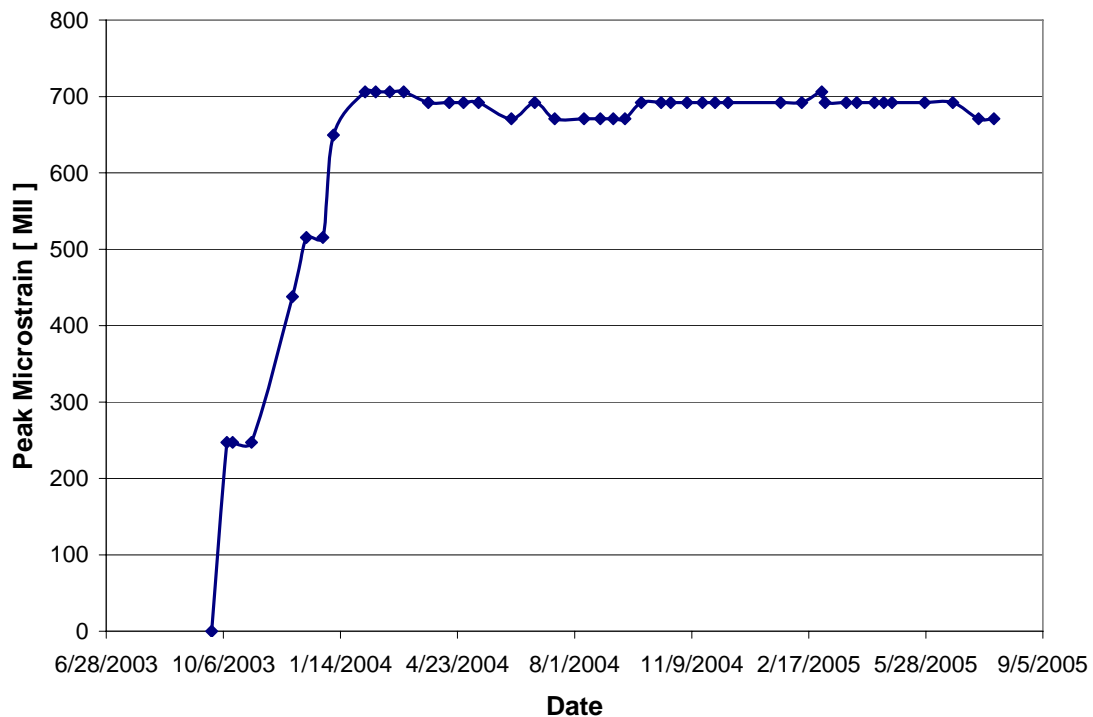
Figure 56. Girder B: Peak Strain Results

Figure 56, Figure 57 and Figure 58 illustrate three representative graphs of peak strain versus time. As can be seen in these graphs, the girders each reached peak strains that were between 650 and 750 MII. The consistency between the peak strains for the various girders indicates that there were very small differences in the response of the girders. It should be pointed out that 650

to 750 MII assuming an modulus of elasticity of 4 ksi corresponds to stress levels in the range of 2.6 to 3.0 ksi and are significantly higher than the strain levels measured during short-term testing. It was found, to the surprise of the research team, that the peak strain gages used in this work were not temperature corrected as the manufacturer had claimed. Therefore, the peak strain recorded by the sensors was the peak of temperature strains plus live load strains. In this case, the strains induced by temperature effects are several times greater than those one would expect under live load. Thus, the research team used a different approach to assess whether damage had occurred. To accomplish this, the research team analyzed the air temperature and active strain data (which when the bridge is unloaded represents temperature strain only) to identify changes in bridge stiffness. Although not a direct assessment of the likelihood of overload, when combined with the visual inspection results presented herein, the research team believes that the observed deterioration was the result of an overload event. Shown in Figure 59, Figure 60 and Figure 61 are examples of the temperature and active strain data for select girders. As can be seen, there is good correlation between the active strain levels and the ambient air temperature. This indicates that the girders were consistently responding to changes in temperature and that there was not likely any damage that would have occurred from an overloaded truck.
