### Technical Report Documentation Page

# **Testing and Evaluation of the Iowa DOT FRP Temporary Bypass Bridge**

### **Bridge Engineering Center**

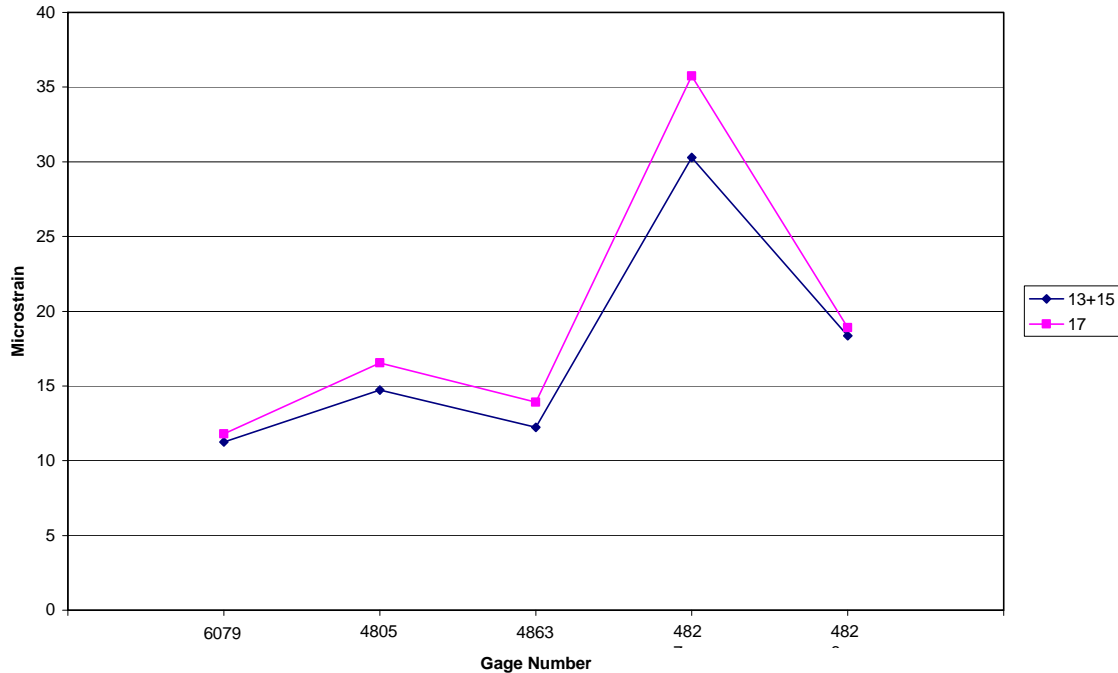
This preliminary testing was helpful in establishing a level of confidence in the performance of the bridge and test set-up. Illustrated in Fig. 19 are the midspan strains profiles for an individual deck panel loaded with two point loads simultaneously (load case 17) as well as the same two point loads loaded individually and then superimposed (load cases 13 and 15). Figure 19, and other data, confirms that the principle of superposition is applicable. Preliminary testing also confirmed that calculated maximum mid-span strains correlated well with maximum measured mid-span strain for a legal load truck.

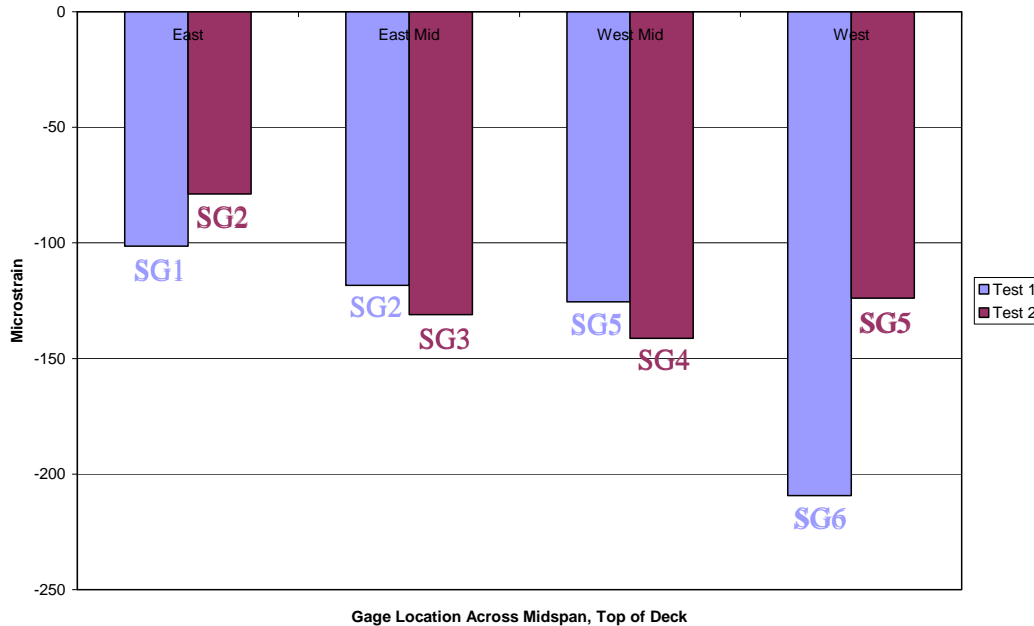
Figure 25. Top panel strain correlation, LC3, Test 1 and 2.

Illustrated in Fig. 24 is the strain profile for the top and bottom gages at mid-span for load case 2 (LC2) for Test 1, which is a symmetrical truck position, and is generally representative of all three load cases for Test 1. Figure 24 indicates that there may be some discrepancy at gage location SG6 (T). Illustrated in Figs. 25 and 26 are panel strain readings from Test 1 and Test 2, respectively, in the area around gage SG6. Based on these two figures, it would appear that the strain measured at SG6 (T) for Test 1 is suspect. It is unclear whether this is due to localized effects from the close proximity of the rear axles, gage bonding issues, or other effects.

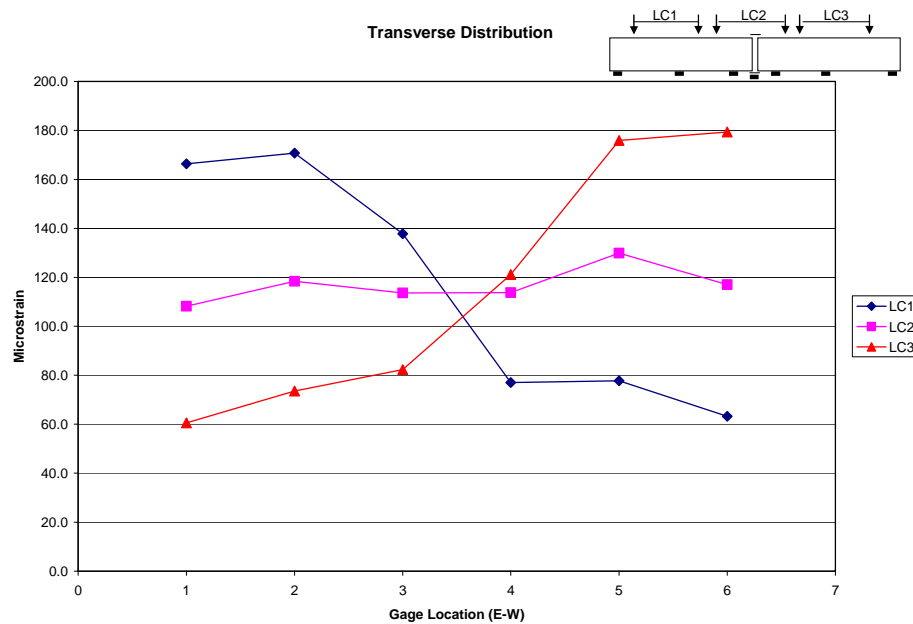
Figure 27. Transverse load distribution at mid-span for all three load cases.

Figures 27 and 28 illustrate the transverse distribution of strain at mid-span for a single lane loaded and two lanes loaded, respectively (similar transverse distribution was calculated at quarter-span but is not shown here). The two lanes loaded case was approximated by superposition of LC 1 and 3. As shown, it is evident that the distribution of strain is relatively symmetric about the longitudinal centerline of the bridge, which suggests adequate load transfer from panel to panel by the steel connection plates. Note that SG7 strain data are not shown in Fig. 27 or 28; these data represent the strain on the steel connection plates. Generally, the strains measured in the steel connection plates were smaller in magnitude than those in the FRP, possibly the result of slip occurring between the connection plate and the panels as well as other factors.

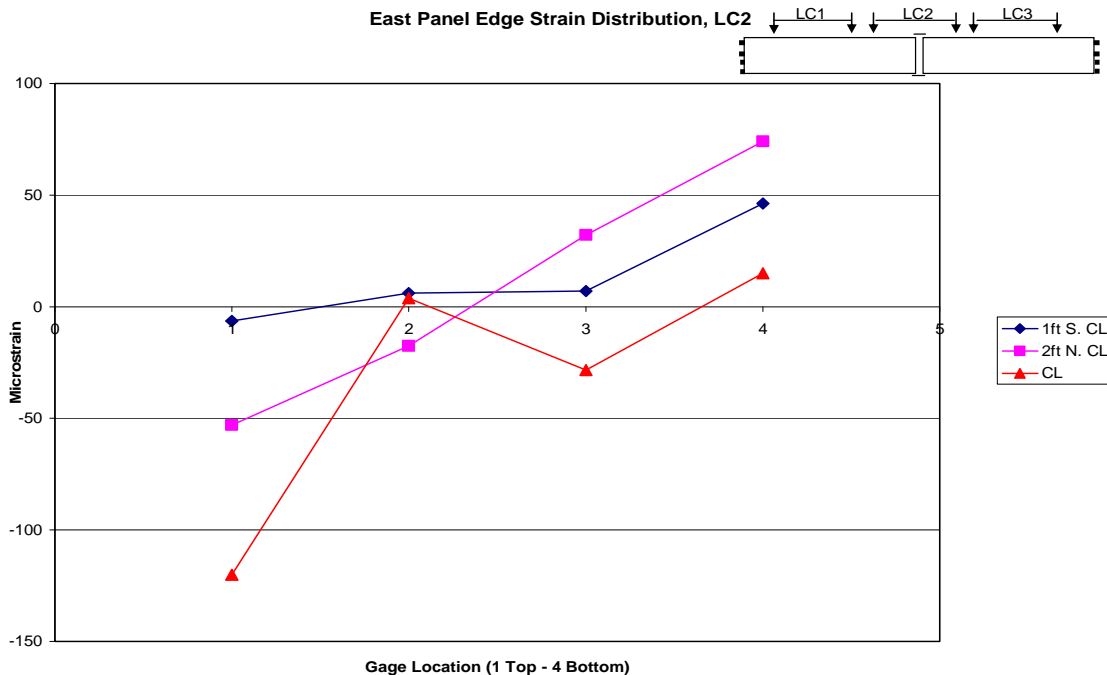
Figure 30. Side panel strain distribution, East side, LC2.

For testing, three vertical cross-sections were instrumented on both the East and West side of the bridge (1ft south of centerline, centerline, and 2 ft north of centerline, see Fig. 29), with four gages placed throughout each cross-section. Figures 30 and 31 illustrate the vertical strain distribution at each location for the East and West sides, respectively, for LC2 which is representative of all load cases. Figures 30 and 31 suggest that there are differences in the neutral axis location from cross section to cross section on the sides of the panels; additionally, Figure 24 also illustrates that the neutral axis may vary across the width of the panel. The reasons for the variability in neutral axis from cross section to cross section are unknown.

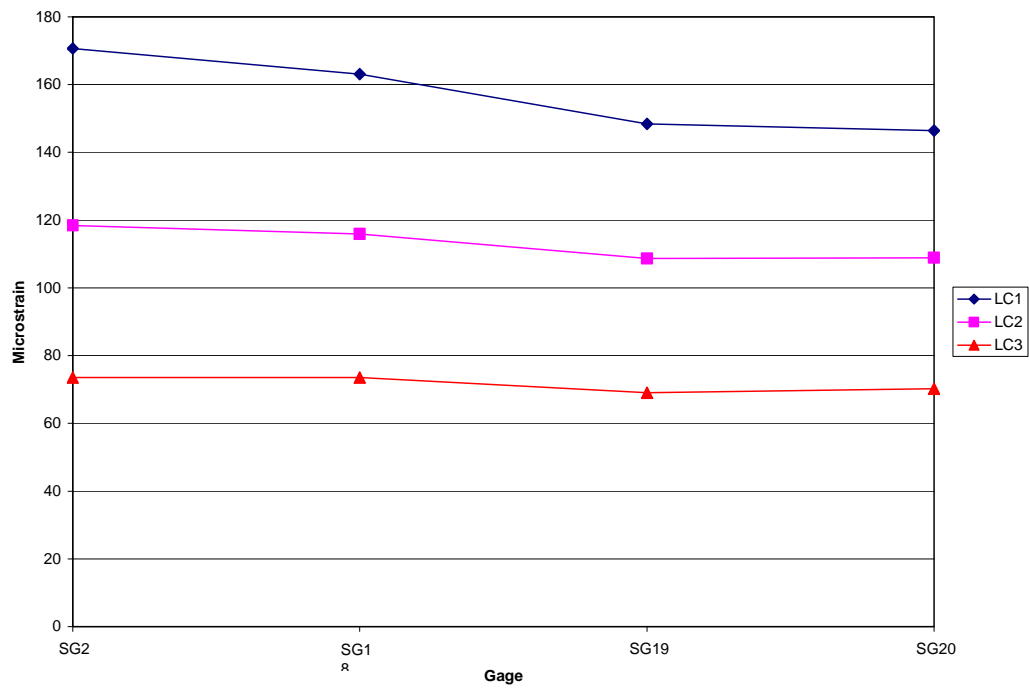
Figure 32. Transverse strain distribution from bottle to bottle.

Figure 32 illustrates the strain profile for gages SG2, SG18, SG19 and SG20, on the bottom of the deck for all three load cases. It is evident from Fig. 32, that transverse distribution of load from bottle to bottle is adequate and relatively constant regardless of load position.
