### ***Visual, Sounding, and Half-Cell Potential Plans***

### ***Petrographic Examination***

**Project:** Iowa State Highway 92 Over Drainage Ditch #25  
WJE No. 2012.5759

***Laboratory Analysis of Reinforcing Bars***

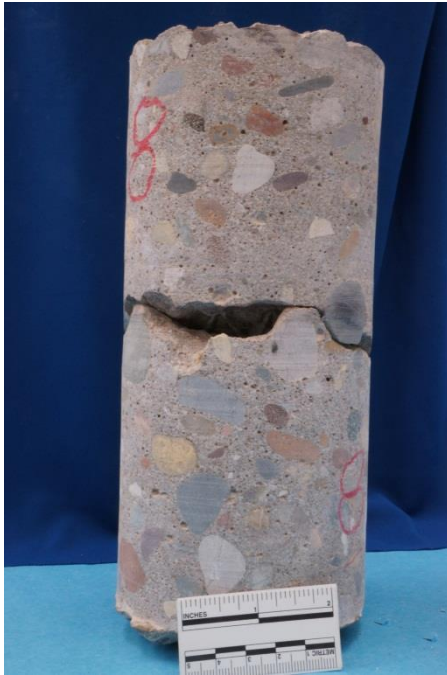
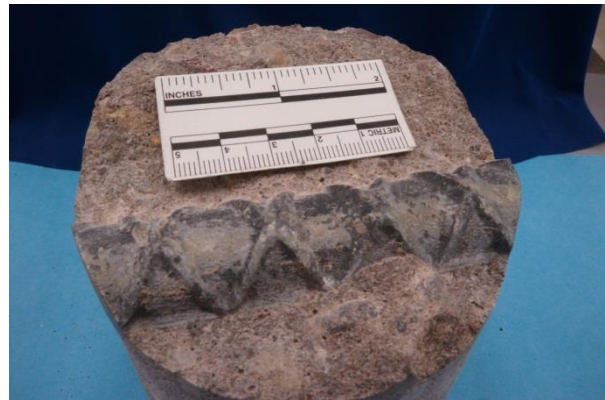
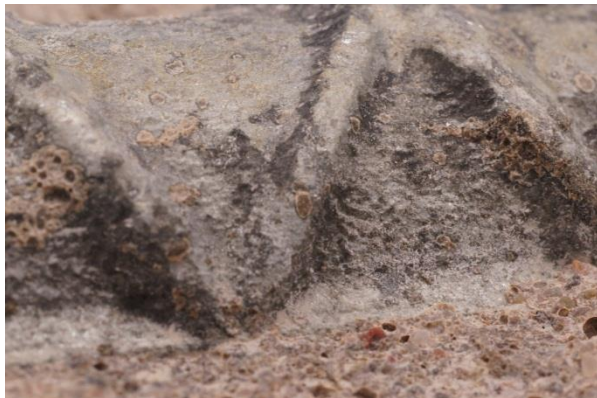
*Figure 8. Photographs of Core 8.*

*Condition* - The top surface of the concrete exhibits rake marks. The top surface is slightly weathered and somewhat uneven. A few aggregate particles have been dislodged from the top surface of the concrete. The concrete mix appears uniform and well consolidated throughout the core sample. The lower section of the core contains an impression of a reinforcing bar. (Figure 1). Corrosion staining was not observed.

A few fine microcracks were detected on the lapped surfaces of the sample (Figures 1, 2, and 3). One microcrack slopes at an angle from the top surface and exits from the side of the core at the depth of 3/4 inch. It splits into a few finer microcracks just below the top surface. The second main microcrack is found in the bottom section of the core. This microcrack extends from the cut, bottom surface mostly through the section, terminating approximately 1/4 inch below the top of that section. The microcrack appears slightly wider near the cut (bottom) surface than near the fractured/cracked (top) surface. Both microcracks mainly pass around aggregate particles. Impression of a rebar is visible in the middle section

The petrographic examination of Core 8 indicates that the concrete mix contains siliceous and calcareous gravel coarse aggregate and natural siliceous sand fine aggregate. The cement paste is strong and of good quality. The estimated water-cement ratio is 0.38 to 0.45, and the approximate cement content is 6 to 7 bags per cubic yard of concrete. Pozzolans were not detected. The concrete is air entrained and contains 6.5 to 7 percent air. The air void system is of good quality and is judged to be adequate for proper protection of the concrete from possible cyclic freeze-thaw damage.

Figure 1. Sections of Core 8; top surface of the concrete is on the left of the photograph. The locations of the microcracks are outlined in red. Impression of a rebar is visible in the middle section of the core. Similar impression (not visible in photo) is also present at the top of the bottom section.

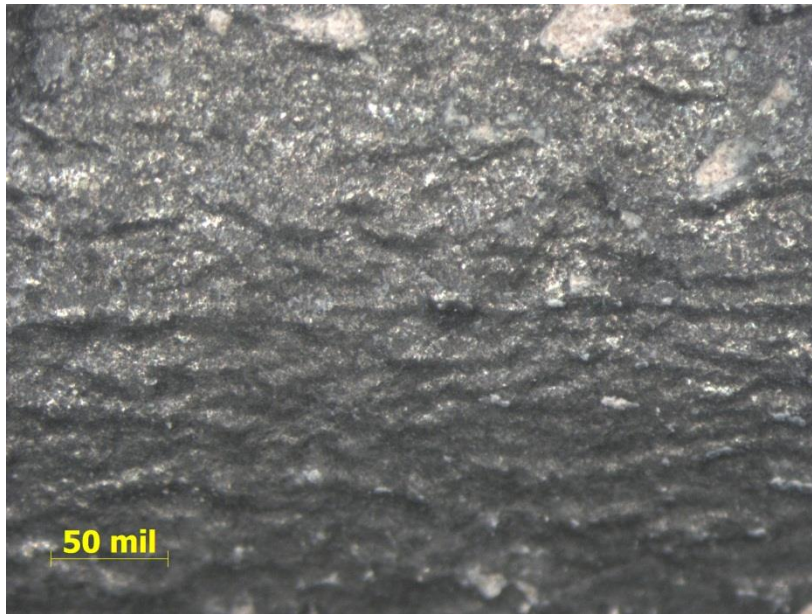
The bottom surface of Sample 8 has areas of both light green-gray shiny surface and dark gray surface. White deposits are present in limited areas. The top surface of the bar is uniform dark gray indicating the absence of corrosion. Light white discoloration may indicate minor surface corrosion of the bottom side of the bar. Photographs and micrographs of the sample are provided in Figure 1 through Figure 3.

*Figure 2. Micrograph of the top side of Sample 8. Note the uniform dark surface.*

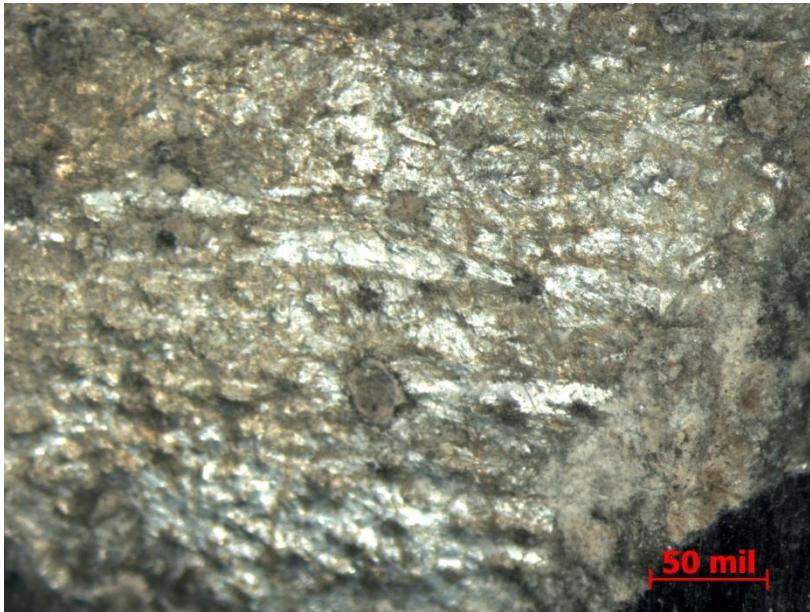
The surface of Sample 3, where not covered with adherent concrete, was light gray, shiny with a metallic appearance on the bottom of the bar. White deposits were present in one area of the bottom of the bar indicative of zinc surface corrosion. The top of the bar had a darker gray appearance with the absence of notable corrosion. Photographs and micrographs of the sample are provided in Figure 4 through Figure 7.

*Figure 5. Micrograph of the bottom of Sample 3, showing the gray shiny surface.*

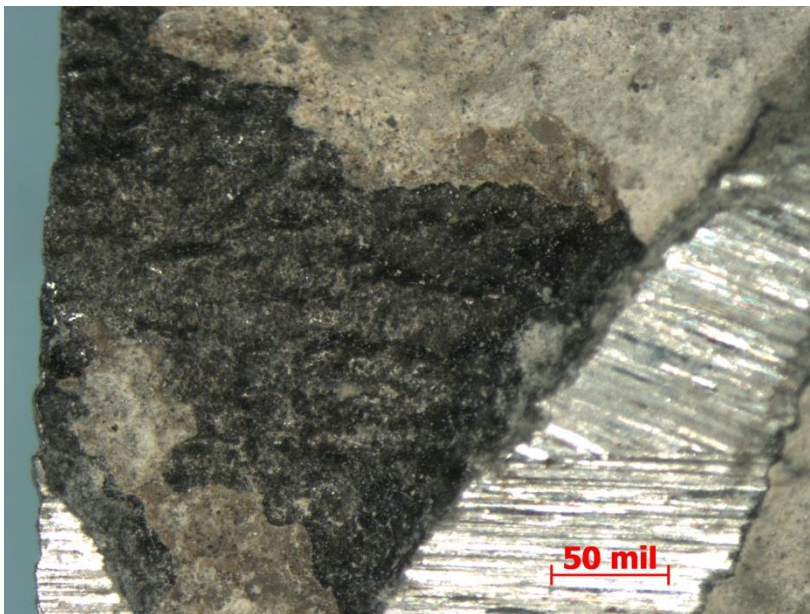
*Figure 6. Micrograph of the top surface of Sample 3, showing the gray surface. The lighter color material on the surface is residual concrete.*

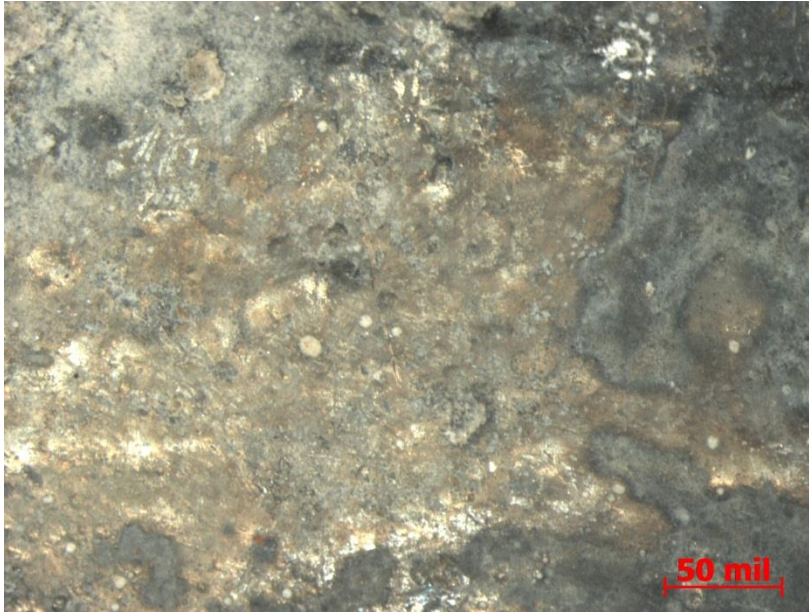
The bottom surface of Sample 7 was lighter in color than the top surface. The appearance ranged from light gray to slightly green and shiny, to spots of white deposit, and a few spots of yellow-green deposit. Surface corrosion of the zinc is likely along the bottom surface of the bar. The top surface had more adherent concrete, but where the bar was exposed, was a uniform dark gray and corrosion was absent. Photographs and micrographs of the sample are provided in Figure 8 through Figure 12.

*Figure 9. Micrograph showing the light green-gray shiny surface on the bottom of Sample 7.*

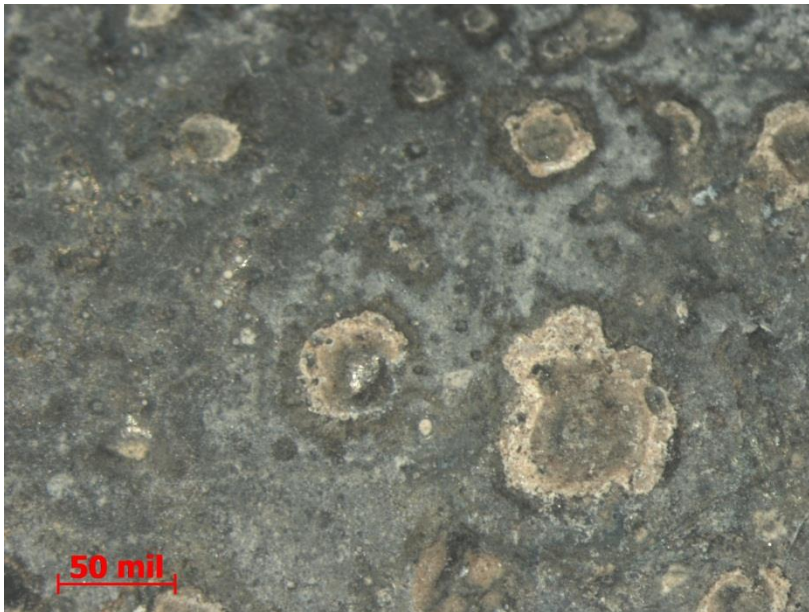
*Figure 10. Micrograph showing the light gray surface of the bottom of Sample 7. The lighter colored deposits are adhered concrete.*

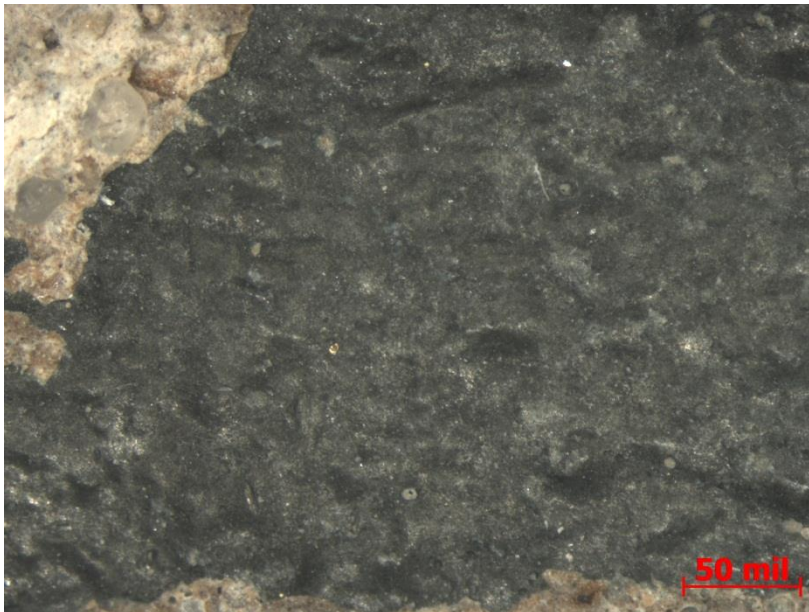
*Figure 12. Micrograph showing the uniform, dark surface of Sample 7.*

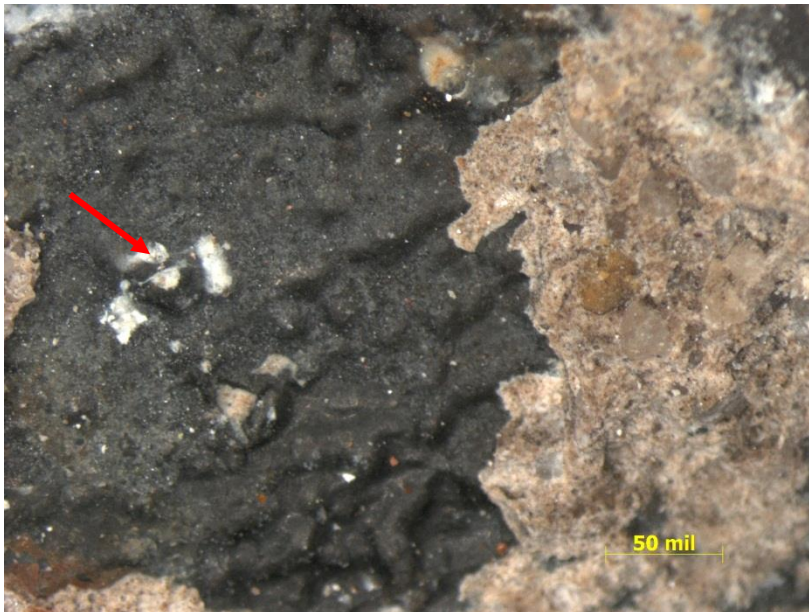
The bottom surface of Sample 10 consists primarily of white and red corrosion product, with some gray surface visible. The top surface consists primarily of red corrosion product, with a stripe of blue-gray deposit near the side of the bar. Corrosion is wide spread and the zinc has been consumed in areas. Photographs and micrographs of the sample are provided in Figure 16 through Figure 20.

*Figure 18. Micrograph of the side of Sample 10, showing concrete (indicated with an arrow) and a dark gray surface with only a small amount of white corrosion product.*

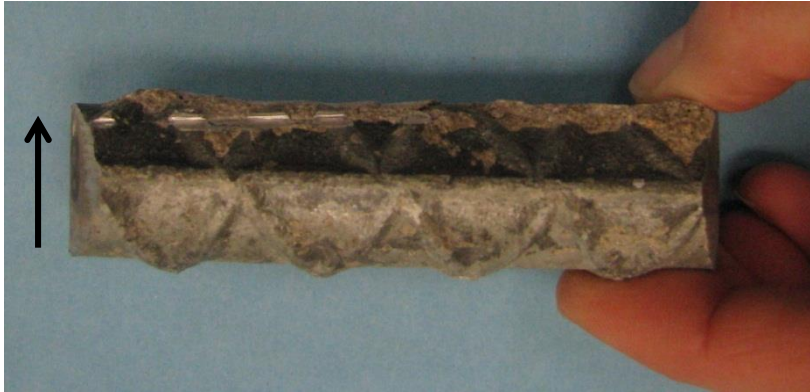
Sample 8 had a distinct dual-color appearance, with the top of the bar (as it was placed in the slab) having a dark gray appearance, with a lighter gray/silver/white appearance on the bottom of the bar (Figure 21). To evaluate compositional differences between the two colors, the surface of Sample 8 was examined using SEM/EDS.

*Figure 21. Photograph of Sample 8, showing the dual colors. An arrow indicates which side faced up in the slab.*

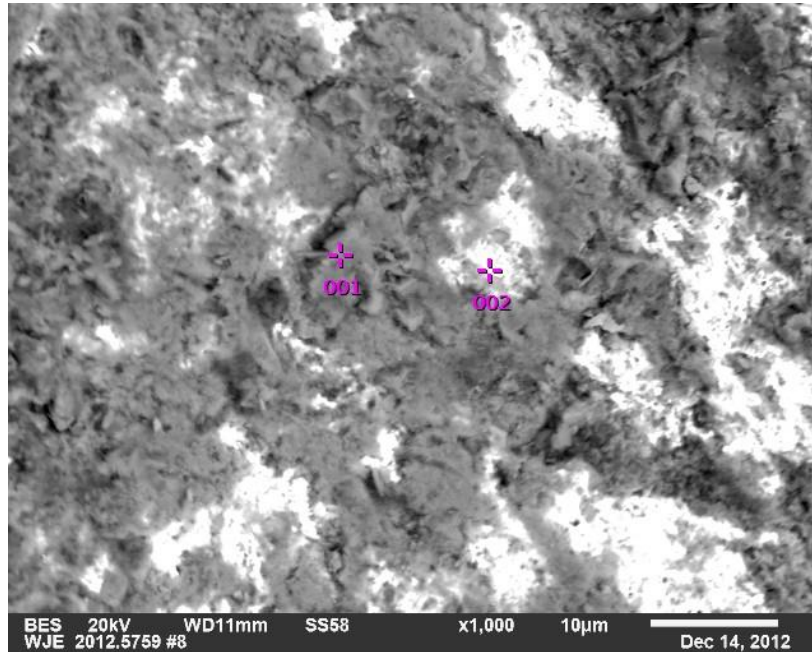
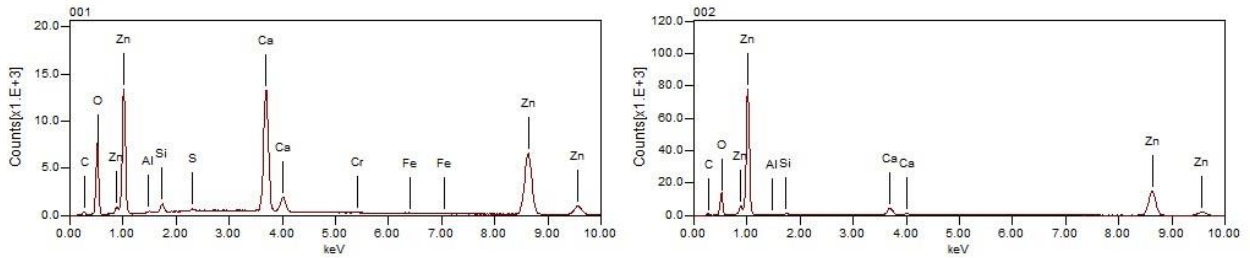
No significant compositional differences were observed between the darker and lighter portions of the bar (Figure 22 and Figure 23). Both consist primarily of zinc and oxygen, with varying amounts of calcium, and small quantities of aluminum, silicon, sulfur, lead, chromium, and iron. The zinc is from the

Figure 22. BE micrograph and point EDS spectra from the dark portion (top) of Sample 8. Each EDS spectrum has a number above the upper left corner which corresponds to the location indicated on the micrograph.

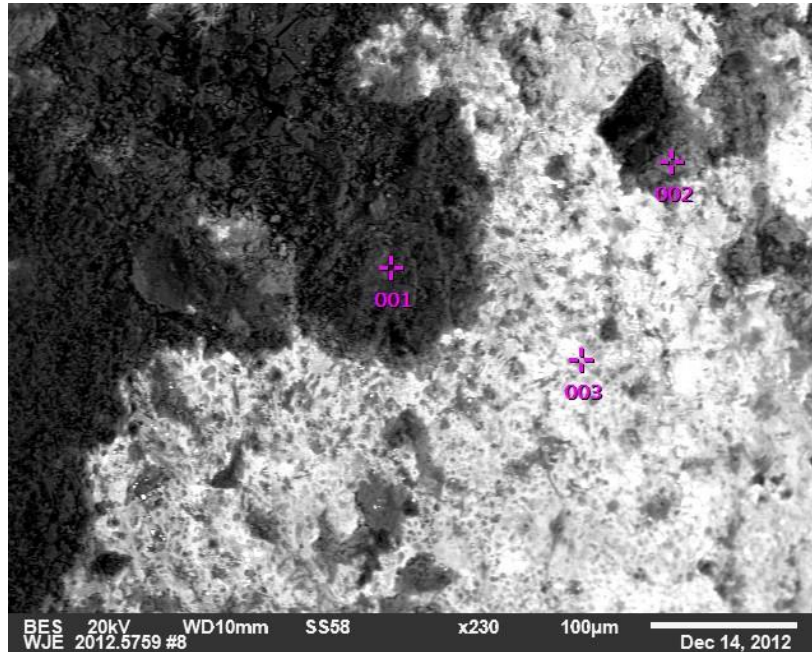
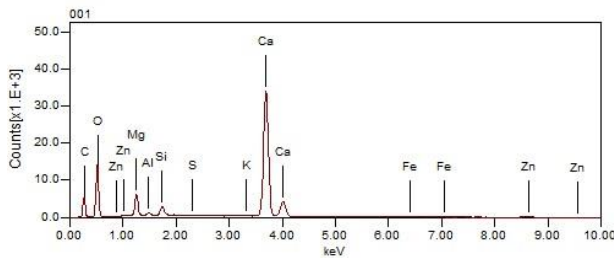
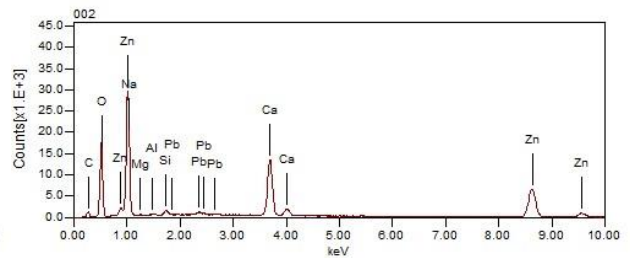
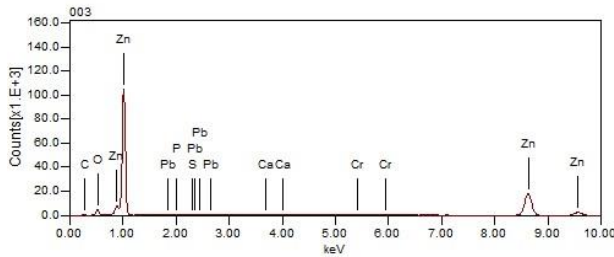
Figure 23. BE micrograph and point EDS spectra from the light portion (bottom) of Sample 8. Each EDS spectrum has a number above the upper left corner which corresponds to the location indicated on the micrograph.

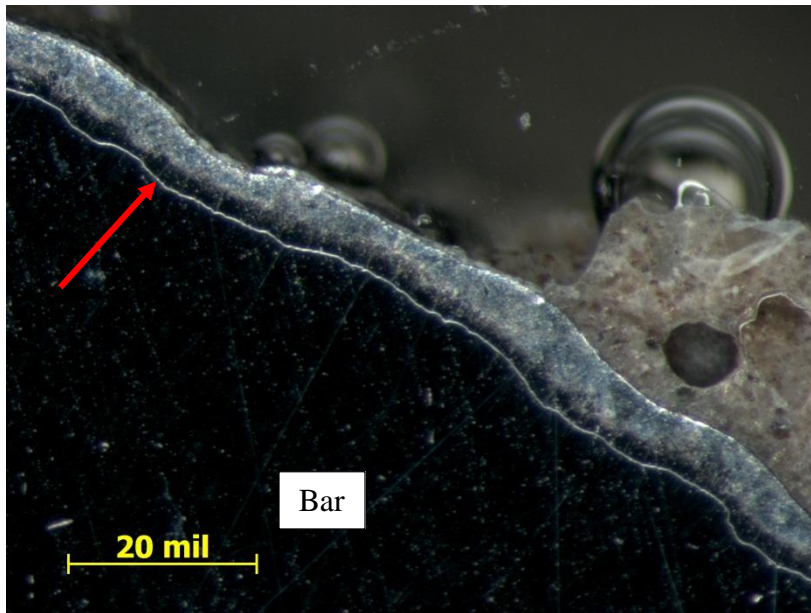
Figure 28. Cross-section of Sample 7, showing the bar (black), the zinc layer (arrow), and small section of concrete adhered to the bar. Epoxy (translucent bubbles), used in the preparation of the cross-section, is also present adhered to the zinc layer.

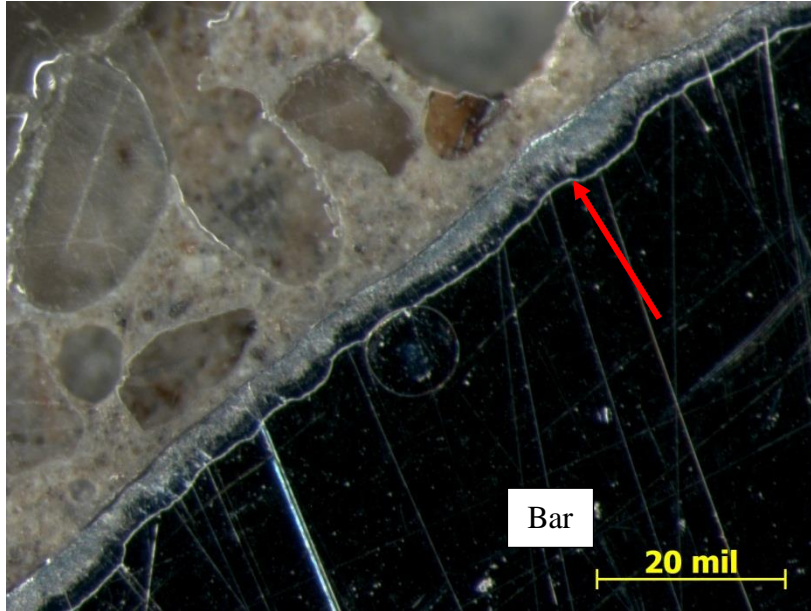
*Figure 29. Cross-section of Sample 8, showing the bar (black) and the zinc layer (arrow), and concrete adhered to the bar.*

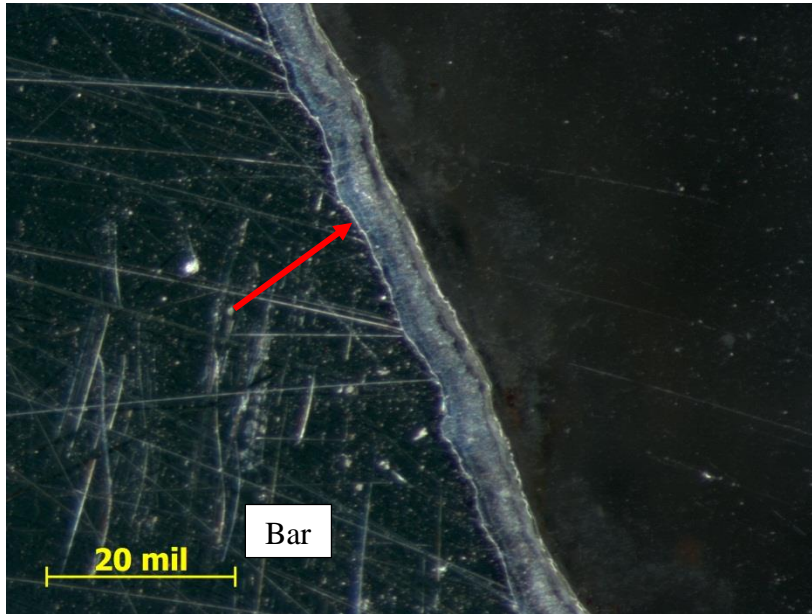
Figure 31. Cross-section of Sample 9, showing the bar and an intact zinc layer (arrow).

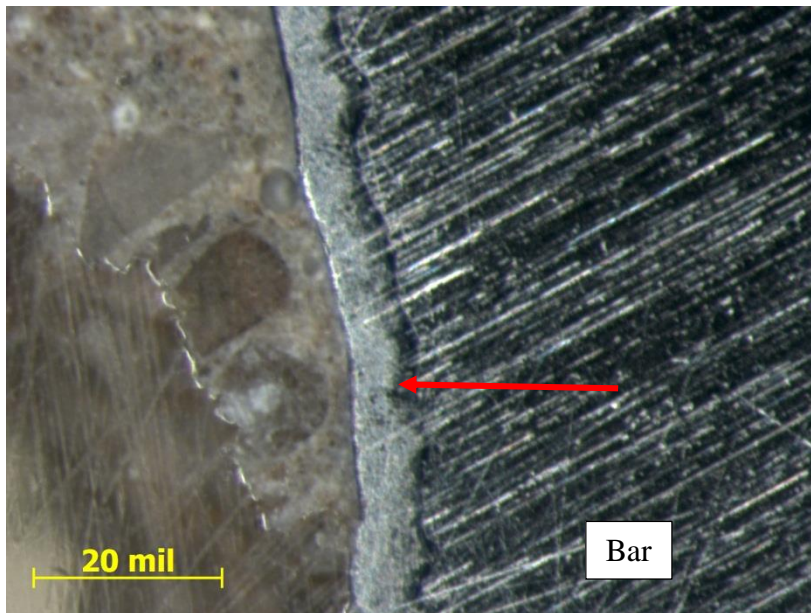
*Figure 34. Cross-section of Sample 10, showing the bar, the intact zinc layer (arrow), and concrete adhered to the bar.*

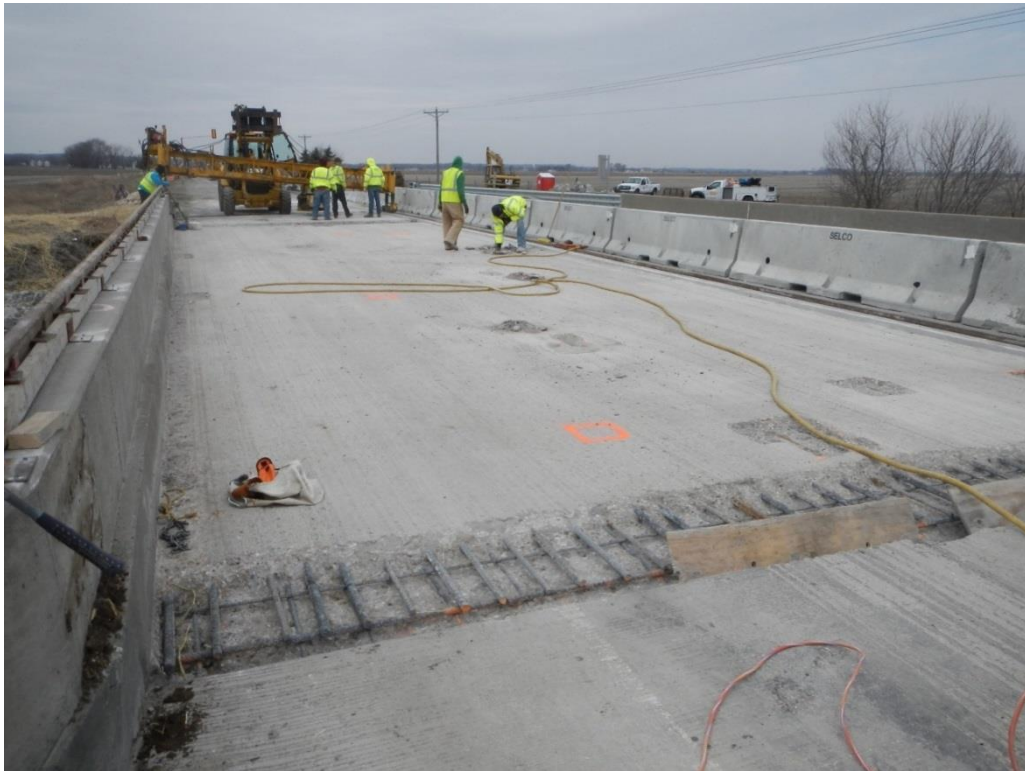
*Figure E5. Overall view of IA92 deck, eastbound lanes during April 2, 2014 site visit.*
