IOWA STATE HIGHWAY 92 OVER DRAINAGE DITCH #25

Performance Evaluation Galvanized Reinforcing Bars

Louisa County, Iowa

Final Report

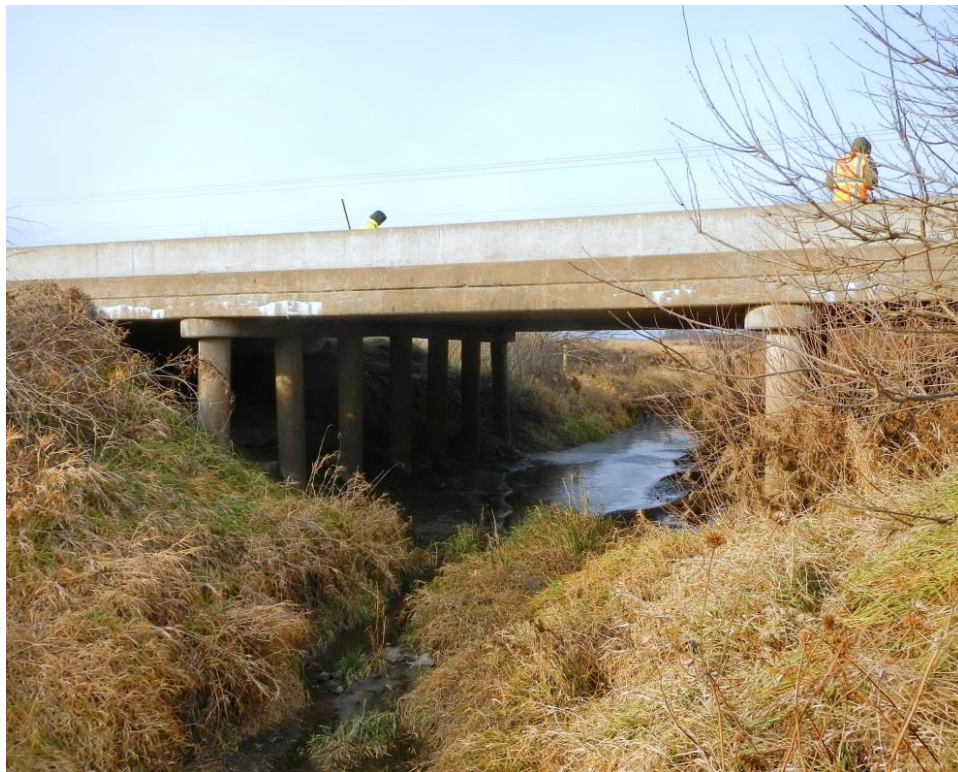
Figure 1.2. South elevation of subject bridge.

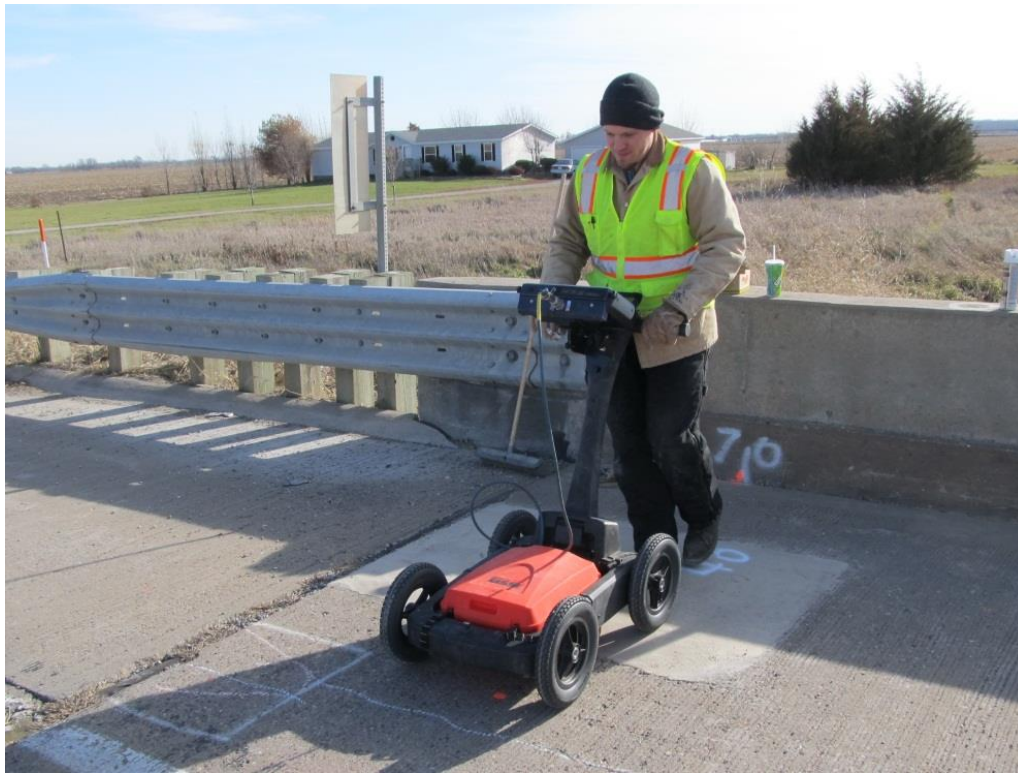
Ground-penetrating radar (GPR) was used to locate and determine the concrete cover over the reinforcing bars (see Figure 2.1). Scans were taken transverse to the bridge span at 5-foot intervals along the length of the bridge to assess cover over the top longitudinal reinforcing bars. Indicated depths of the top reinforcing bars on the GPR scans were calibrated for each bridge to actual depth measurements of the top reinforcing bars taken at core locations.

Figure 2.1. Measuring reinforcing cover depth with GPR.

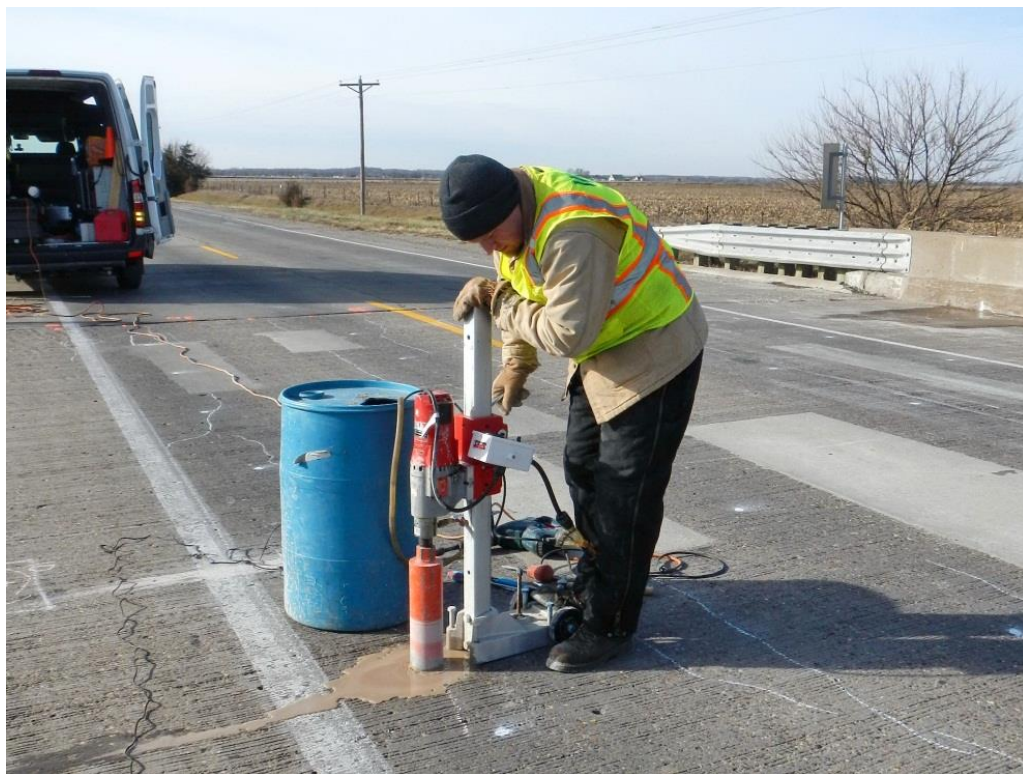
Ten 4-inch diameter core samples were drilled from the top surface of the deck, as shown in Figure 2.2. Core locations were distributed across the deck surface in order to represent typical conditions. All core samples were located to intersect one or more reinforcing bars. Five of the cores were taken from areas of the deck that contained cracks and delaminations. The locations of the cores for this bridge are shown in the deck plan views contained in Appendix A. Each core hole was patched with a rapid-setting repair material.

Figure 2.2. Drilling a core sample from the deck.

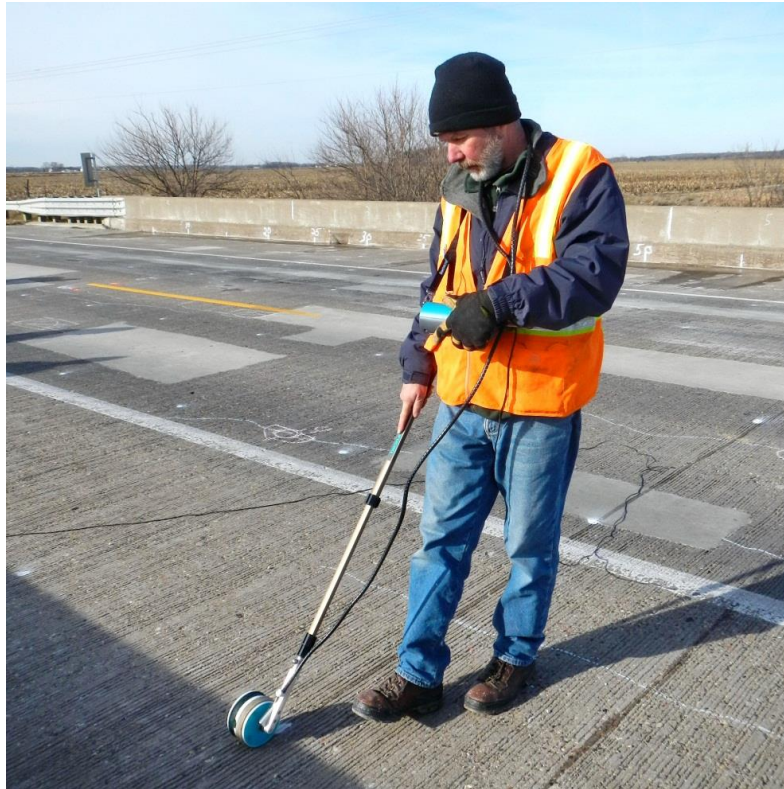
A copper-copper sulfate half-cell potential (HCP) survey was conducted to obtain an indication of corrosion risk for the reinforcing steel. HCP testing was performed in general accordance with ASTM C876, *Standard Test Method for Half-Cell Potentials of Uncoated Reinforcing Steel in Concrete* over the full survey area of each bridge using two different pieces of equipment: a single rolling wheel, as shown in Figure 2.3 and a nine-cell rolling test frame (see Figure 2.4). The single rolling wheel equipment (Proceq Canin+) is capable of close-interval (set at 3 inches for this bridge) measurements in the direction of the wheel, but requires multiple passes to cover an area. The rolling test frame measures an area 16 feet wide, but has single-point references cells that are spaced 2 feet apart. For both pieces of equipment, half-cell measurements were collected at 2.5-foot intervals along the length of the bridge using data loggers with 10 M-ohm internal impedance. Connections to the reinforcing steel were made by drilling down

Figure 2.3. Measuring half-cell potentials with single rolling wheel equipment (Proceq Canin+).

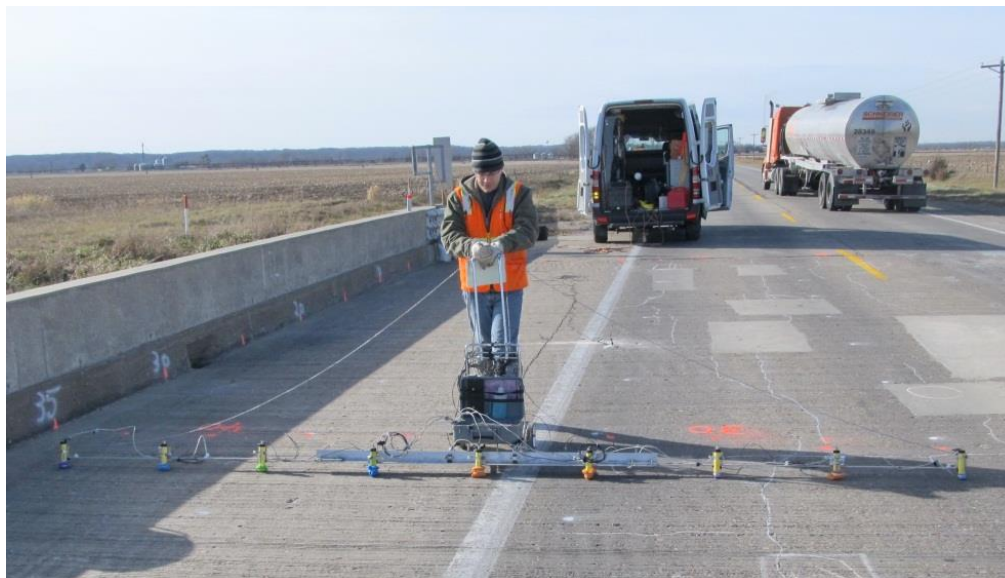
Figure 2.4. Measuring half-cell potentials with the nine-cell rolling test frame.

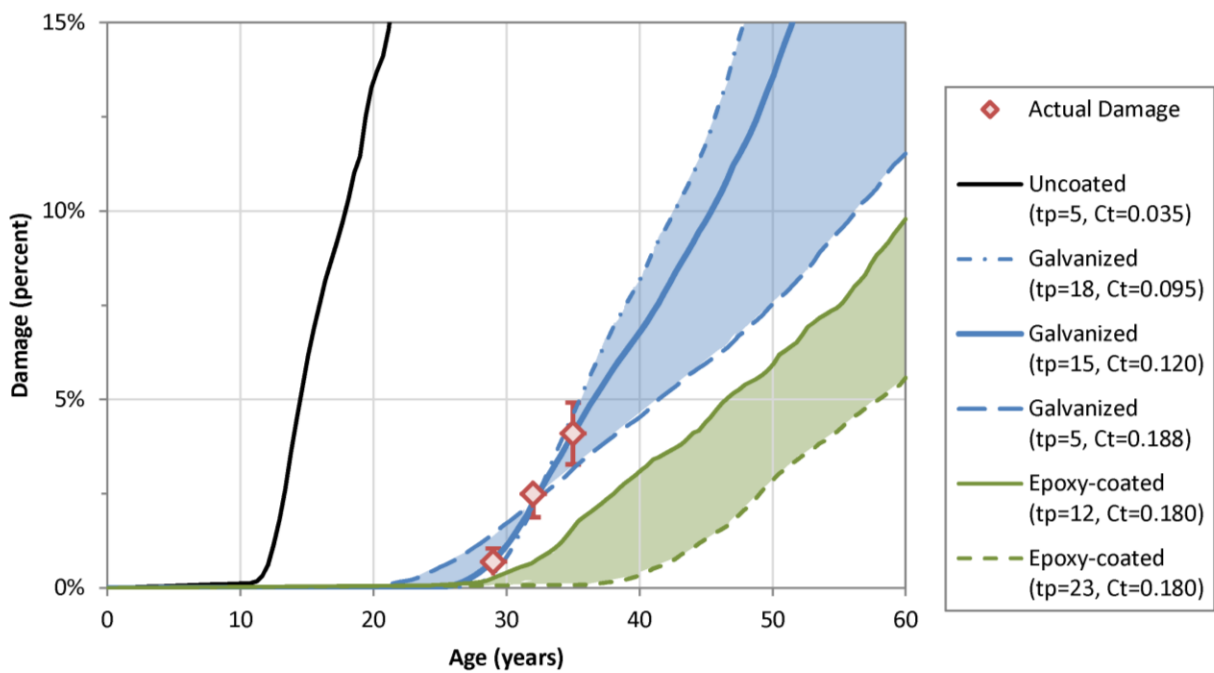
Multiple cases were run for the service life model to evaluate the expected performance of uncoated, galvanized, and epoxy-coated bars. These cases varied in the parameters for corrosion threshold and propagation time, as described above and as shown in Table 4.2. The results of the service life model, in terms of damage (area of deck exhibiting corrosion-related delamination or spalling) versus time is plotted in Figure 4.3. The figure shows results with the parameters considered for uncoated bars (black), galvanized bars (blue), and epoxy-coated bars (green). The range between the parameter estimates for similar materials is shaded.

The predicted damage evolution for galvanized bars in Figure 4.3 shows generally good agreement with the damage history for all three modeled cases, considering the uncertainty outlined above, when the assumed chloride thresholds (representing the lower bound, "best estimate" and upper bound based on the laboratory investigation) are paired with the appropriate propagation time (i.e., when the lower threshold is paired with higher propagation time and vice versa). Because the selected chloride threshold effectively controls the slope of the damage curve, chloride thresholds outside the upper and lower bounds found by the laboratory studies would not fit the measured progression of damage.

Figure 4.3. Results of service life model for bridge. (Propagation time (t_p) is given in years, and chloride threshold (c_t) is given in percent by weight of concrete.)
