## **Strengthening Steel Girder Bridges with CFRP Plates**

Based upon the laboratory results, a second project was undertaken in which an existing steel-girder bridge was strengthened using CFRP plates. This bridge is a 150 ft x 30 ft three-span continuous rolled I-beam bridge in southwestern Iowa. The original non-composite four beam bridge was widened in 1965 by adding two additional composite beams. A recent rating of this bridge determined that several of the original beams were understrength in the positive moment regions, thus CFRP was bonded to the positive moment regions of the bottom flanges of the two original interior beams and the “new” exterior beams. At some locations on the exterior beams, the plates were installed on the top surface of the bottom flange to investigate the performance and in-service durability under detrimental environmental conditions. This bridge has been load tested three times: before and after installation of the CFRP plates, and approximately one year later to determine the effectiveness of the strengthening system. Results are presented to illustrate this effectiveness.

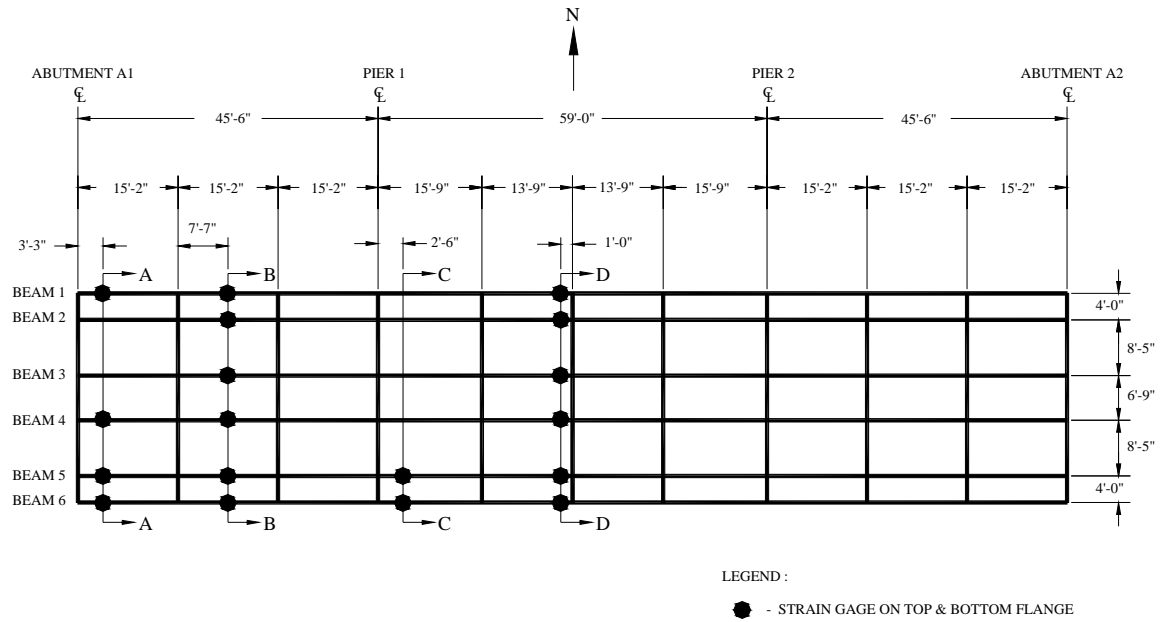
a. Instrumentation layout

An initial diagnostic load test was conducted prior to the installation of the CFRP plate strengthening system to establish a baseline static behavior of the unstrengthened bridge. The location of the instrumentation was selected to effectively monitor the overall global response of the bridge to live load. As can be seen in Fig. 9a, a total of thirty-six strain gages were installed on the bridge with twenty-four gages on the positive bending moment regions and twelve gages on the negative bending moment regions.

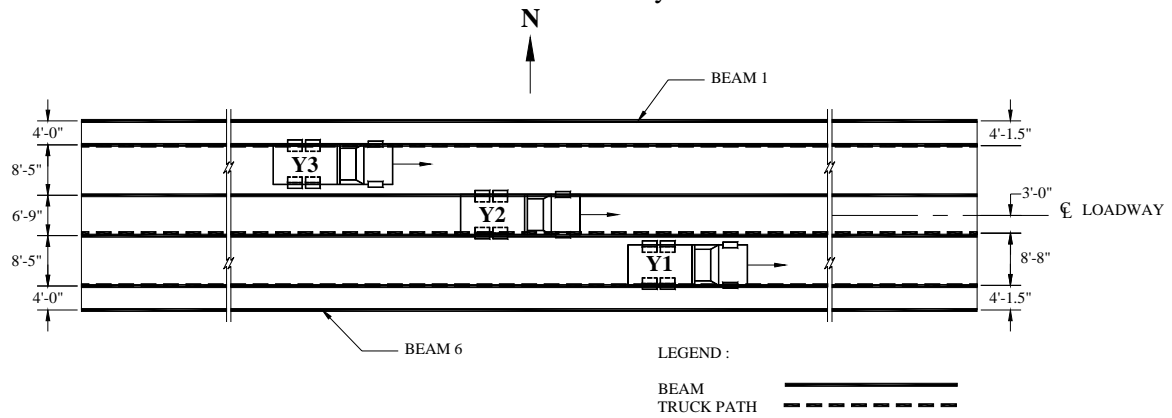
b. Truck positions

Three different truck paths were used to examine the performance of the bridge. These truck paths were chosen so that maximum strains could be generated in select girders. For convenience, load paths are referred to as Y1, Y2 or Y3 as shown in Fig. 9b. All tests were conducted from west to east. The Iowa DOT provided the load truck which had a total weight of 52.76 kips with 13.78 kips and 38.98 kips on the front and rear axles, respectively. This truck was 16 ft - 10.5 in. long between the center of the front axle and the center of the rear axles, 6 ft - 8 in. wide between the centers of the front tires, and 6 ft wide between the rear tires.

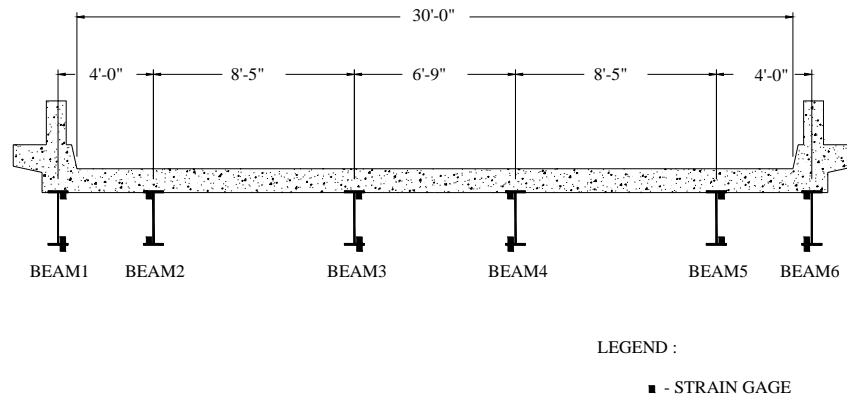
c. Cross-section (Section D)

The follow-up load tests were conducted approximately two months and one year after the installation of the strengthening system to assess changes in behavior due to the addition of the CFRP plates or time. The procedures used in the follow-up load tests were the same as those used in the initial test except for the truck weight and the number of strain transducers. In these tests, four additional transducers were installed on the CFRP plates as shown in Fig. 9c in the center span to determine the bond performance.

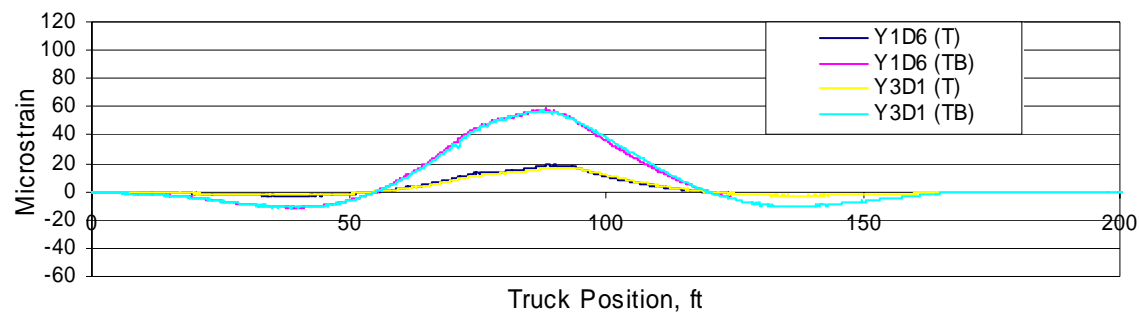
As shown in Fig. 10a, the measured strains indicate good lateral symmetry that corresponds to the symmetrical configuration of the bridge and the truck paths used. Some of the minor differences in transverse symmetry may be attributed to either difference in local stiffness, difference in rotational end restraint at the abutment, or possible experimental error that might have occurred during the testing (e.g., differences in truck wheel line distribution and/or truck lateral positioning).

a. Lateral symmetry: strain in Beam 6 (Path Y1) and Beam 1 (Path Y3)

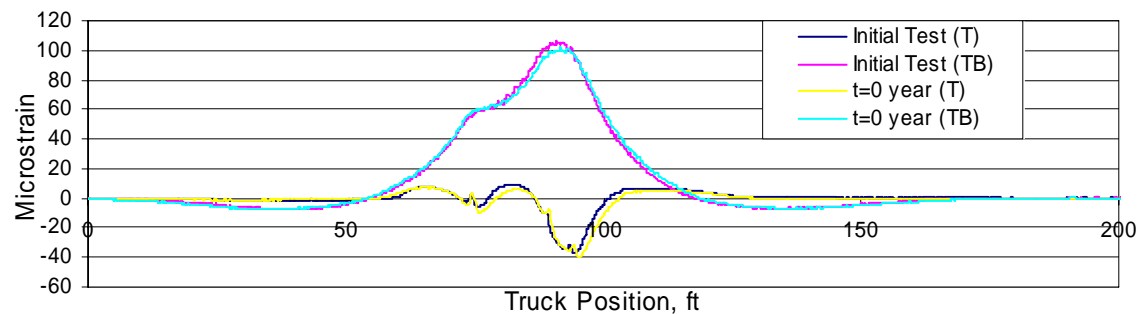
From the analysis discussed earlier, it was determined that an approximate stiffness increase of 1.2% per layer was obtained for the middle two beams. By comparing strains in each test it was observed that the follow-up test did produce fairly consistent strains with those measured during the initial test. This consistency in strain indicates that the strengthening system did not significantly alter the behavior of the bridge as predicted. Although it is not possible to precisely account for all the sources of strain, it is evident from the consistency of the strain data that the installation of the CFRP plates had little impact on changing the stiffness of the bridge. It also indicates that the live load distribution characteristics are virtually the same before and after the installation of the strengthening system. A typical comparison between the pre- and post-strengthening response is shown in Fig. 10b.

b. Similarity in response before and after strengthening: strain in Beams 3

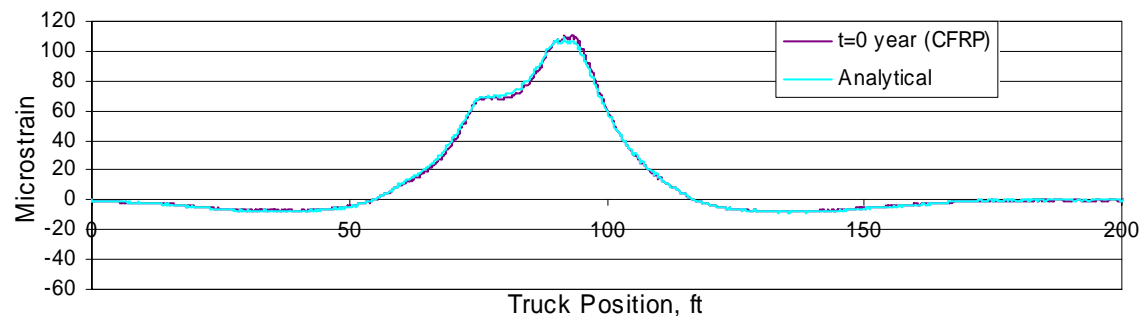
From the comparison, it was found that the difference between the analytical and experimental strain was only 3.8% on average. The similarity between the analytical and experimental strain is shown in Fig. 10c. Considering the sensitivity of the neutral axis location that could change significantly with a small change in strain, this percentage error is considered to be relatively small; thus, it appears that, at least initially, that there was good bond between the beam and CFRP plates.

c. Strain in Beam 4 CFRP plate
