## Test and Evaluation Report

### **Load Test to Assess Fatigue Detail Performance on Westbound I-80 Bridge over the Cedar River**

February 8, 2010

**Bridge Engineering Center**  
2901 South Loop Dr.  
Suite 3100  
Ames, IA 50010  
(515) 294-8103

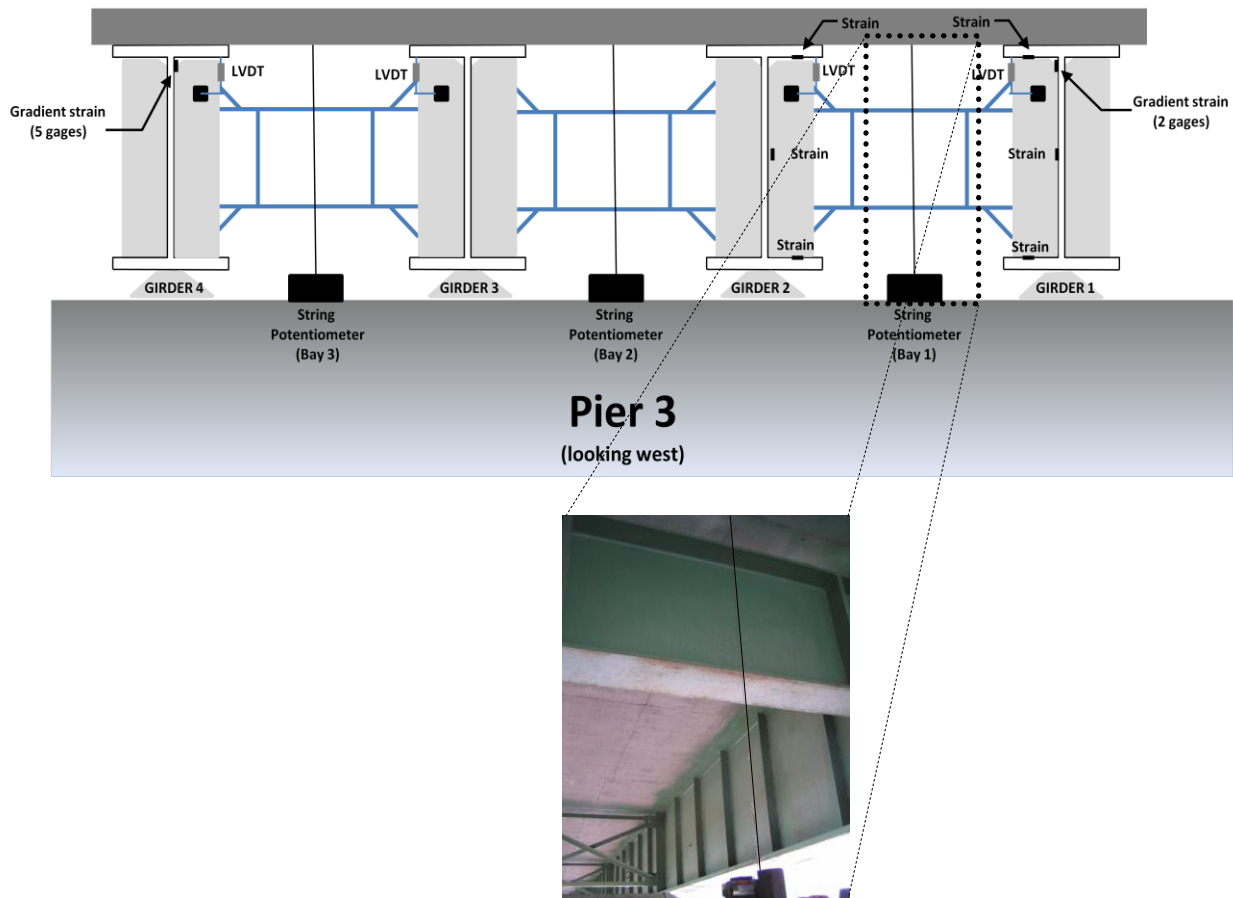
**Figure 9. Schematic of the load test instrumentation at Pier 3 (looking west). Note that the three deck bay vertical displacements were made relative to the top of the pier cap beam.**

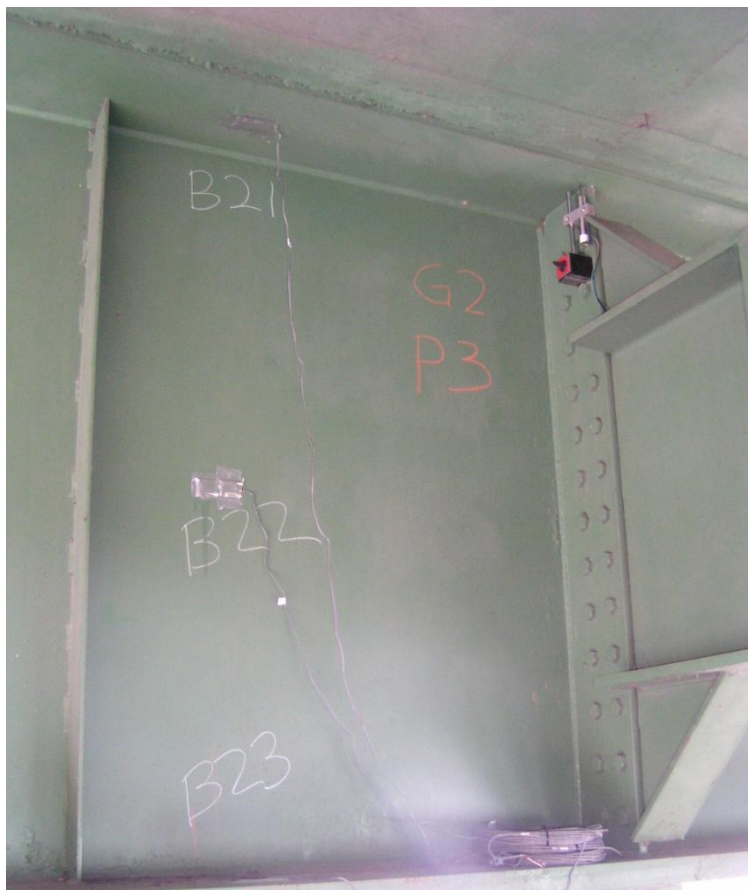
As shown in Figure 9 earlier in this report (and also below in Figure 22), and as described earlier in the instrumentation section of the report, Girders 1 and 2 were instrumented with 3 strain gages each (top flange, bottom flange and mid-depth of web) near Pier 3 to quantify the flexural behavior of the girders. Load Case 1 (Iowa DOT snooper, Truck 2 and Truck 1 traveling back-to-back-to-back in the middle of the north lane, and separated by approximately 20 ft) resulted in the largest compressive girder strain (bottom flange) of 58 micro-strain (approximate stress of 1.74 ksi) at a distance  $d/2$  from the centerline of the pier bearing. Figure 23 shows for Load Case 1 at Girder 2 the strain profile. Figure 24 contains a strain history plot for the all three girder strain gages a distance of  $d/2$  from the support, for Girder 1, Load Case 1. As noted, the largest tensile strain observed was 14 micro-strain (approximate stress of 0.42 ksi). Girder 1 also had the largest strain reversal from -56 to 14 micro-strain or a total strain range of 70 micro-strain (approximate stress of 2.1 ksi).

**Figure 22. Strain gages B21, B22 and B23 on Girder 2 to assess flexural behavior near Pier 3.**
