**Final Report on the  
I-129 Missouri River Bridge  
Deck Condition Assessment Using Non-Destructive  
Testing Methods**

**Bridge No. 9700.0S129, Sioux City, IA**

**November 5, 2012**

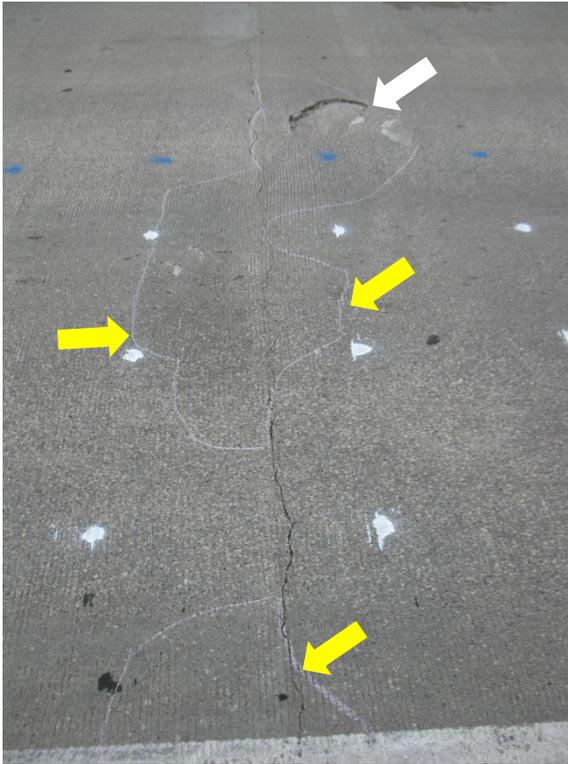
*Figure 2.4. Typical delamination (highlighted with chalk) of concrete at a crack. Surface spalling is also visible (white arrow).*

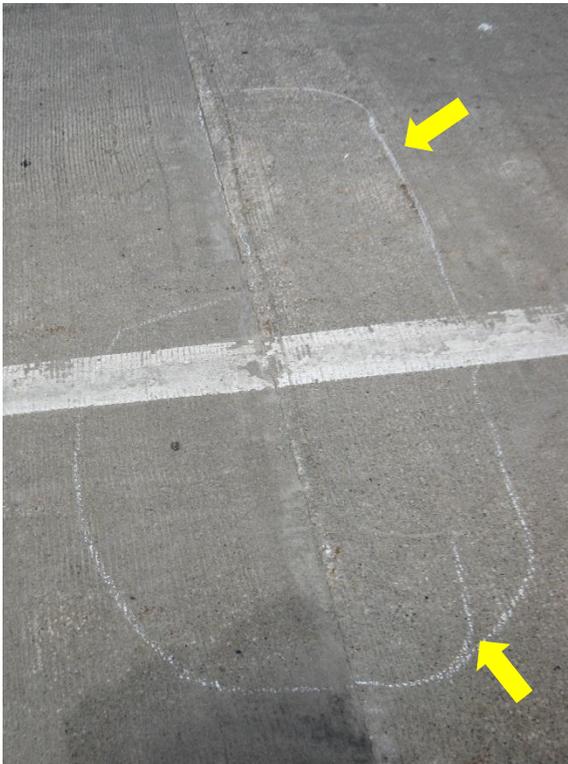
*Figure 2.5. Delamination (highlighted with chalk) of concrete at a construction joint in overlay.*

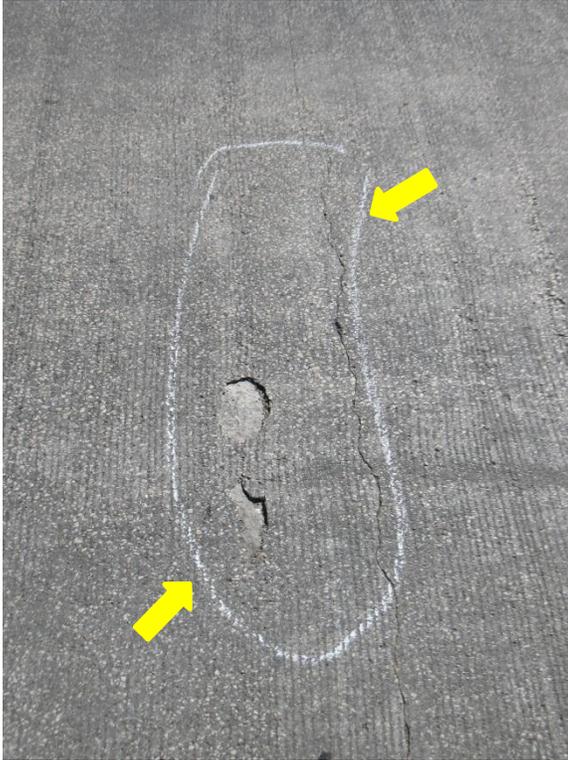
*Figure 2.6. Delamination (highlighted with chalk) of concrete on one side of crack.*

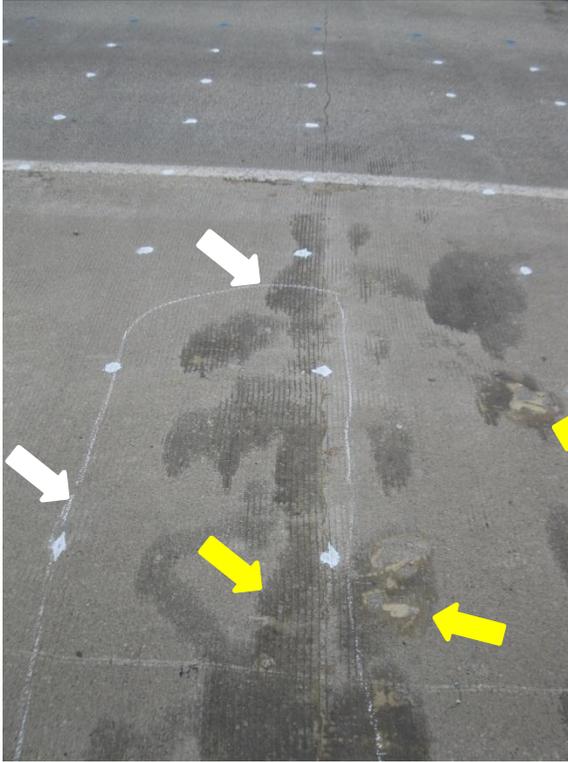
*Figure 2.8. Delamination of surface concrete (white arrows) along crack where evidence of existing epoxy injection repairs (yellow arrows) is evident.*

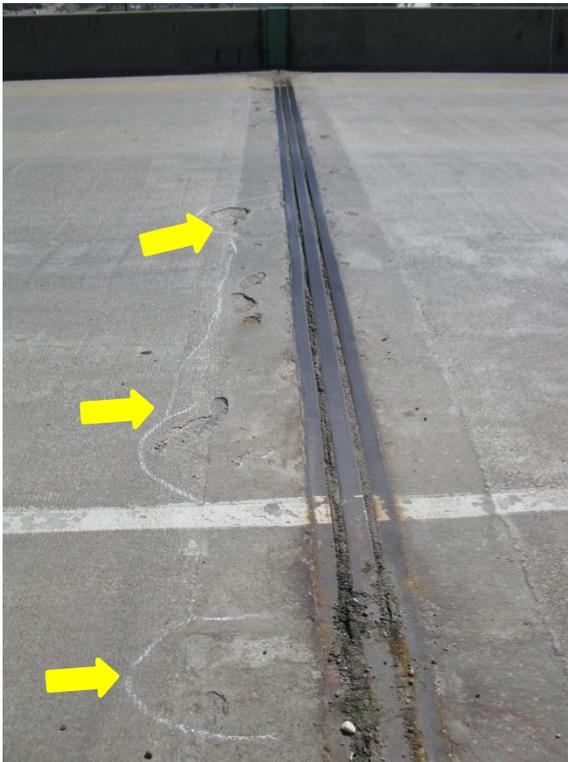
*Figure 2.9. Typical delamination of concrete deck surface (highlighted in chalk) near a modular expansion joint seal system.*

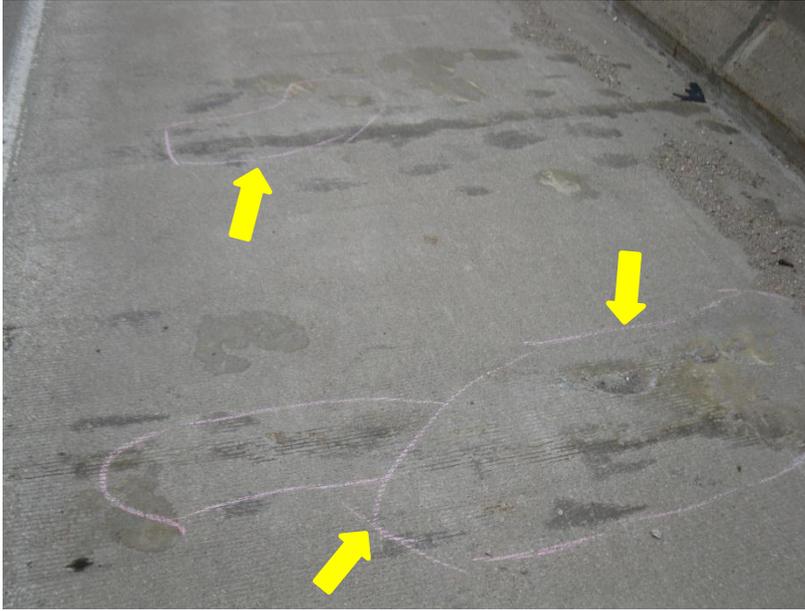
*Figure 2.10. Delamination in shoulder (highlighted in chalk). Note epoxy injection resin on the surface.*

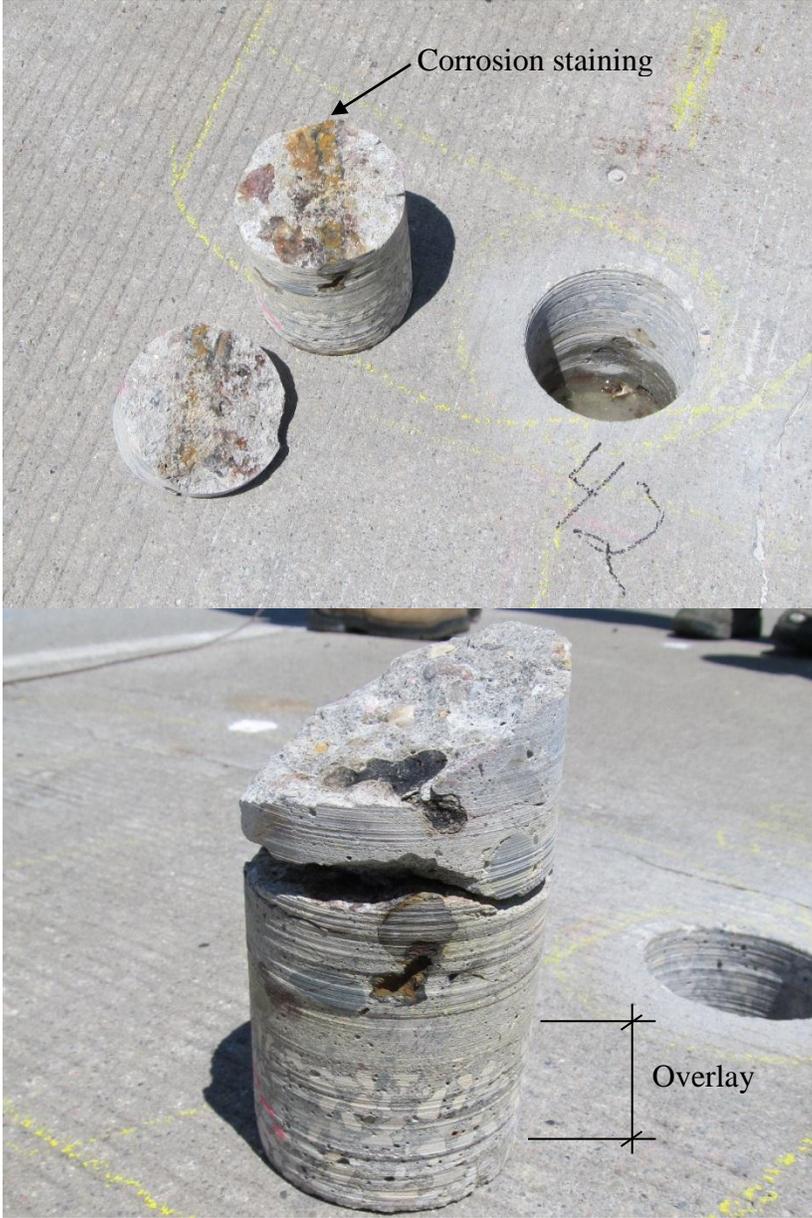
Core sections separated to show both faces of core at delamination plane.

*Figure 2.11. Core sample with evidence of horizontal cracking/delamination along the plane of reinforcement due to corrosion of the reinforcing. Note smaller coarse aggregate in overlay visible in bottom photograph.*

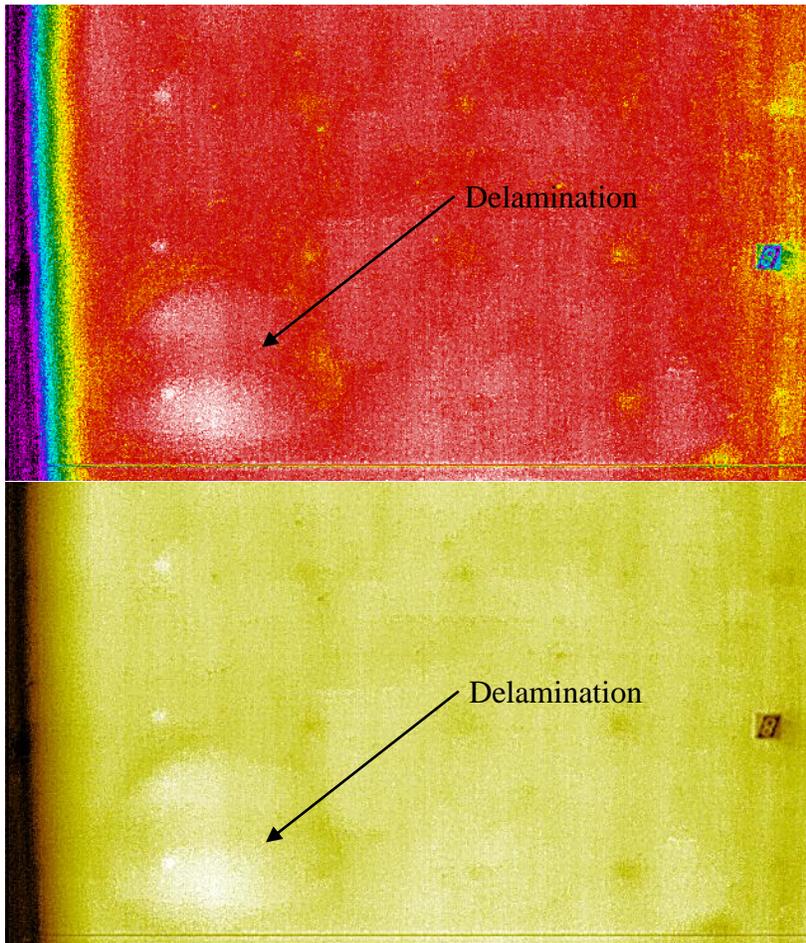
*Figure 3.3. Sample infrared image, filtered using the rainbow (top) and sepia (bottom) palettes with upper and lower temperature bounds separated by 18°F (10°C). A delamination is present in the lower left corner of the image (arrow).*

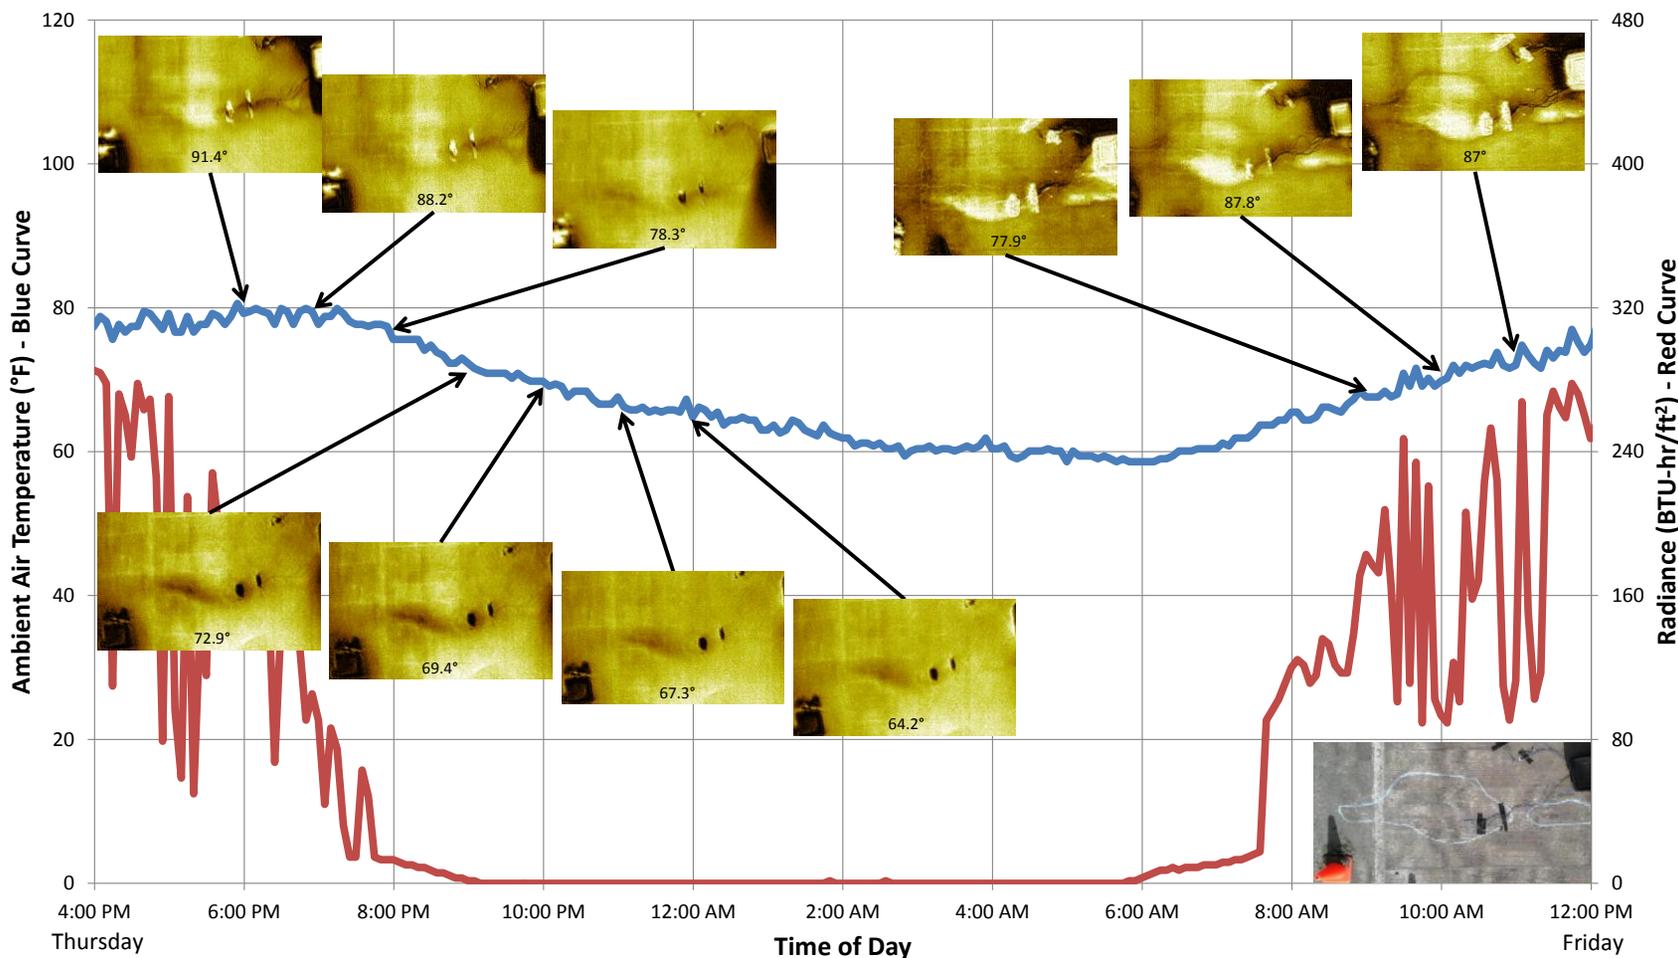
Figure 3.10. Appearance of known delamination at the installed weather station over a 20-hour period, plotted with ambient air temperature and solar radiance. The temperature of the surface of the delamination is indicated on each image. The visual appearance of the delamination outlined in blue chalk is shown in the lower right. Some of the dark or light features in the image result from items on the deck, such as a traffic cone and tape fixing the thermocouple wires in place.

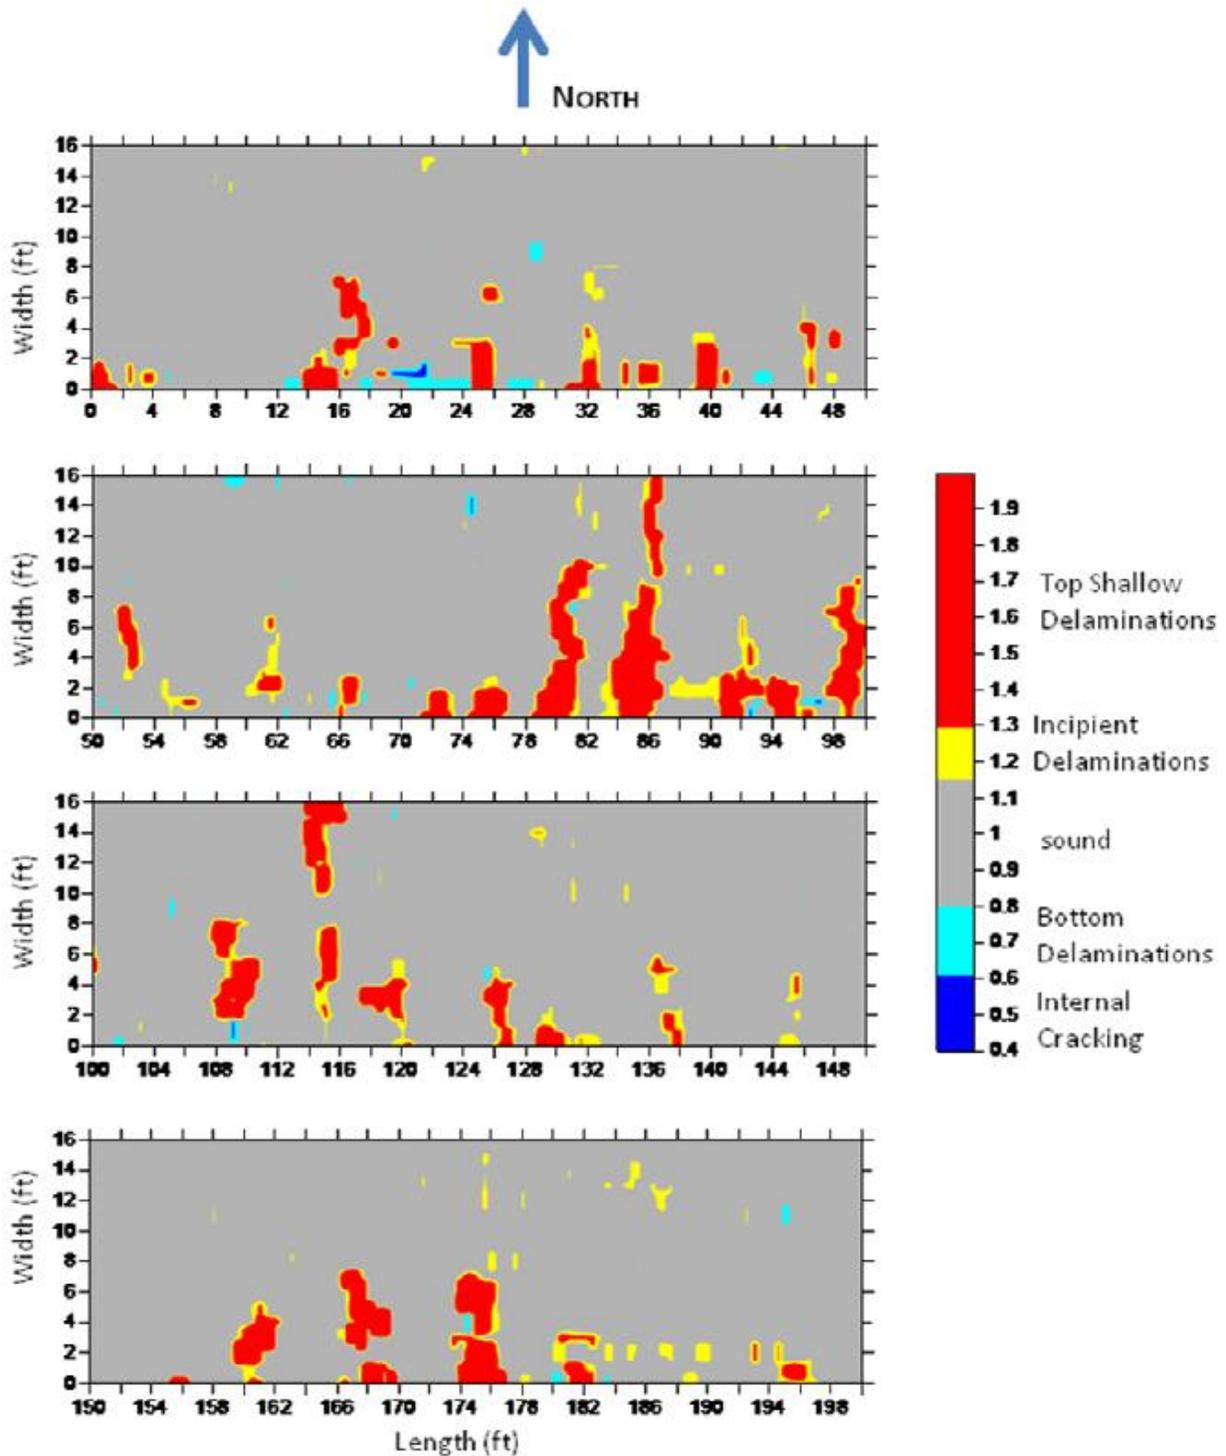
Results of the scanning IE testing within each of the in-depth study areas were interpreted by Olson and translated onto color-coded maps. An example of one of these maps, taken from Olson's report, is shown in Figure 5.3, which shows the delaminations detected in Study Area EB-1. The plots present the ratio of the resultant thickness measured by IE to the design thickness of the deck (10 in.). Theoretically, a perfectly sound deck would return a ratio of 1.0. However, because variability in the results and the deck can be expected, ratios within 20 percent of 1.0 (between 0.8 and 1.15) were assumed by Olson to indicate a sound deck. Shallow delaminations are typically characterized by a low frequency response because the mechanical energy pulse tends to excite flexural modes of vibration. This produces a resultant thickness ratio greater than 1.0 at shallow delaminations. Resultant ratios of greater than 1.30 were identified by Olson as 'top shallow delaminations' and are shown as red in the color-coded maps. Areas at which the resultant ratio measured 1.15 to 1.30 were identified by Olson as 'incipient delaminations' and were reported to be areas of internal damage or cracking that will likely become a delamination in the future. The incipient delaminations are highlighted in yellow in the color-coded maps. Additionally, areas in which the resultant ratio measured less than 0.80 were identified by Olson as potential areas containing

Figure 5.3. Result from Olson scan of in-depth Study Area EB-1, showing areas of concrete delamination near the top deck surface in red.

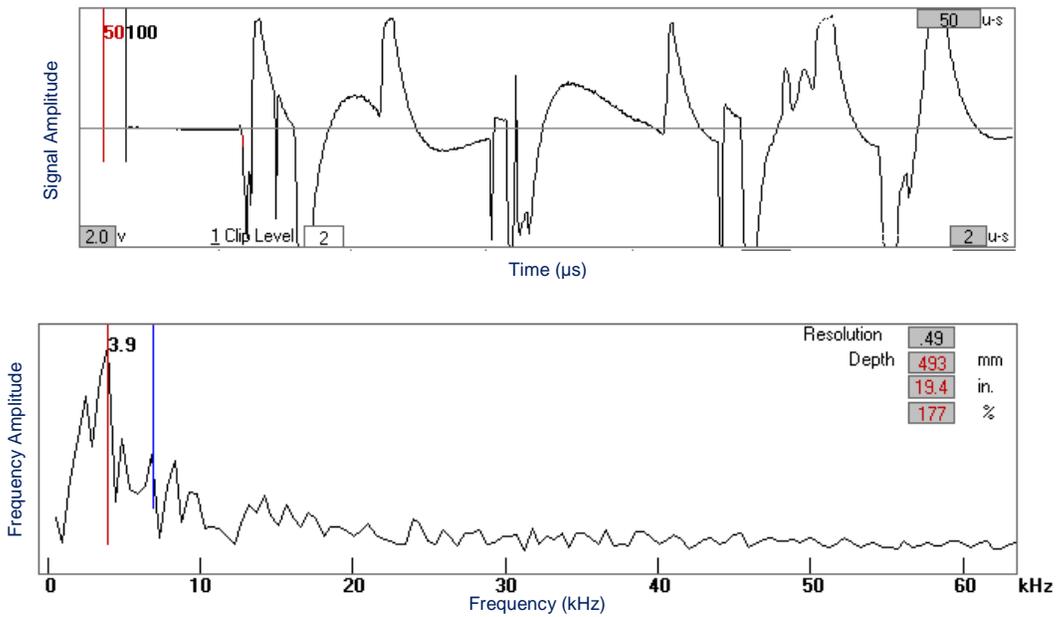
Figure 5.6. IE test result showing a shallow delamination (Study Area EB-1; Station 318).

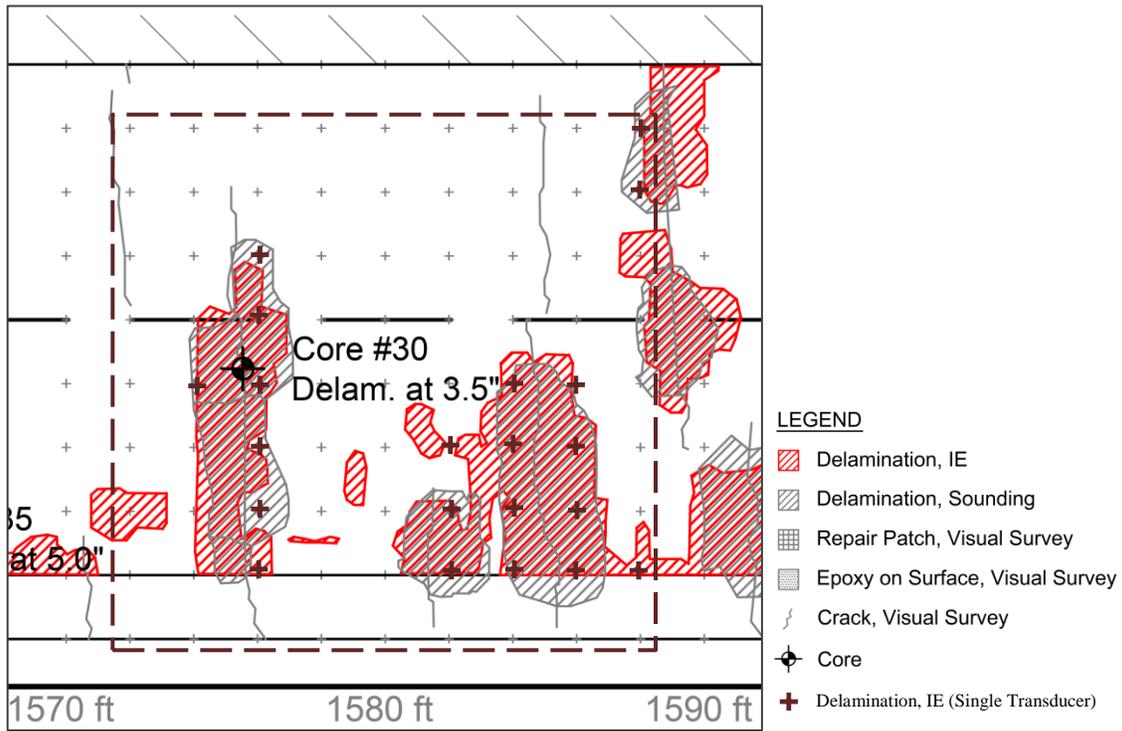
Results of the single-transducer IE testing were overlaid onto portions of the plan view drawings provided in Appendix D. Testing results at Station 1572 to 1588 within Study Area EB-2 are shown in Figure 5.8. In the figure, areas of shallow delaminations identified by scanning IE are hatched red and discrete test points identified as delaminated by the single-transducer IE testing are shown as dark crosses. In each of the three selected test areas, results of the IE testing using the single-transducer unit correlated well with the areas of shallow delaminations identified with scanning IE.

Figure 5.8. Results of single-transducer IE testing (delaminations identified at brown crosses) shown along with results of Scanning IE (hatched red) and sounding at Study Area EB-2 (Station 1572 to 1588).

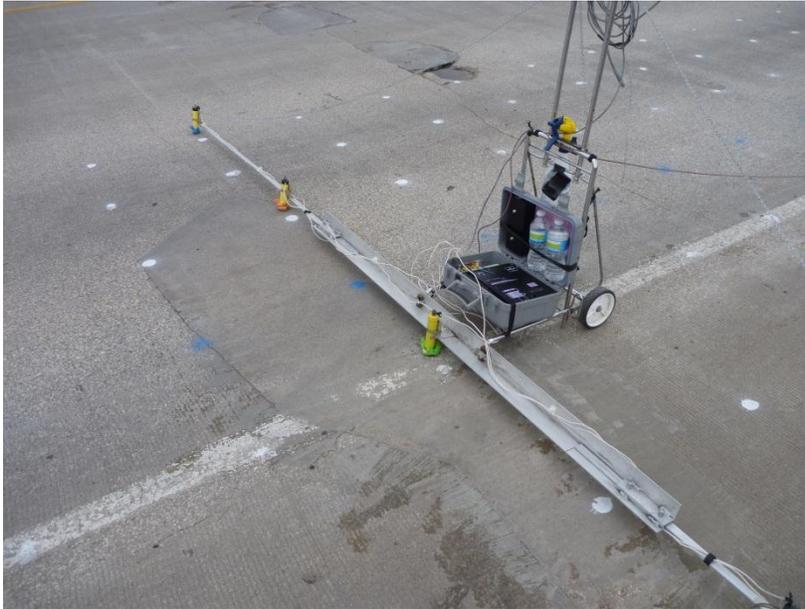
*Figure 6.4. Rolling cart with five CSEs and datalogger, used for half-cell potential measurements.*

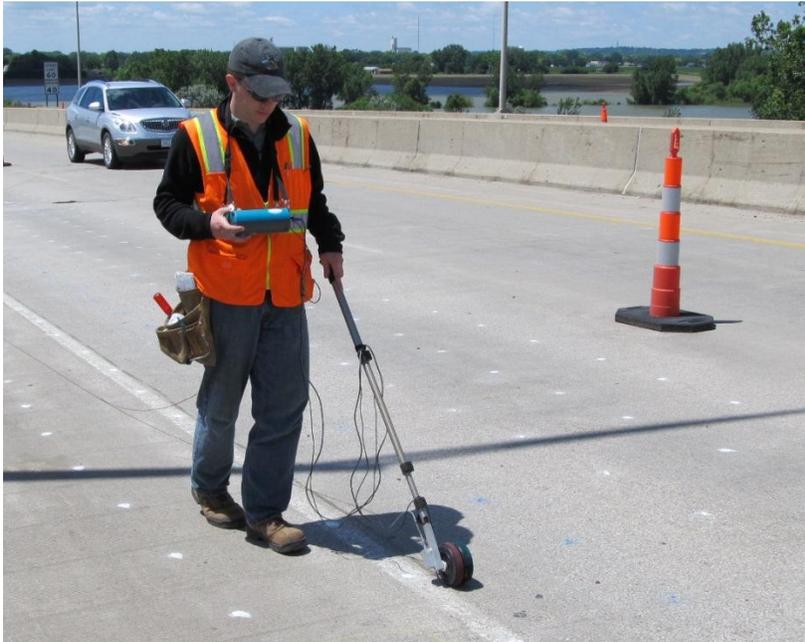
*Figure 6.5. Measuring half-cell potential using a CSE integrated with a rolling wheel.*

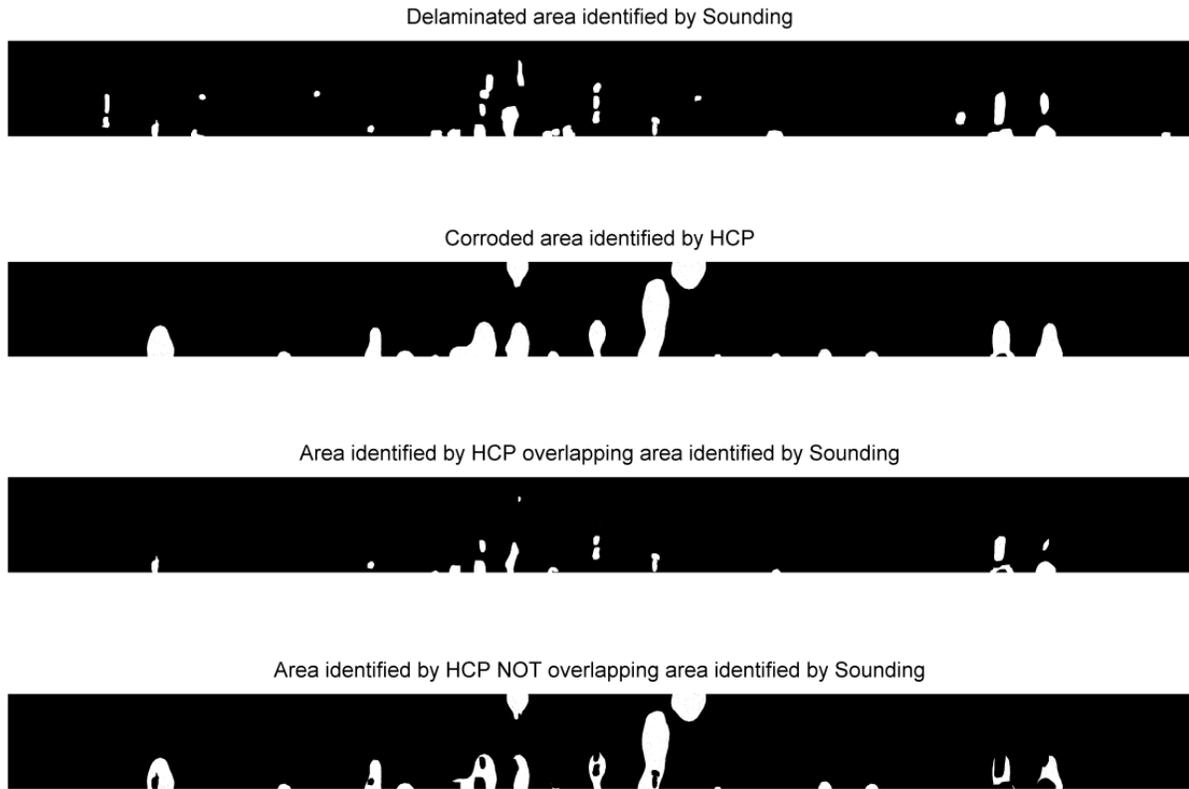
*Figure 6.7. Images used to calculate the overlapped and not overlapped area between the delaminated areas identified by sounding and the areas identified by half-cell potential survey threshold of -250 mV vs CSE (example from Study Area EB-1).*

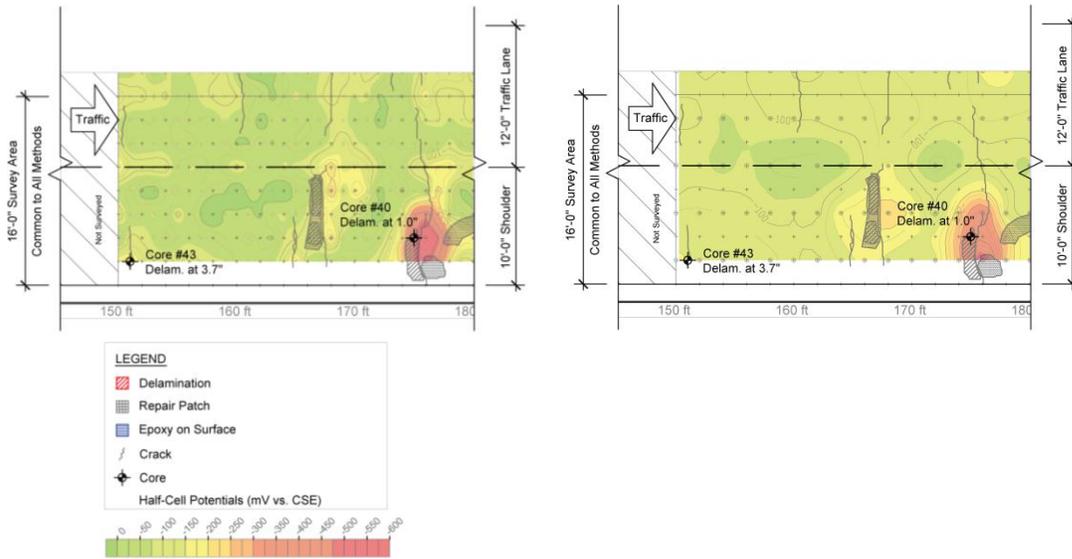
Figure 6.8. Comparison between a) single rolling wheel and b) rolling cart equipment. Note that the elevated corrosion potential at Core #40 is shown in both a) and b), but that the elevated corrosion potential at Core #43 is only resolved in data collected with the single rolling wheel shown in a).

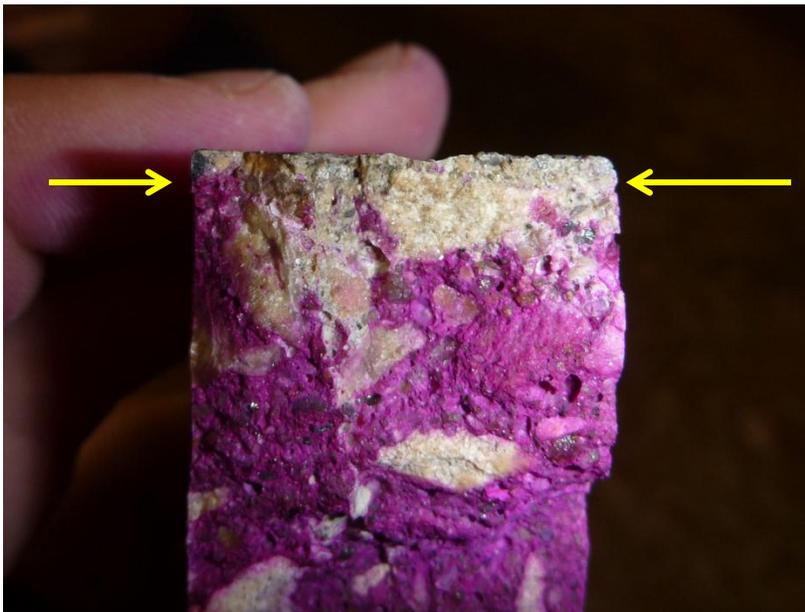
Figure 8.2. Phenolphthalein indicator on a freshly cracked surface of a core. The depth of carbonation is indicated by the arrow (pink color indicates  $pH > 9$ ).

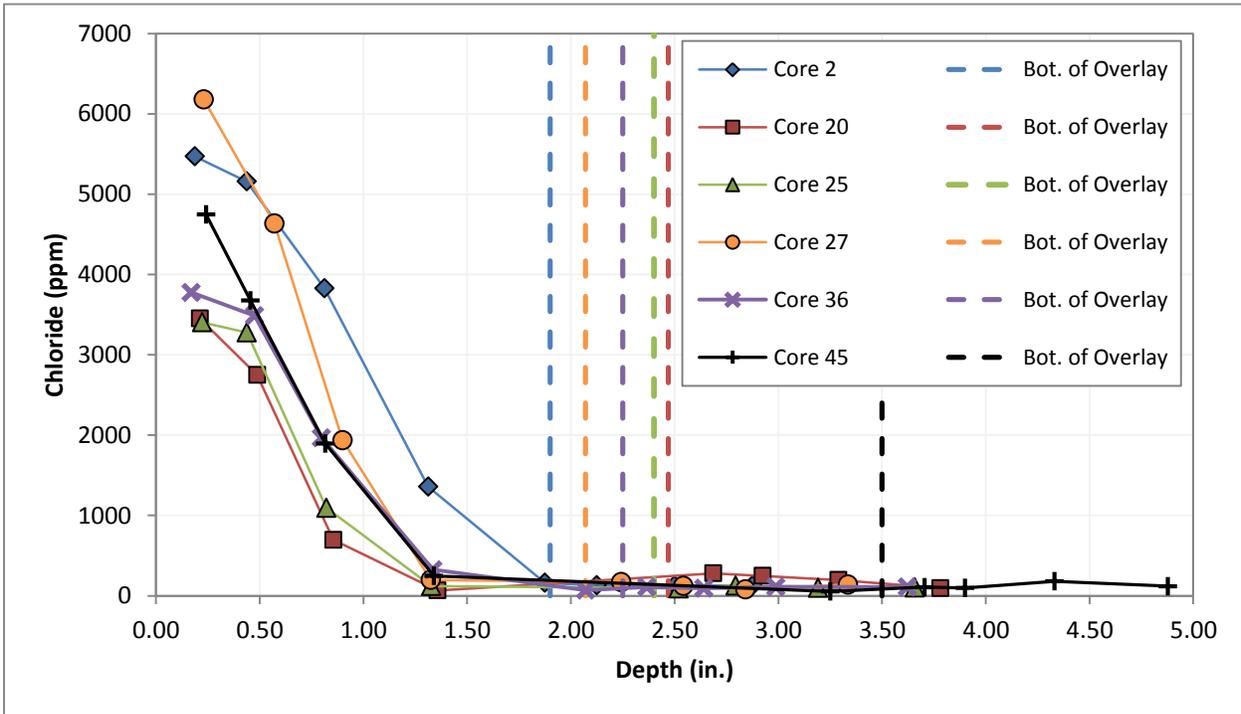
**8.2.3.3 Findings.** In this report, chloride concentrations are given in terms of acid-soluble chloride, which represents nearly all chloride contained in the concrete sample, including any chloride chemically bound within the aggregate. The measured chloride contents versus depth are shown in Figure 8.3 through Figure 8.5. The figures show data from cores with sound concrete (uncracked and without delaminations), cores with delaminations, and cores with through-thickness vertical cracks, respectively. The cores contained moderate levels of background chloride (approximately 100 ppm), which is identified by uniform chloride levels over a range of depths beyond where significant surface-applied chlorides would be expected to have penetrated. The laboratory data from the chloride testing is provided in Appendix G.

Figure 8.3. Cores from sound concrete (uncracked and no delaminations). Measured chloride contents and overlay thickness, measured as distance from the top surface of the overlay.

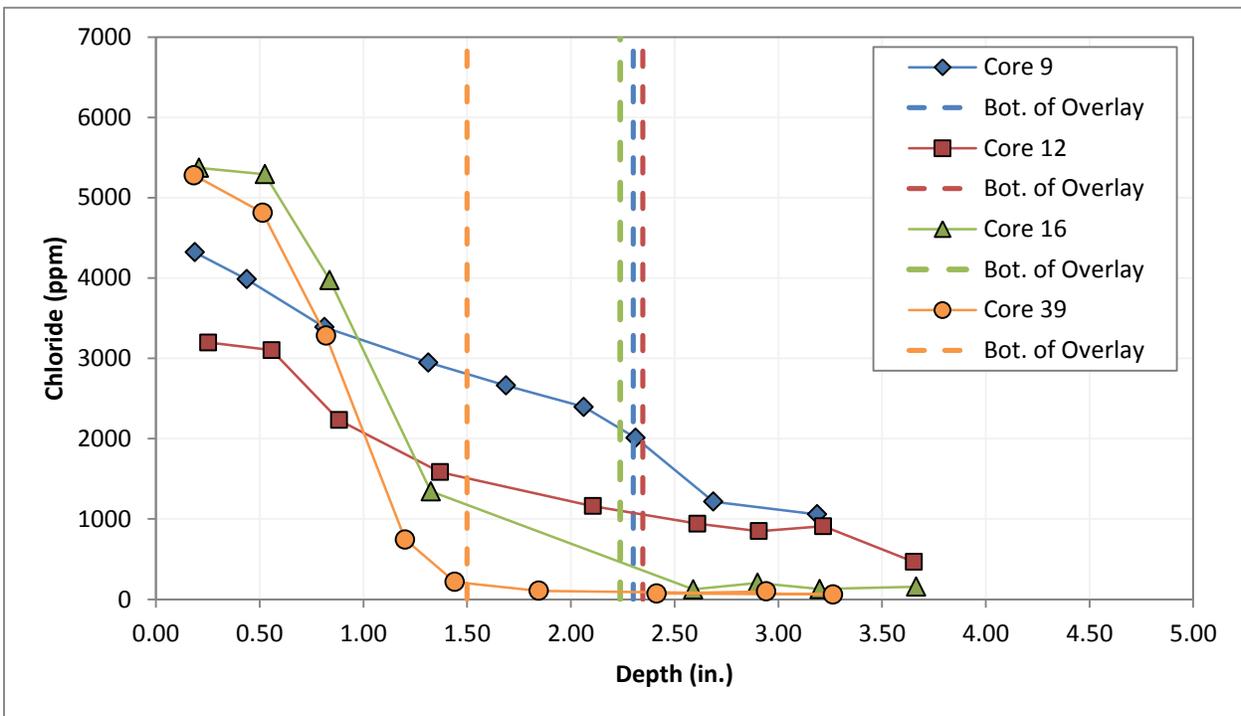
Figure 8.4. Cores with delaminations. Measured chloride contents and overlay thickness, measured as distance from the top surface of the overlay.

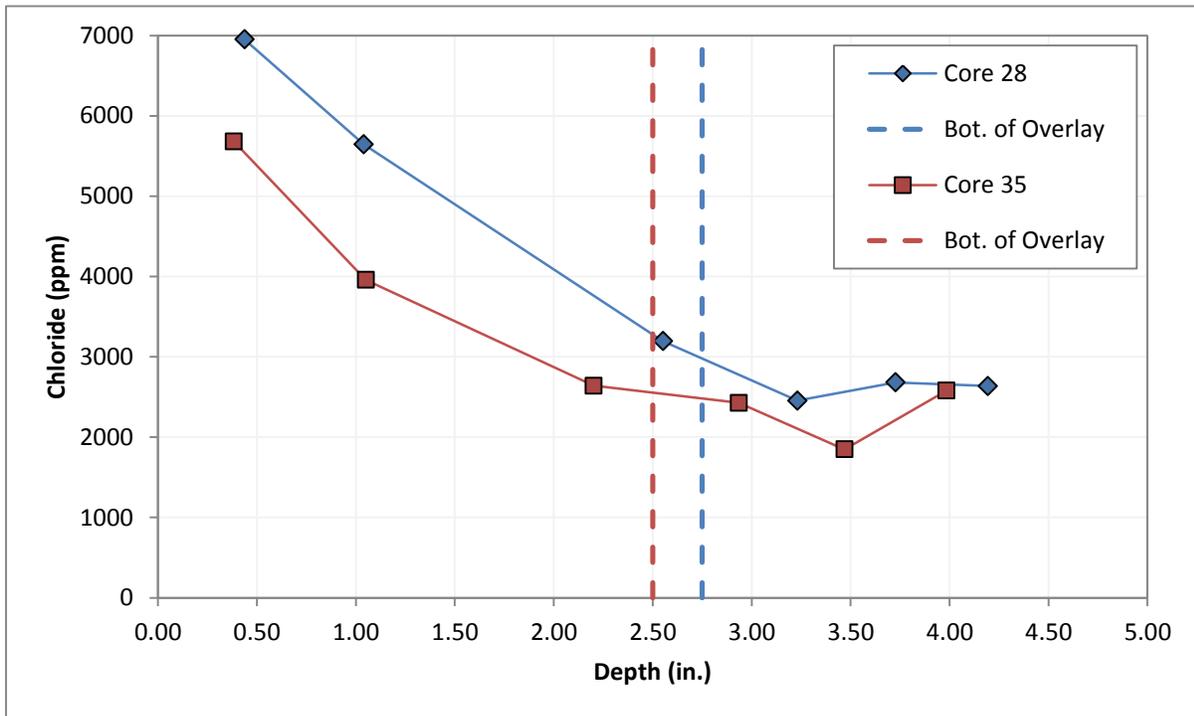
Figure 8.5. Cores with through-thickness vertical cracks. Measured chloride contents and overlay thickness, measured as distance from the top surface of the overlay.

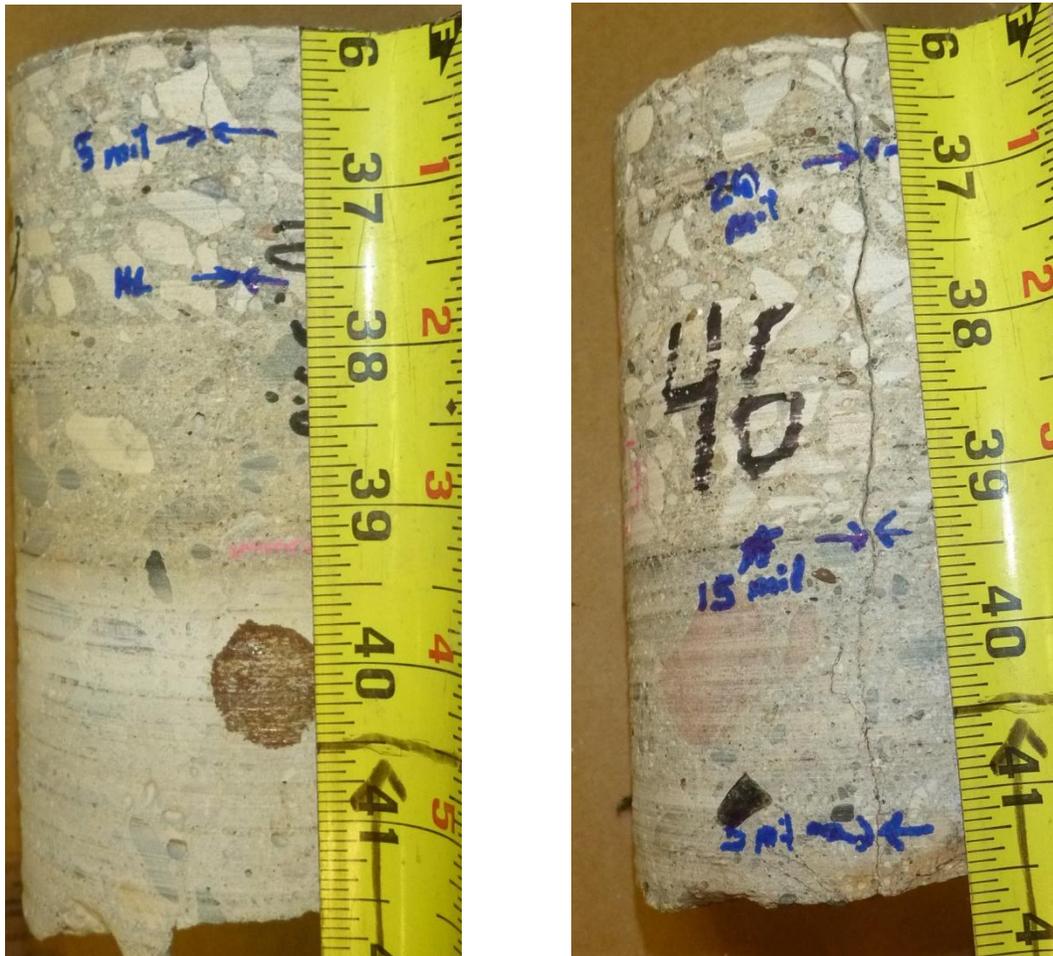
Crack widths ranged from 10 to 30 mils; further examination of extracted cores indicated that the cracks narrowed to 1/3 or less of the surface width as they approached the bar depth (Figure 8.7). For the purposes of modeling and based on the findings of the field investigation, crack width was estimated to be log-normally distributed, with a median value of 5 mils and a coefficient of variation of 60 percent.

Figure 8.7. Comparison of crack width versus depth for Cores 33 and 46.

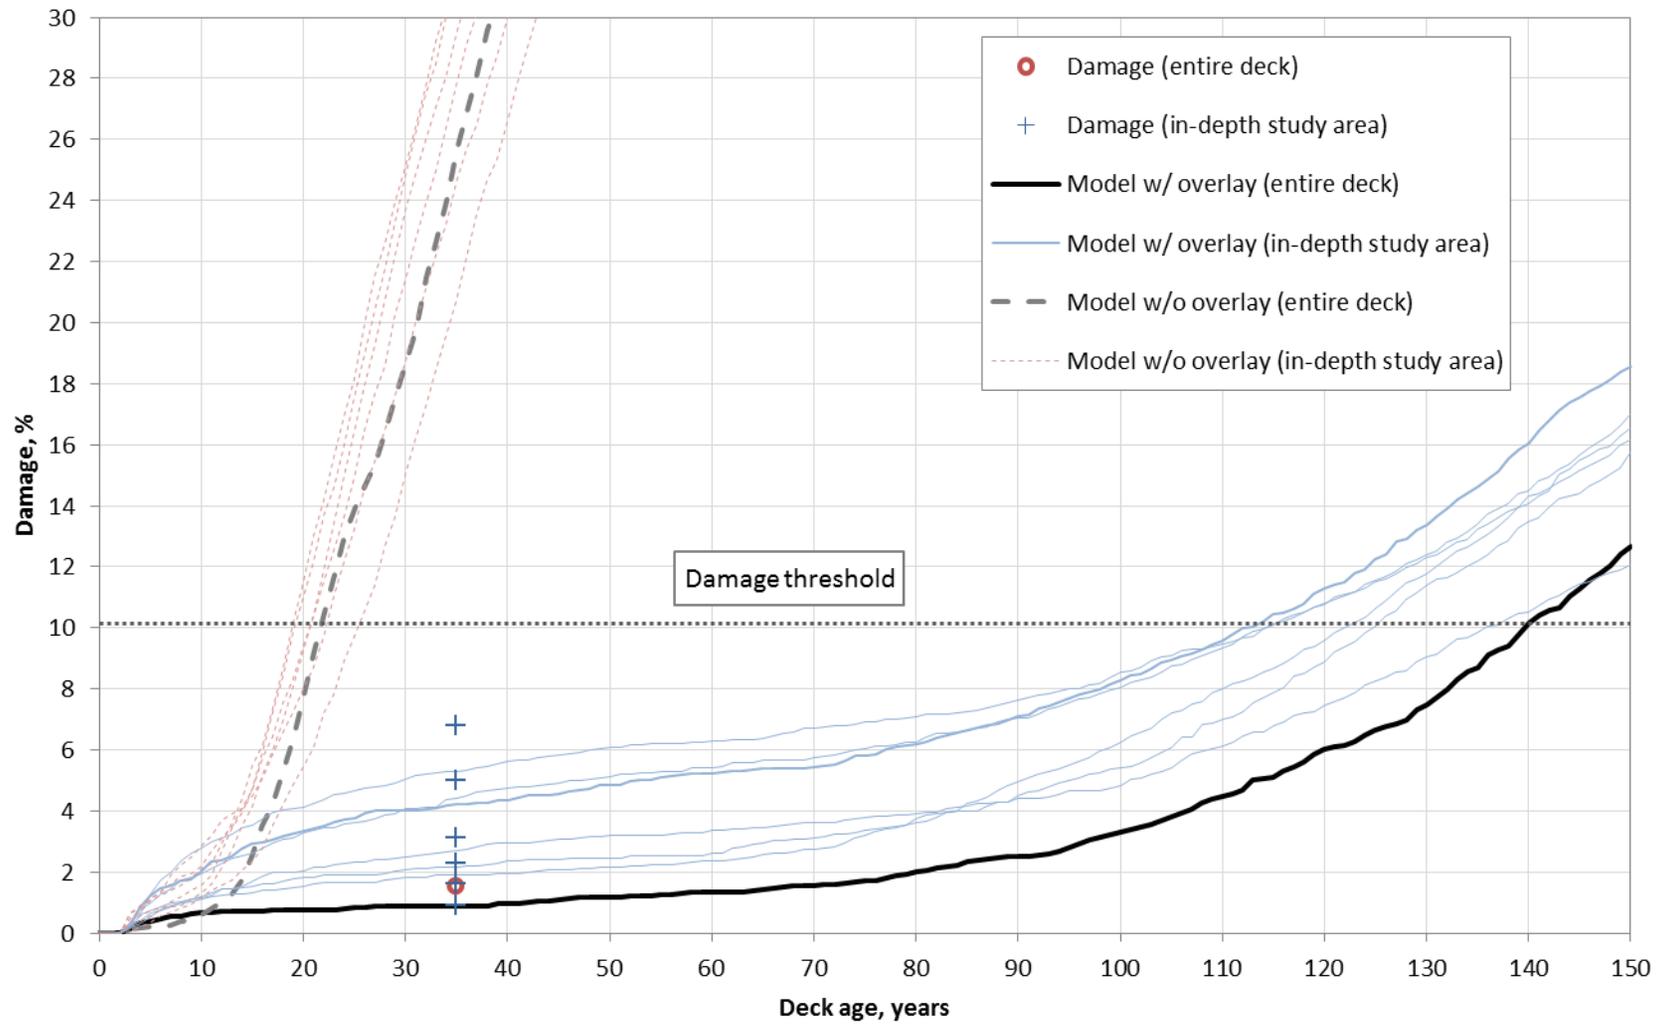
**8.3.2.1 Projected Service Life.** The service life model results, in terms of predicted damage (area of deck exhibiting corrosion-related delamination or spalling) versus time, for the entire deck on average and for each of the in-depth study areas are plotted in Figure 8.10. In the figure, solid lines indicate the predicted damage versus time for the I-129 bridge as constructed, which includes the beneficial effects of the low-permeability overlay. Also shown on this figure as single points are the actual damage areas observed to date for the entire deck and for each of the in-depth study areas.

**8.3.2.2 Comparison between Performance With and Without Overlay.** To provide a basis of quantifying the benefits provided by the overlay, a similar analysis to that reported above was performed based on the assumption that the chloride penetration resistance of the overlay was the same as that assumed for the deck slab (i.e., the same apparent diffusion coefficient). This represents the condition where the full deck was constructed homogeneously without an overlay. The predicted damage versus time curves for the bridge based on these assumptions, with all other variables kept the same, are shown as the dotted lines in Figure 8.10.

Figure 8.10. Service life model results: Plot of damage versus deck age for both the in-depth study areas and the entire deck.

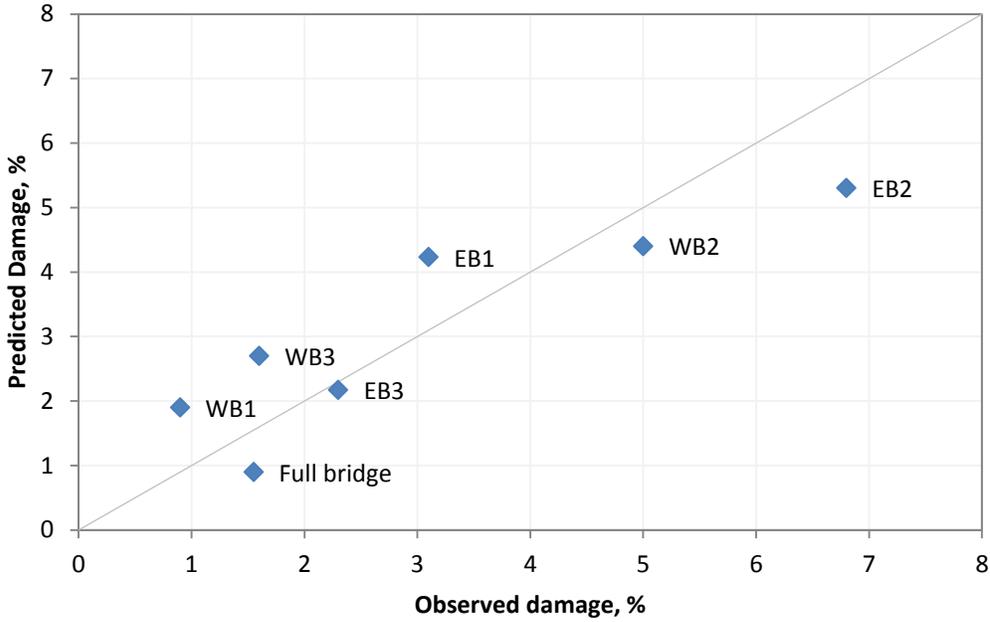
The actual predicted damage versus observed damage through 35 years is plotted for the entire deck and in-depth study areas in Figure 8.11. A diagonal line is provided for reference on the plot, which would indicate a perfect match between predicted and observed values. The plot shows that, although predicted values vary somewhat from observed values, the model predicts observed damage quite well.

Figure 8.11. Plot of predicted damage versus observed damage at 35 years. Data includes both in-depth study areas and entire deck. Line represents perfect agreement between prediction and observed conditions.

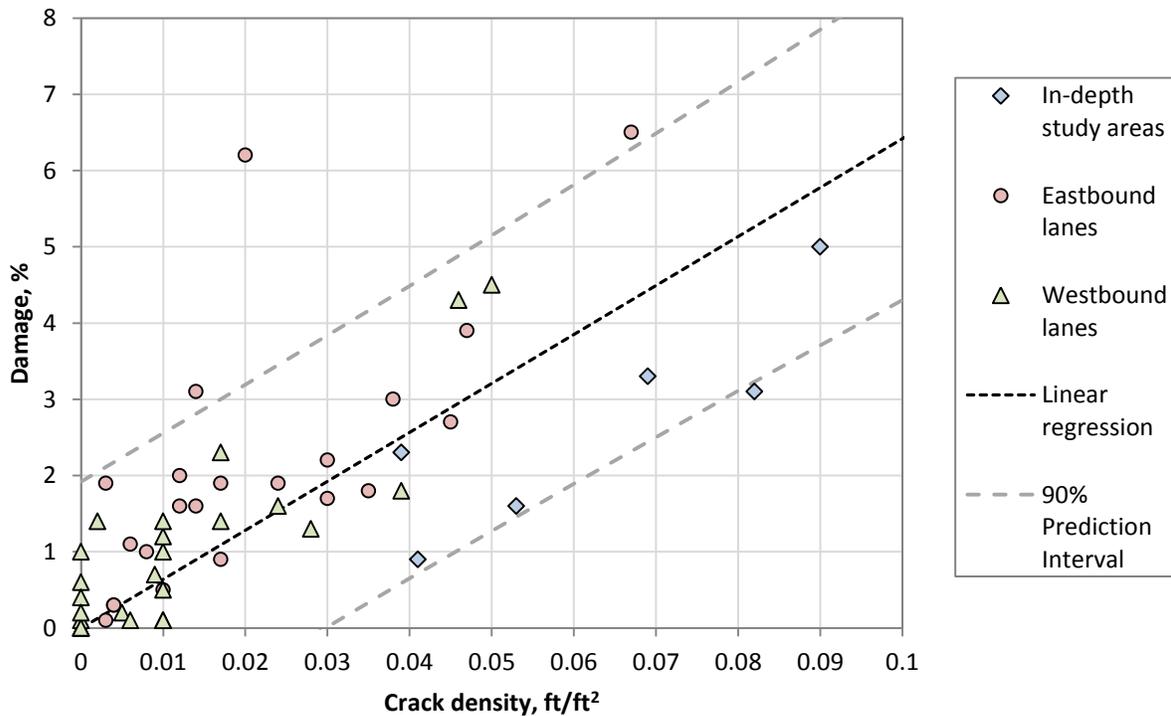
Considering that the bridge as-surveyed is in the second phase of the damage curve, the currently observed damage should strongly correlate with the observed crack density, since that controls the extent of damage in the first phase of the damage curve. Figure 8.12 illustrates this linear relationship between crack density and currently observed damage.

Figure 8.12. Relationship between crack density and observed damage.

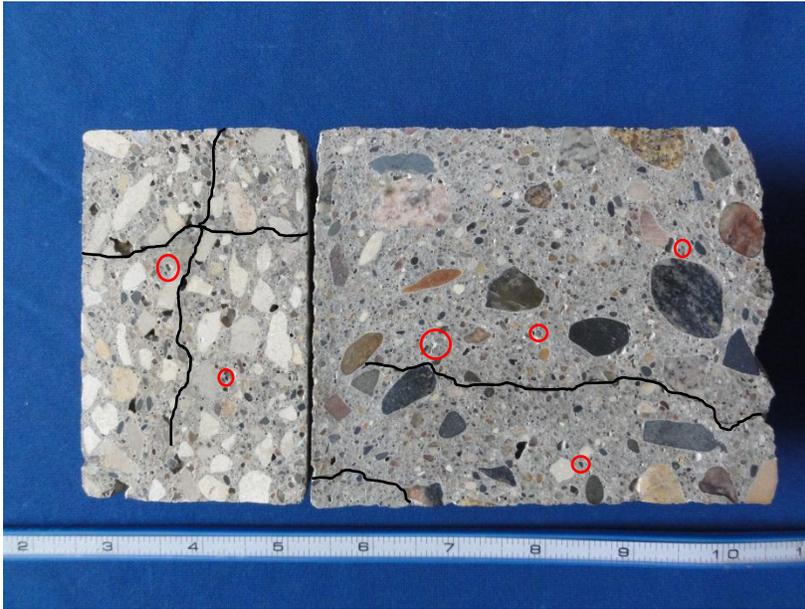
Cracks were detected in both the topping and the substrate concretes. The topping layer had two microcracks; one horizontal, located mid-depth of the layer, and the other vertical. Secondary deposits of salt were present within the pores of the cement paste in localized areas of the top 1 inch of the overlay concrete. (Figures 2, 3, and 4). Because the core was taken adjacent to a delamination, it is possible the horizontal crack is an extension of the delamination plane that has not yet penetrated to the surface.

*Figure 2. Lapped section of Core 6; top of the core is on the left of the photo. The locations of the microcracks are outlined. The largest reactive shale particles are encircled.*

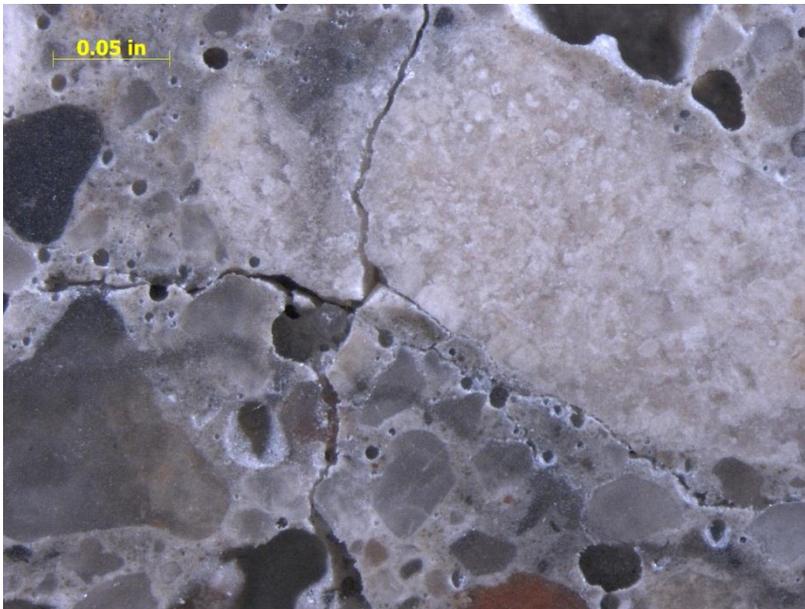
*Figure 3. Core 6 topping; close up view of the area where the vertical and horizontal microcracks intercept.*
