**Final Report on the  
I-129 Missouri River Bridge  
Deck Condition Assessment Using Non-Destructive  
Testing Methods**

**Bridge No. 9700.0S129, Sioux City, IA**

**November 5, 2012**

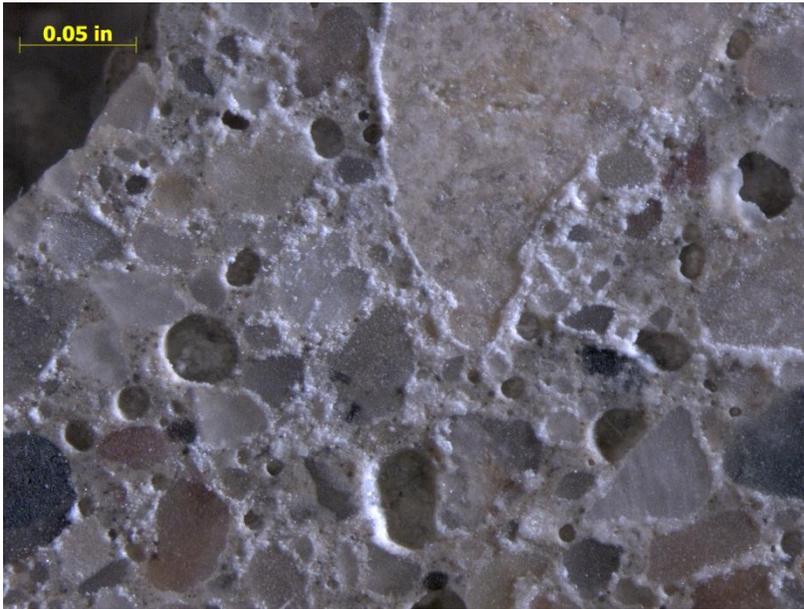
*Figure 4. Core 6 topping; example of secondary salts deposits (most likely deicing compounds) precipitating from the pores of the cement paste in the top regions of topping layer.*

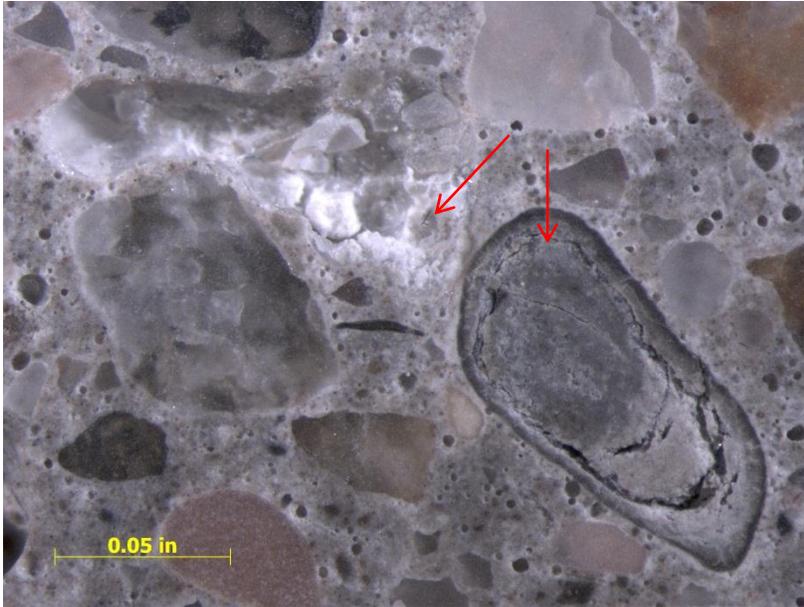
The fine aggregate was natural siliceous and calcareous sand that had composition similar to the fine aggregate in the topping layer. A particle of shale containing reactive elements and associated ASR gel was detected on the lapped section of the core. However, there were no cracks in the surrounding cement paste (Figure 6).

*Figure 6. Core 6 base concrete; shown is the largest sand particle of reactive shale. White ASR gel partially fills large air void that is adjacent to the particle. Cracks are present within the shale particle but they do not extend to the surrounding cement paste.*

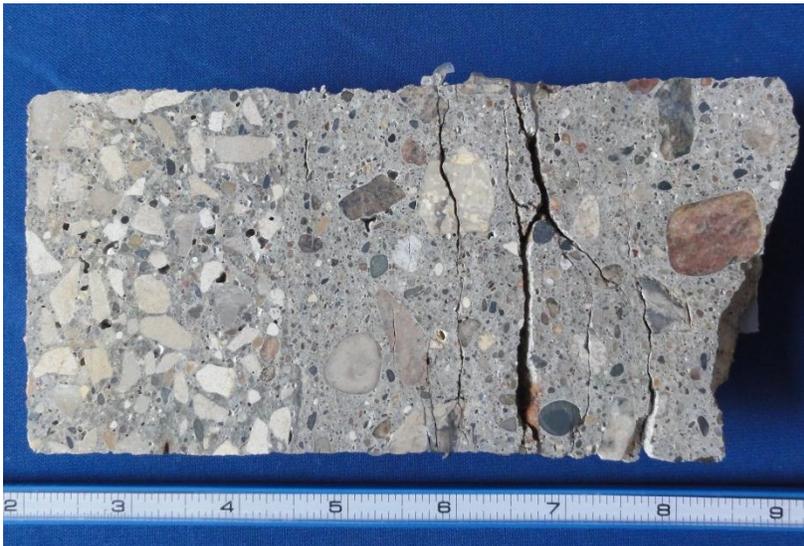
The core was 5 to 6-3/4 inches long, and 3-3/4 inches in diameter. The core consisted of two different concrete mixes: a topping constituting the top 2-1/4 inch of the core; and base concrete constituting the bottom 2-3/4 to 4-1/2 inches of the core. The top surface of the core had shallow grooves as in Core 6, and the bottom end was a fractured surface. As received, the topping was bonded to the substrate concrete (Figure 7). A 3/4-inch diameter (No. 6) rebar was embedded in base concrete, 3-1/2 inches from the top of the core. The rebar was significantly corroded (Figures 8 and 9).

*Figure 7. Lapped section of Core 42; top end is on the left of the photo. Numerous cracks due to corrosion and ASR are present in the base concrete; no cracking was detected in the topping concrete.*

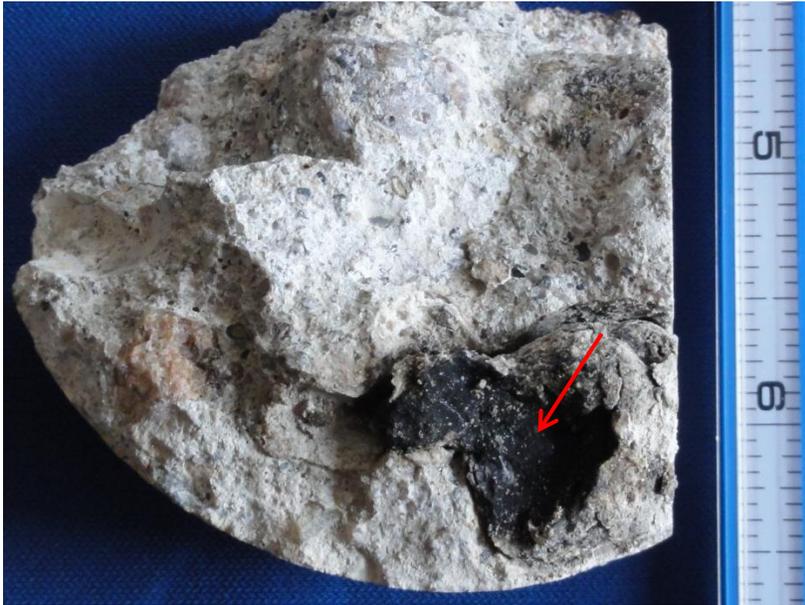
*Aggregates* - The coarse aggregates in the base concrete were similar to Core 6. However, the coarse aggregates also contained reactive particles not detected in Core 6. The source of most of the ASR gel in cracks appeared to be a large, dark lump that was embedded at the fractured bottom end of the core. The lump appeared to be an industrial waste product and was composed mainly of siliceous glassy material, similar to silica fume. The approximate dimensions of the lump were 1 inch by 3/4 inch. The lump was most likely a contaminant within the aggregate (Figures 10 and 11).

*Figure 10. Core 42; large lump of industrial waste containing reactive glass embedded at the bottom of the base concrete.*

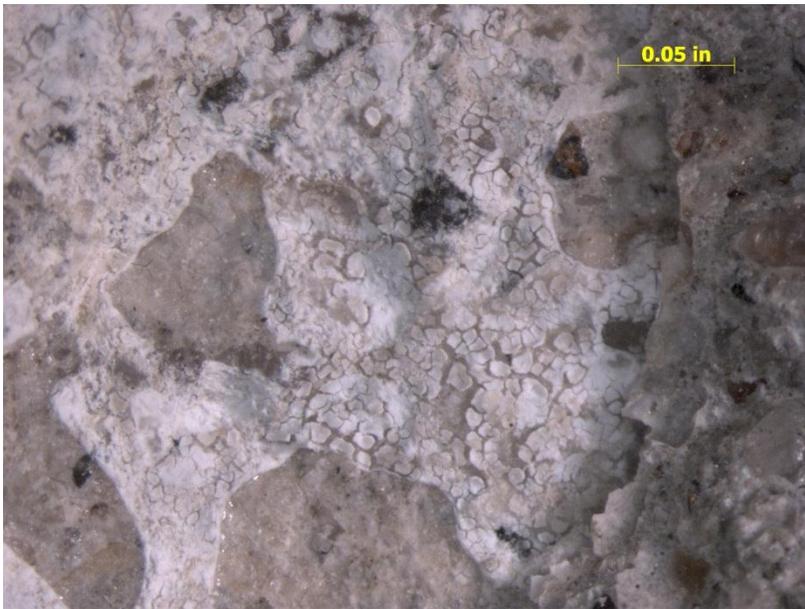
*Figure 11. Core 42; close up of the light color area of the bottom surface of the core from Figure 8 showing that the surface is coated with ASR gel.*

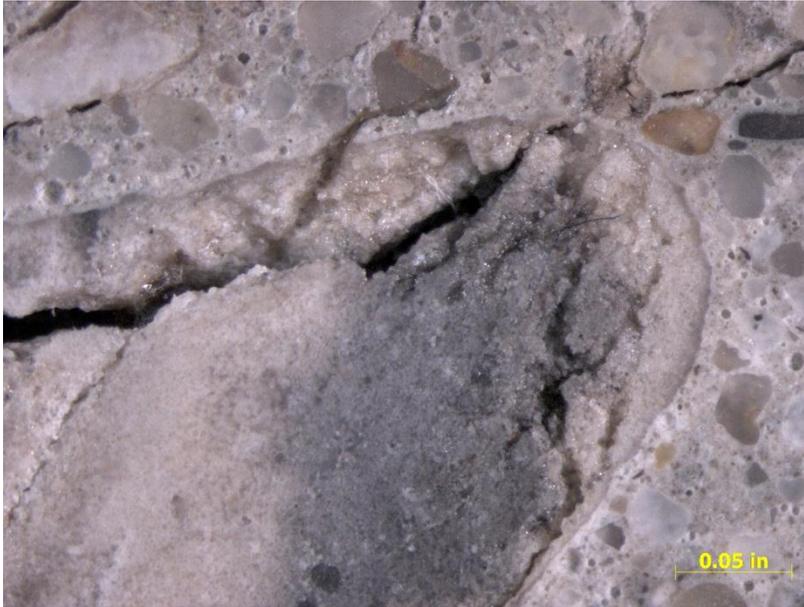
Also present in the cracked zone were two particles of sandstone; one was relatively large measuring 1/2 by 3/8 inch. Similar particles were not observed in any other location of either of the two cores (Figure 12). This particle contained reactive elements and was partially consumed in ASR.

*Figure 12. Core 42 base concrete; reactive sandstone particle, partially consumed in ASR; cracks extending into the surrounding cement paste.*

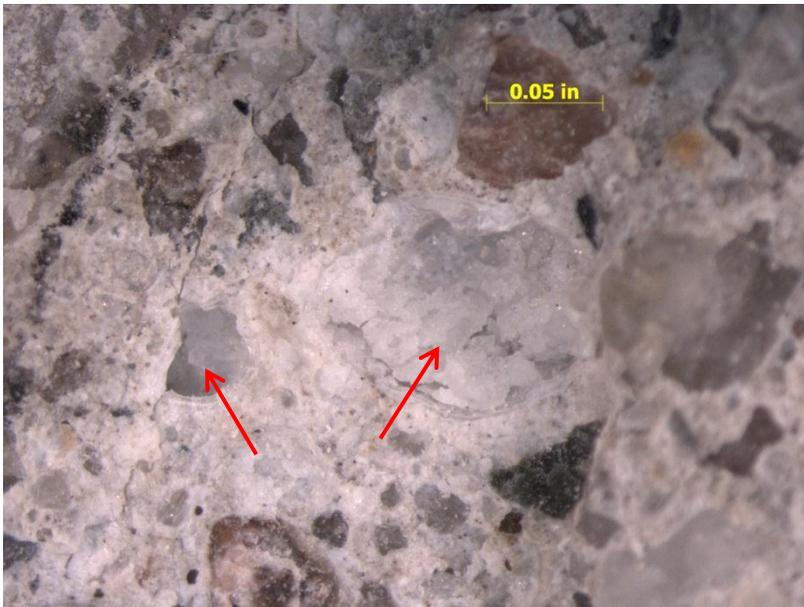
The fine aggregates were similar to those in Core 6. Soft particles of shale contained major amounts of siliceous, glassy material. Some of these particles were associated with the presence of ASR gel (Figure 13).

*Figure 13. Core 42; air voids partially filled with ASR gel at one of the crack surfaces in the base concrete.*

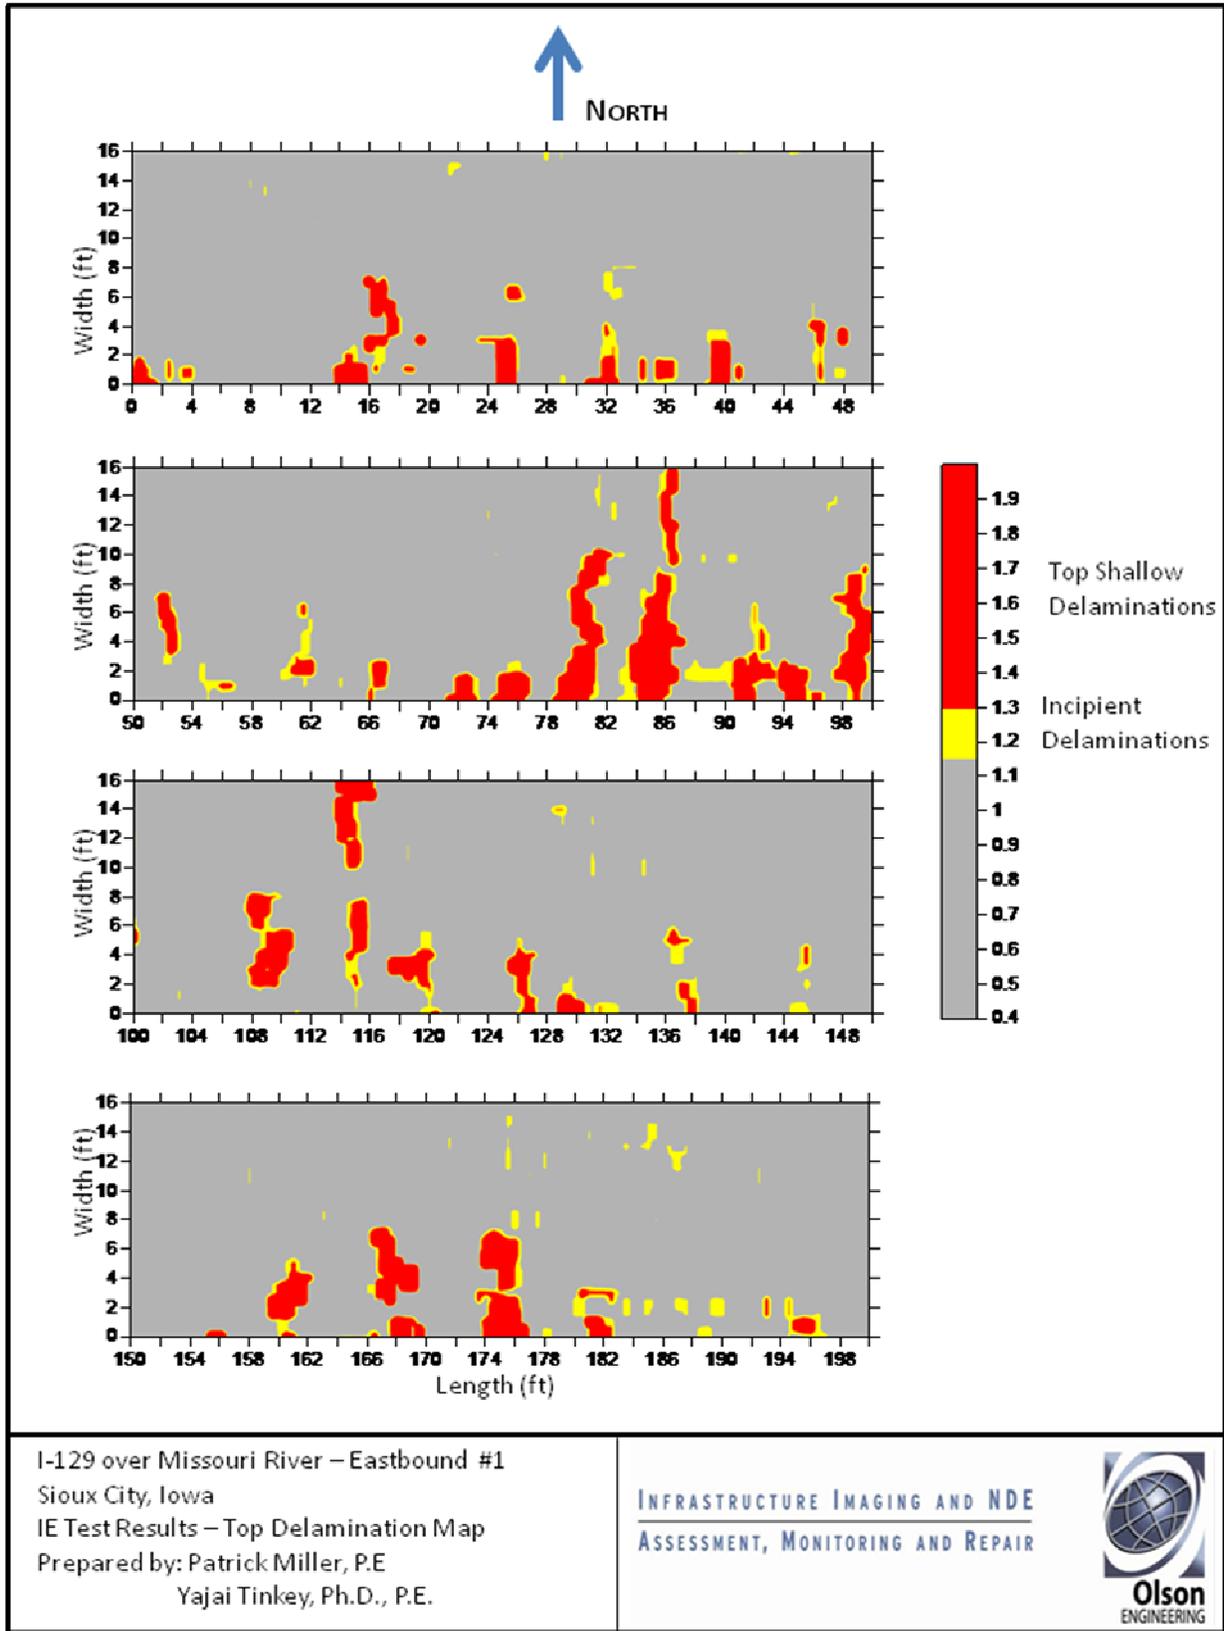
Figure B1 – Top Delamination Maps for Eastbound #1

The plan view color plots of the results representing the general conditions of the test section are presented in Appendix A. Top delamination maps are presented in Appendix B. The top delamination maps (Appendix B) indicate that there are several areas of delamination within each of the six test areas. The areas with the most delaminations are Eastbound Area 2, Eastbound Area 1, and Westbound Area 2. Olson Engineering's experience has shown that top delaminations (where it is audible when sounding) typically have calculated thickness values that are 30% higher than the expected echo thickness (purple and red areas). The yellow areas (15 – 30% higher) produced questionable results and may be due to developing/incipient delaminations. The blue areas have resonant frequencies which are notably less than the expected full thickness echo. It is possible that these areas are due to cracking at the bottom layer of rebar steel and may emerge in the future as bottom delaminations. Areas with resonances within approximately 20% of the expected resonance from a full deck thickness echo are considered sound. The variations in resonant frequency are attributed to small variations in actual thickness due to cast in place construction and resurfacing, as well as slight, natural variations in the concrete velocity. Table I in Section 1.0 presents the summary of the BDS-IE test results of the 6 deck areas.
