Vibration Monitoring of Luminaires on the Burlington Cable-Stayed Bridge

The Iowa Department of Transportation

Iowa DOT
Kenneth F. Dunker

August 5, 2002

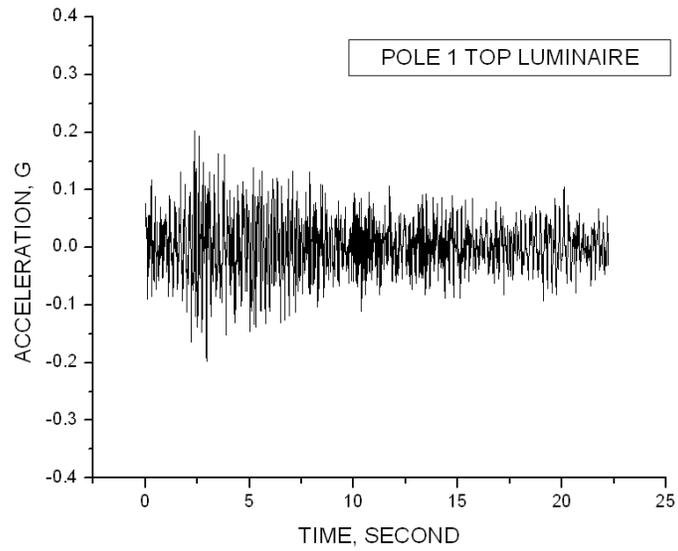
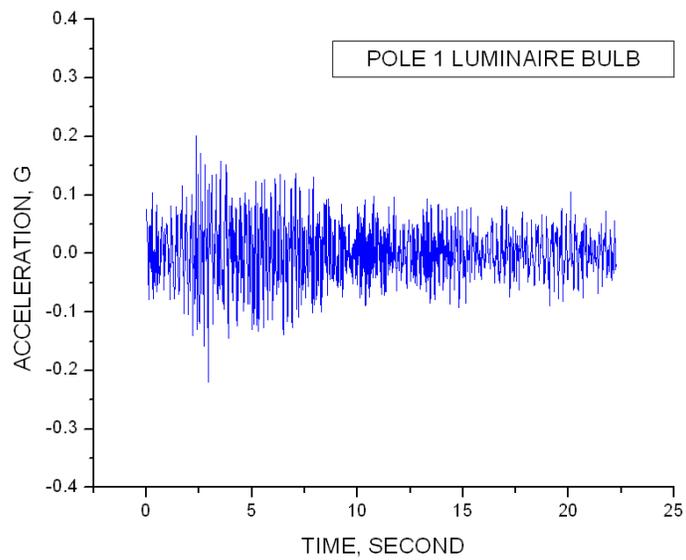
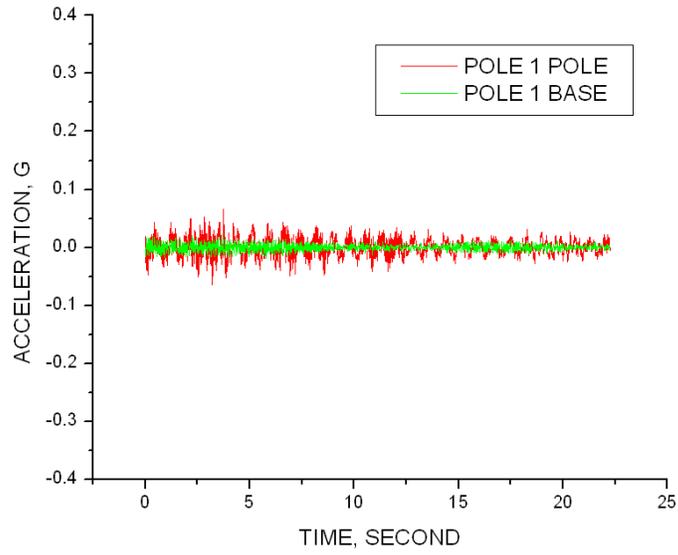
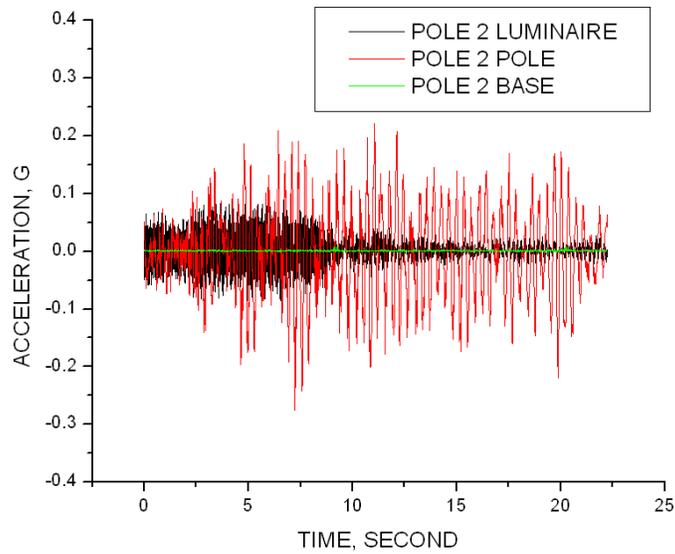
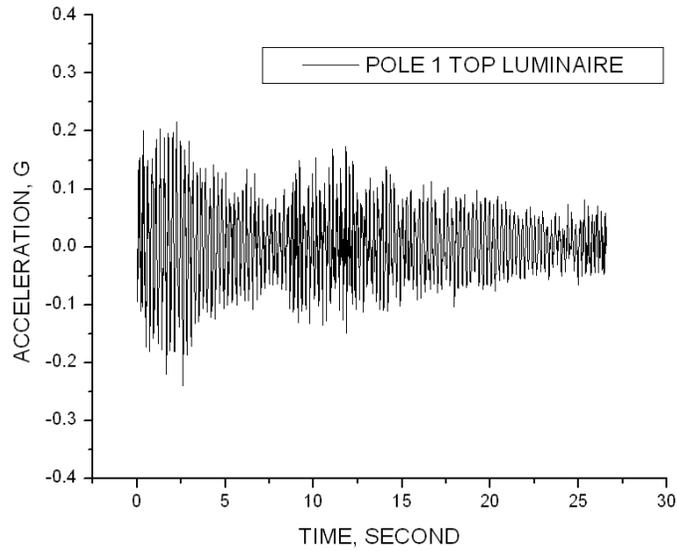
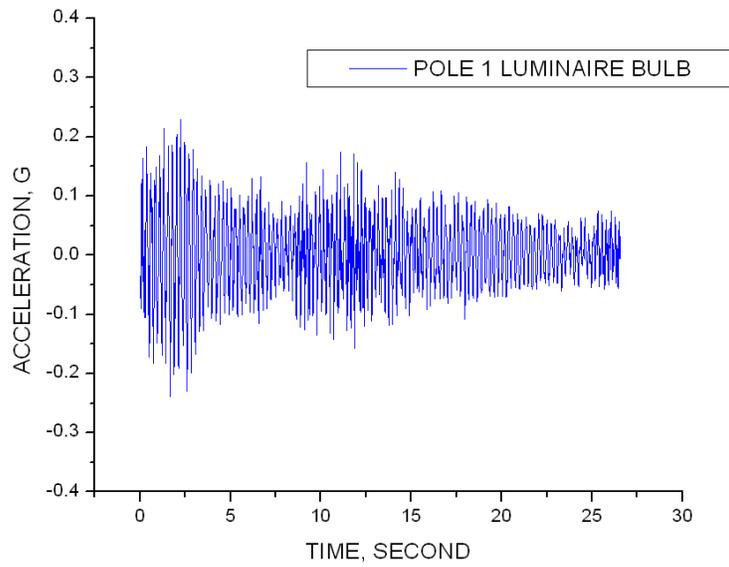
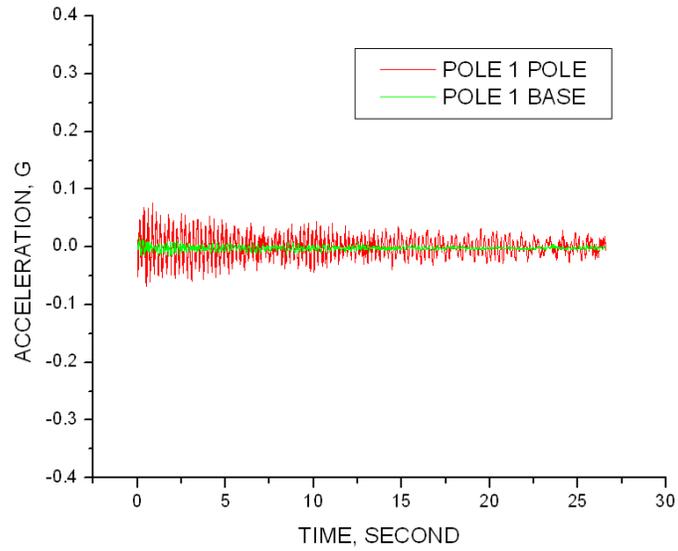
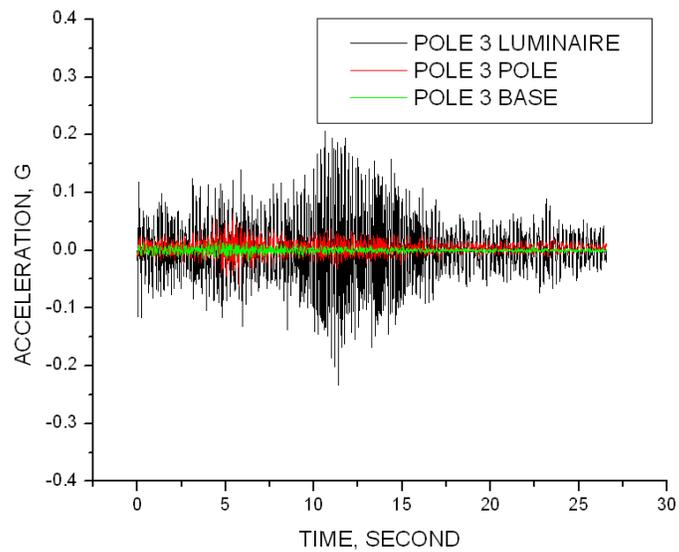
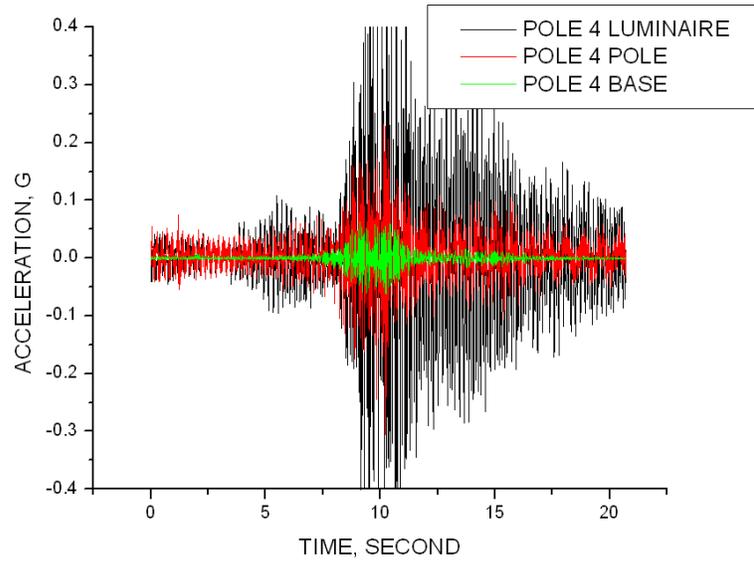
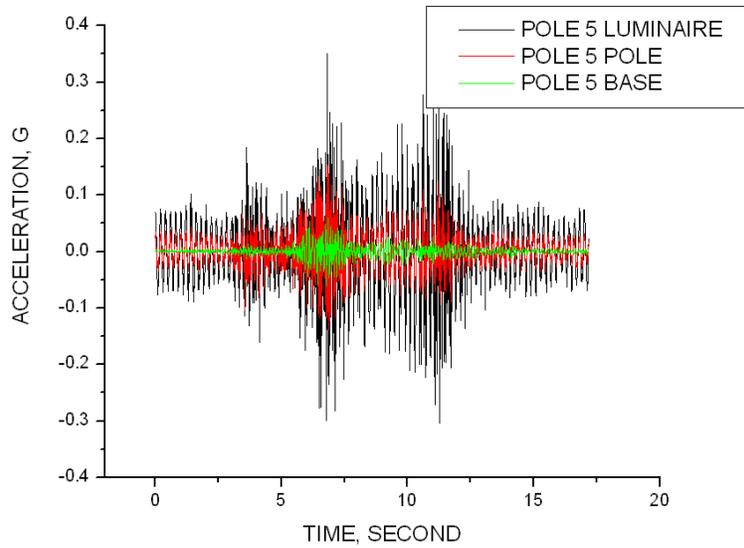
Figure 5. Typical acceleration data.

The data collected from these tests indicates that installing a damper on the exit ramp light pole tended to reduce the acceleration level. However, it was found that installing dampers on main span pole had no impact on acceleration levels. It should also be pointed out that it was also qualitatively noted during testing that vibration of the bridge, and also in the light poles, tended to continue for a relatively long duration after the test load had passed. Unfortunately, the testing procedure used, specifically the fact that the bridge was continuously open to traffic, did not allow for quantification of the length of these vibrations. Several general observations can be made from the data taken during the testing as follows:
