# FIELD INSTRUMENTATION AND TESTING OF HIGH-MAST LIGHTING TOWERS IN THE STATE OF IOWA

## DRAFT FINAL REPORT

January 2006

Iowa Department of Transportation  
Office of Bridges and Structures  
800 Lincoln Way  
Ames, IA 50010

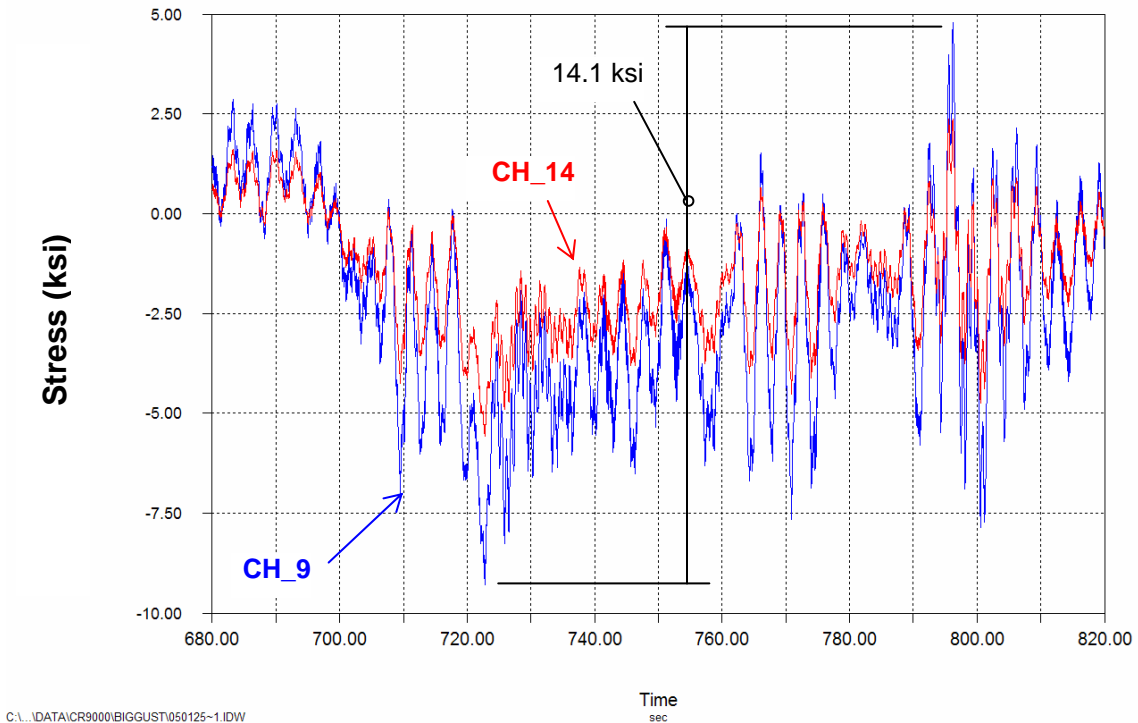
Figure 4.13– Detailed stress time-history for a large wind event at the As-built tower on January 22, 2005 and 5:20AM

Finally, Figure 4.13 contains a stress time-history for the same wind event, for strain gages CH\_9 and CH\_14. Gage CH\_9 is above the hand hole, while CH\_14 is several feet above the hand hole on the same face of the pole. It can be seen that the stress histories are similar except that the stress at the hand hole (CH\_9) is higher due to the stress concentration there. Furthermore, the Figure indicates that the stress range at the hand hole is very high, equal to 14.1 ksi. This was also evident from the stress-range histogram shown in Figure 4.1. Again, it was found that during the long-term monitoring phase of the project, that the largest stress ranges were caused by natural wind gusting, and the response was primarily in the first mode.

It can be seen in Figures 4.12 and 4.13 that the wind speed at the time of this event is low, ranging between 3 and 10 mph. When the wind speed reaches a critical value (approximately 6 mph), vortex shedding commences. When the frequency of the vortex shedding matches a vibration frequency of the tower, the tower locks-in and begins to oscillate in that mode of vibration. In this case the second mode of vibration is excited (see Figure 3.4b). The frequency of vibration is 1.32 Hz. The stress range measured in these strain gages is approximately 2 ksi. After the wind speed drops below 6 mph (the critical wind speed), the vortex shedding ends.

Though this stress is not excessively high, there are approximately 1300 stress cycles caused by this single event. It has been found that the 2nd mode vortex shedding is most common at these towers, but that the measured stress range is low. However, due to the fact that the socket connection at the base has poor fatigue resistance (the CAFL

may be less than 2.3 ksi for  $E'$ ), vortex shedding has the potential to cause a large number of damage-causing cycles.

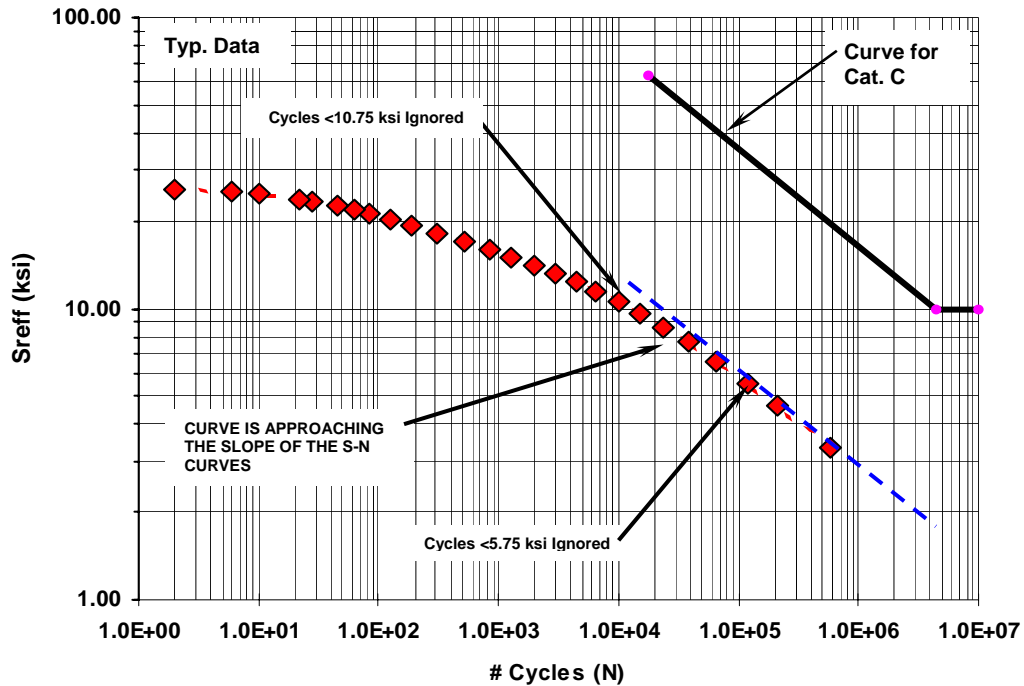
Figure B.1 – Effect of truncating cycles at different stress range cut off levels  
*(Typical data from a strain gage at a fatigue sensitive detail)*

Figure B.1, shows the effect on the calculated effective stress range for several levels of truncation using typical field acquired long-term monitoring data collected from strain gage installed on a bridge. The data presented in Figure B.1 are also listed in Table B.1 showing the selected truncation level and its impact on the effective stress range.

As demonstrated by Figure B.1, as the truncation level decreases (from the lowest level), the effective stress range and corresponding number of cycles approaches the slope of the S-N curve for Category C, which is also plotted in Figure B.1 (i.e., a slope of  $-3$  on a log-log plot). As long as the cut off level selected is consistent with the slope of the fatigue resistance curve, considering additional stress cycles at lower truncation levels does not improve the damage assessment and can therefore be ignored. As can be seen, using a truncation level as high as 10 ksi, the curve is nearly asymptotic to the slope of the S-N curves. Hence, an accurate prediction of the total fatigue life results.
