Report on  
Evaluation of Interstate 80 Sign Truss

**Office of Bridges and Structures  
The Iowa Department of Transportation**

Terry J. Wipf  
Brent M. Phares

September 25, 2002

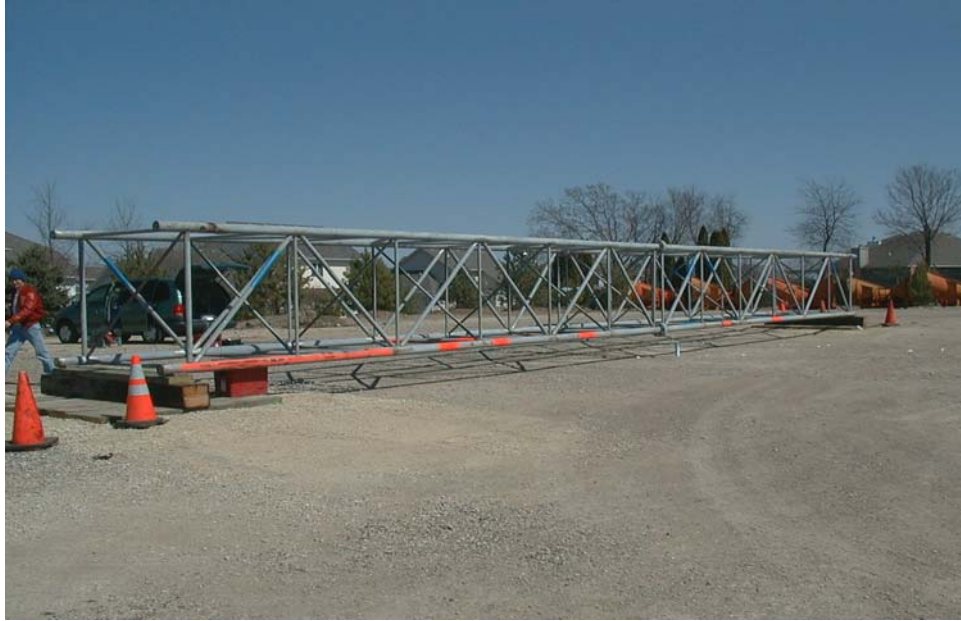
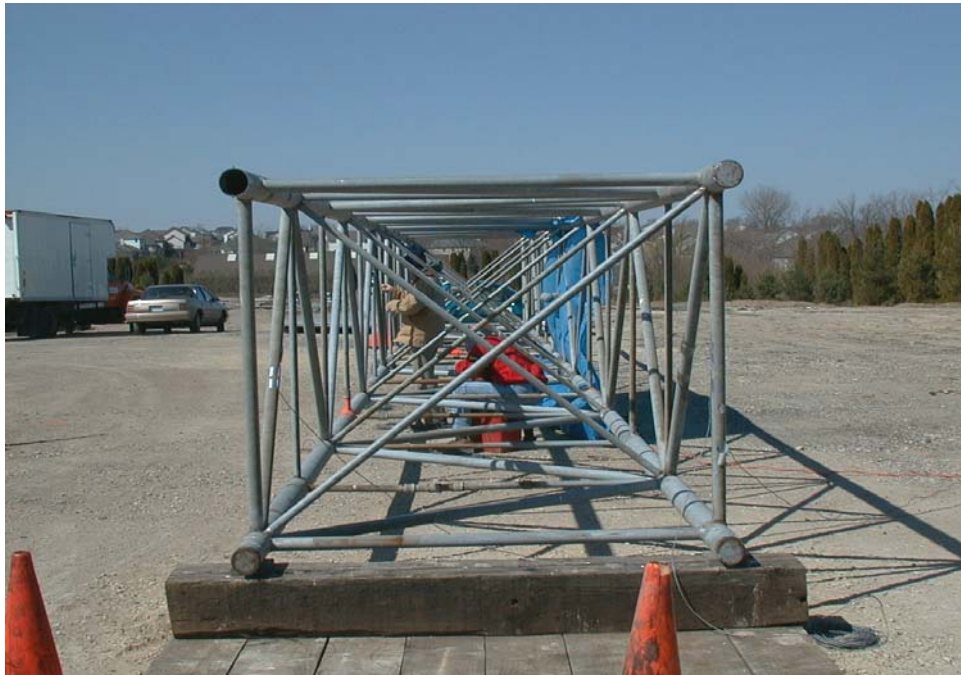
b. Side View of the Sign Truss  
Figure 3. Experimental Setup.

Two load tests were conducted in March and April of 2000. Both tests were performed at the Iowa DOT maintenance garage facility after removing the damaged truss from service. Figure 3 shows photos of the test set-up. Note that the truss was rotated 90 degrees from its normal orientation so that the effect of wind loads could be simulated by applying vertical loads.

a. 3D View of the Sign Support Truss Before Testing

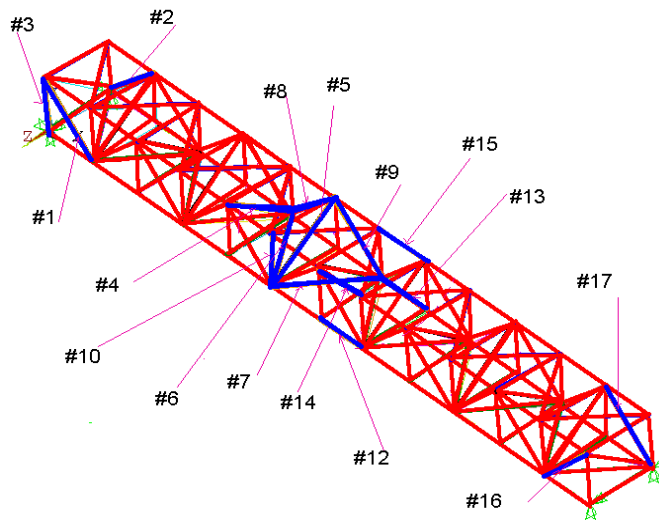
Figure 5. View of Truss Showing the Strain Gage Locations

Before the test, the truss was instrumented with strain gages. The strain gages were mounted on sixteen truss members and oriented such that only axial load was measured. Figure 5 shows a schematic of the truss with the instrumented members highlighted.

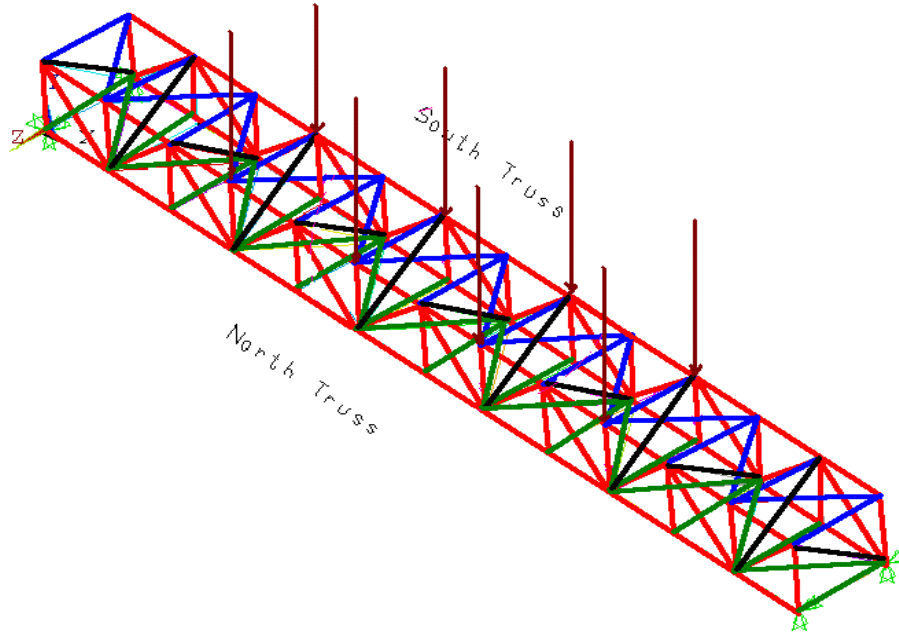
Figure 7. 3D Finite Element Model of the Truss.

A three-dimensional finite element model of the truss was developed using ANSYS. Each member was represented by three-dimensional beam elements (Beam44 element in ANSYS). The geometrical properties of the members were based on the cross sectional dimensions of the truss members given in the design plans. The Beam44 element has six degrees of freedom at each node: translations in the nodal X, Y, Z directions and rotations about the nodal X, Y, Z axes. The loads consisted of 4 concentrated forces applied equally on the north and south trusses. The boundary conditions at the truss ends were considered to be pinned at the west end and a roller at the east end. Figure 7 shows the finite element idealization of the truss structure.

The model was analyzed for both test cases (i.e., undamaged and damaged {element 29 in the model}). The maximum deflection before removing the cut member was found to be 0.59 in.; after removal the deflection was 0.87 in. For comparison purposes, a simple 2D model of the structure was developed and analyzed. The results of the 2D model were found to be very close to those of the 3D model for the undamaged truss. This means that using simple 2D models would be sufficient to assess the overall structural behavior of the truss. However, it was found that a 2D model would not accurately predict the behavior of the damaged truss. The 3D analysis strain results are summarized in Table 2. Figure 8 shows the results for members in the vicinity of the removed member.
