*Office of Bridges and Structures*

# ***Emergency Response Manual for Over Height Collisions to Bridges***

*Issue Date: September 11, 2014*

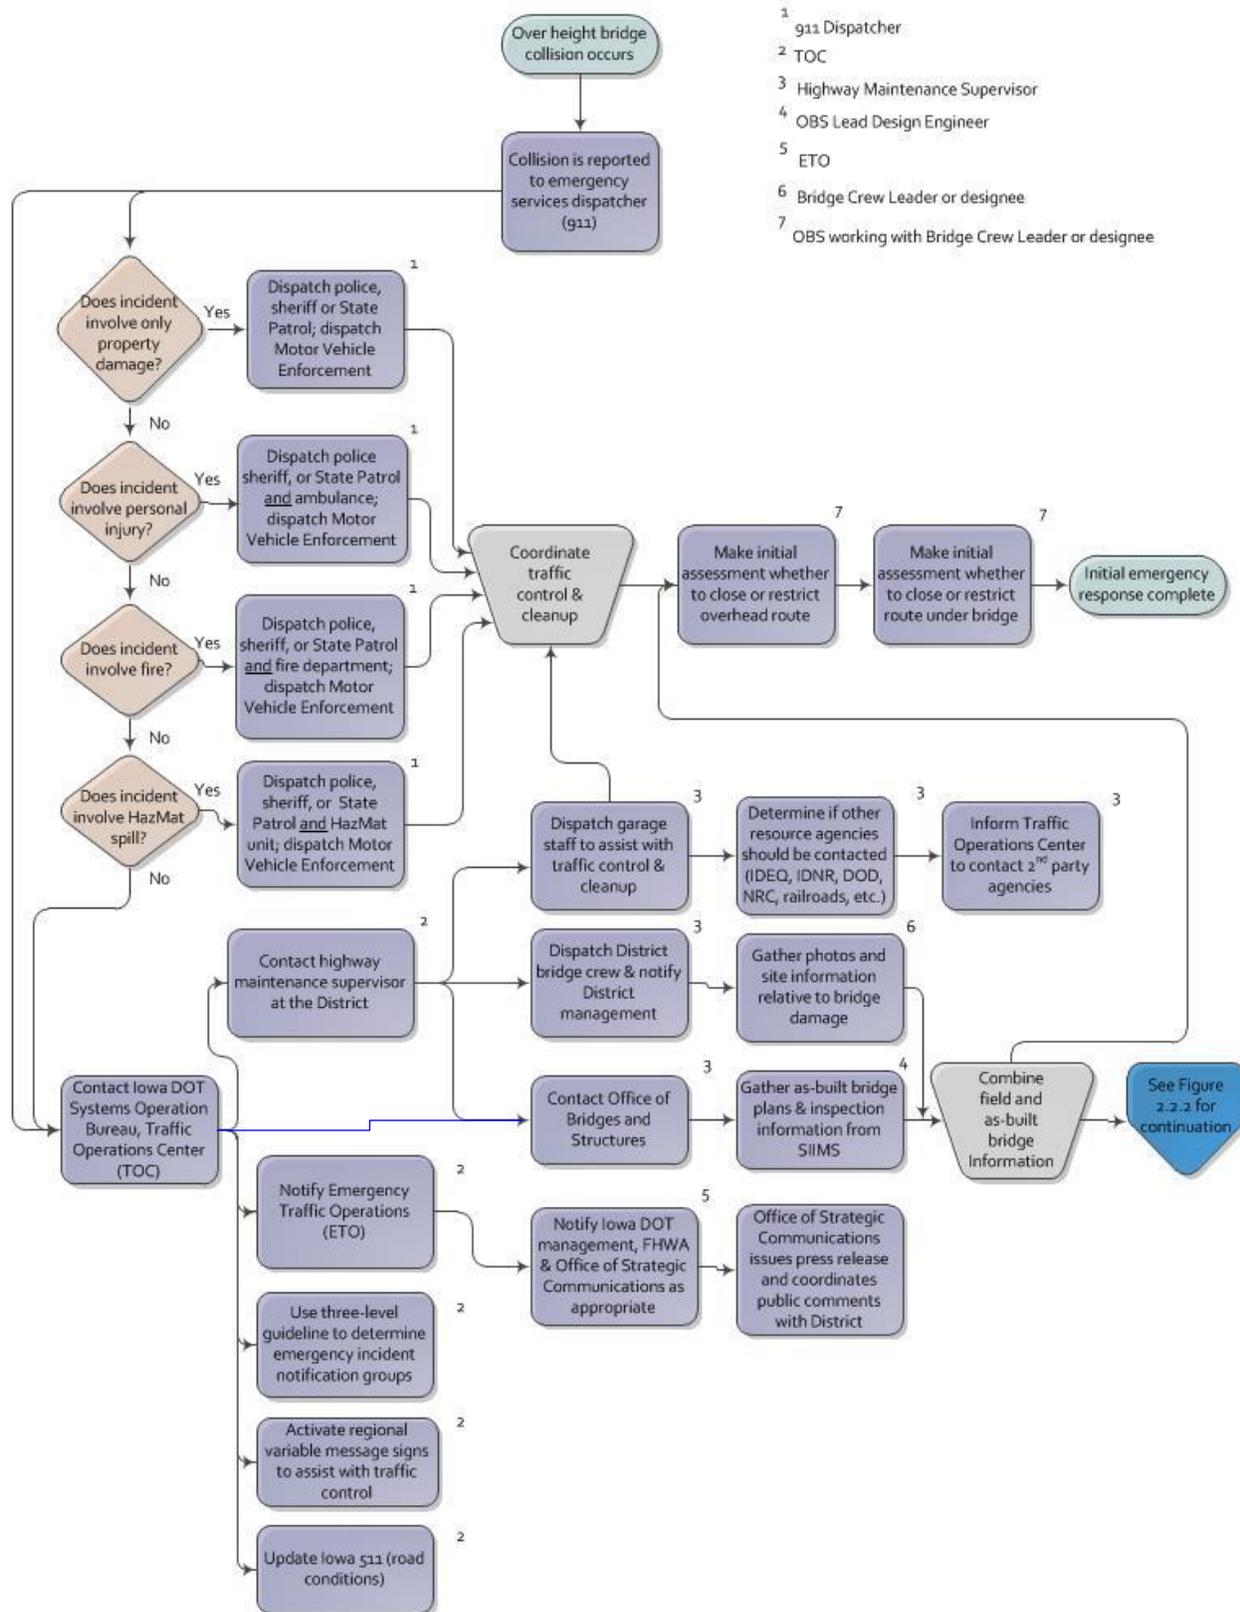
Figure 2.2-1. Initial Emergency Response Flow Chart

Three flowcharts presented in this section of the manual outline the emergency response procedures for an over height collision to a bridge. Figure 2.2-1 shows the procedures for the initial emergency response. This phase of the response is focused on addressing the immediate needs at the bridge site, including preserving life, minimizing injury, preserving public safety, minimizing hardship and suffering, restoring essential services, protecting property and the environment, and providing timely and accurate emergency communication to the public through media. The process outlined also addresses conducting an initial assessment of the damaged bridge based on as-built information available to OBS and information supplied by the on-site District Bridge Crew Leader or other authorized District staff as designated by the District Engineer or Assistant District Engineer.

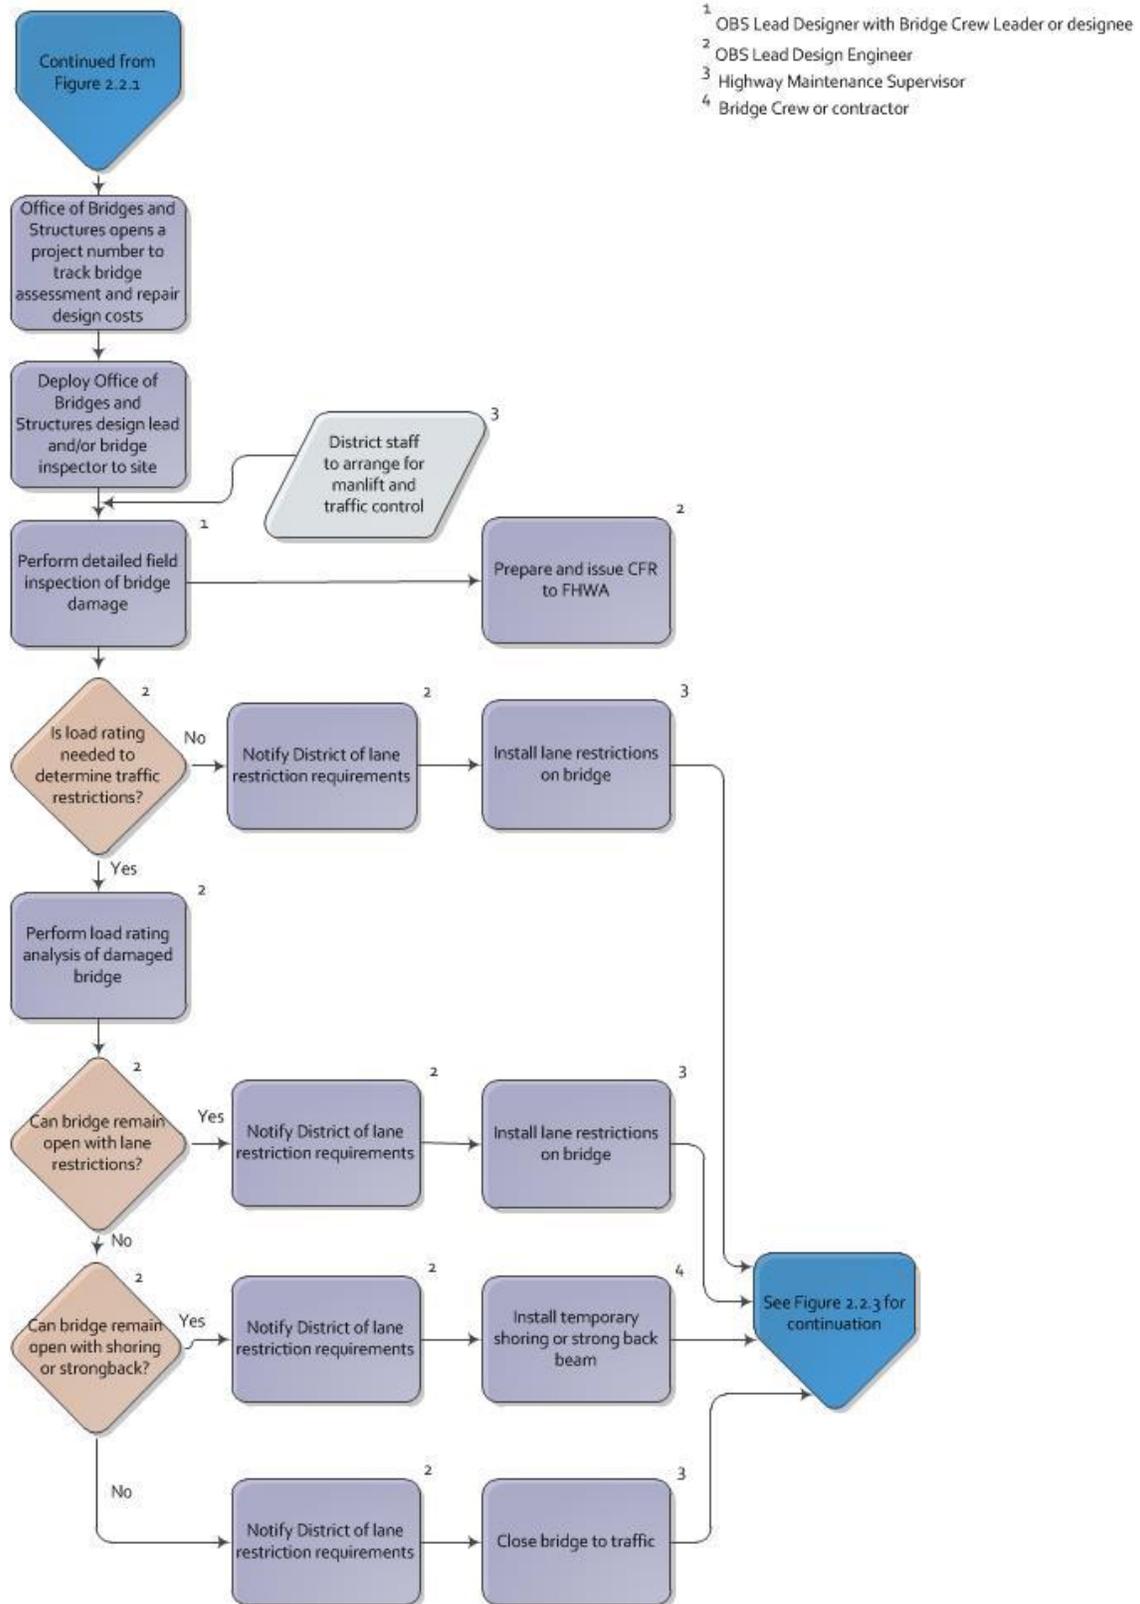
Figure 2.2-2. Detailed Bridge Assessment Flow Chart

The flowchart in Figure 2.2-2 addresses the steps to be taken to further assess the damaged bridge once the initial emergency is over. The procedures involve a detailed inspection of the bridge damage and a load rating analysis to determine whether the structure can remain in service while repairs are designed and prepared for contract. This assessment may result in the use of temporary measures to help support the bridge or it may result in a decision to close the bridge to traffic.

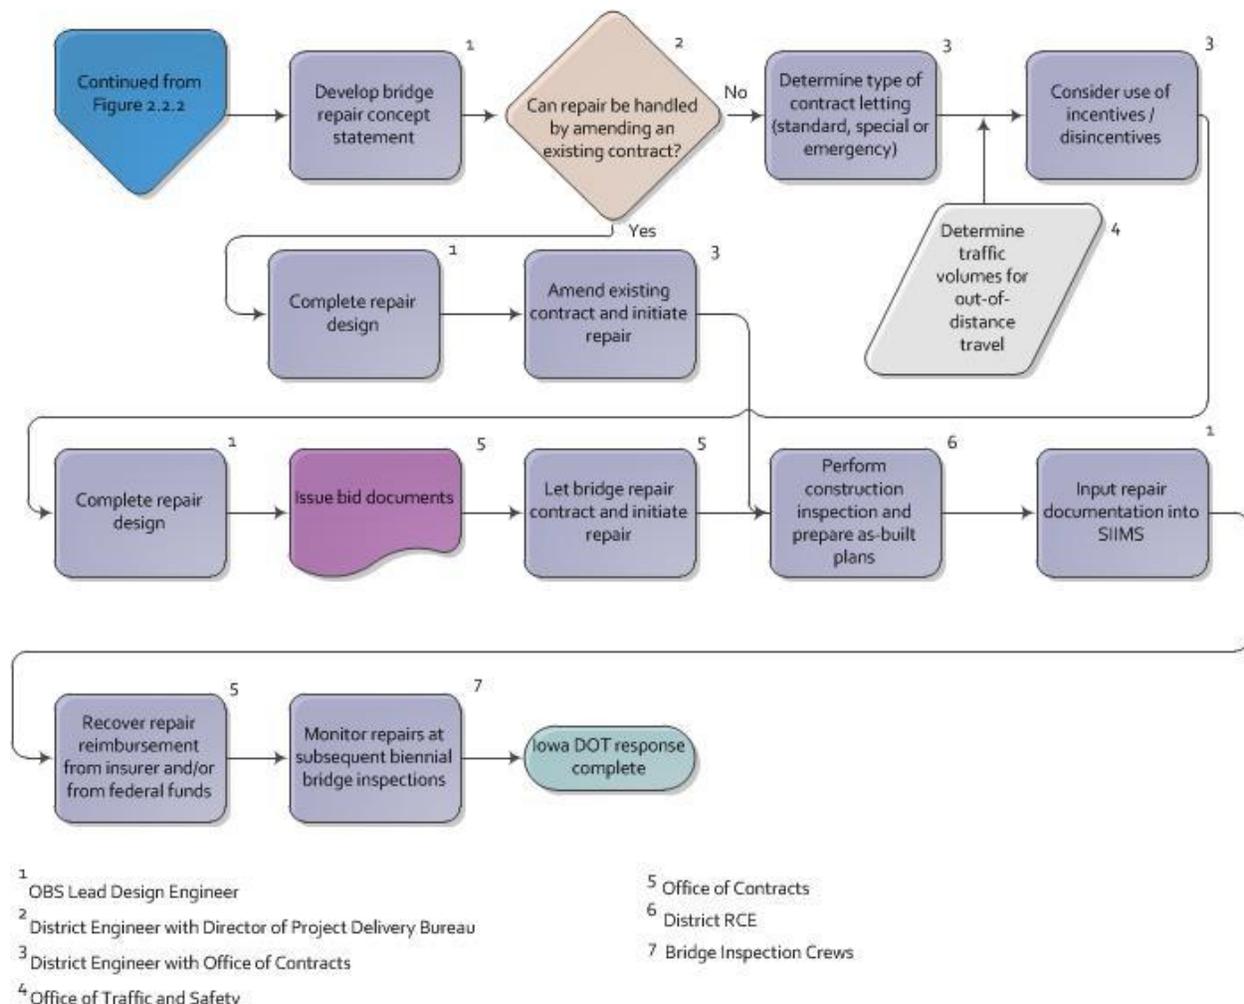
Figure 2.2-3. Repair Design and Contract Letting Flow Chart

Figure 2.2-3 shows the steps involved with designing repairs, preparing a contract letting for repairs, and completing the bridge repairs so that full traffic function and operation can be returned to the overhead route as well as the route below the bridge.

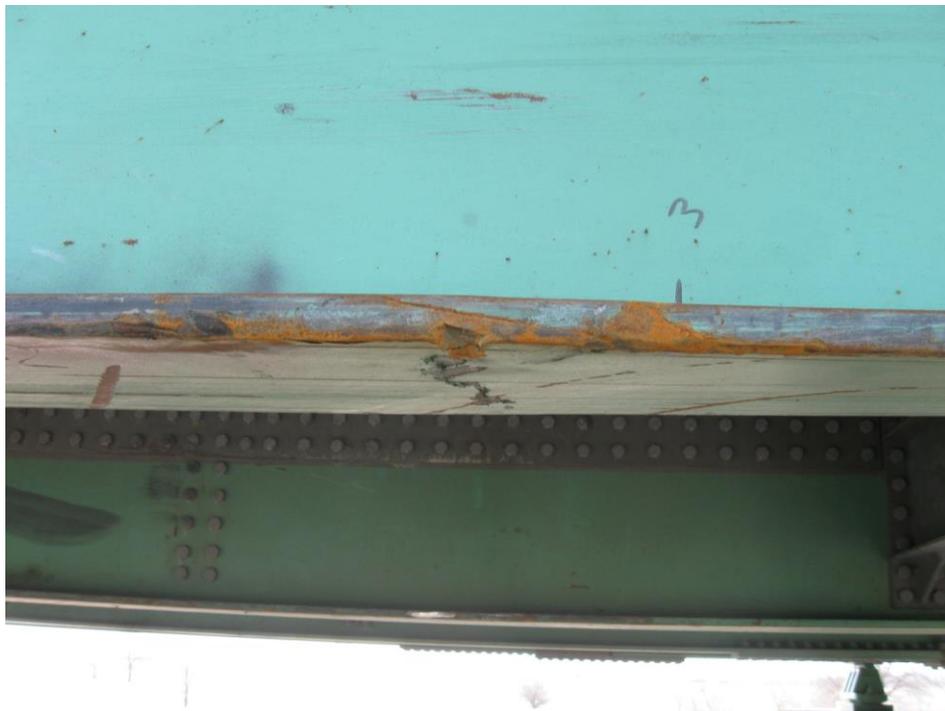
Figure 2.9.3.1-1. Steel Gouge and Paint Scrape

Figure 2.9.3.1-1 shows minor damage to a steel beam bridge consisting of paint scrapes and gouging of the bottom flange. Typically this type of damage should be repaired in a timely manner by removing the gouges by grinding as outlined in Section 3.5 of this manual. In most cases, the bridge may remain open without traffic restrictions if the gouging is not excessive.

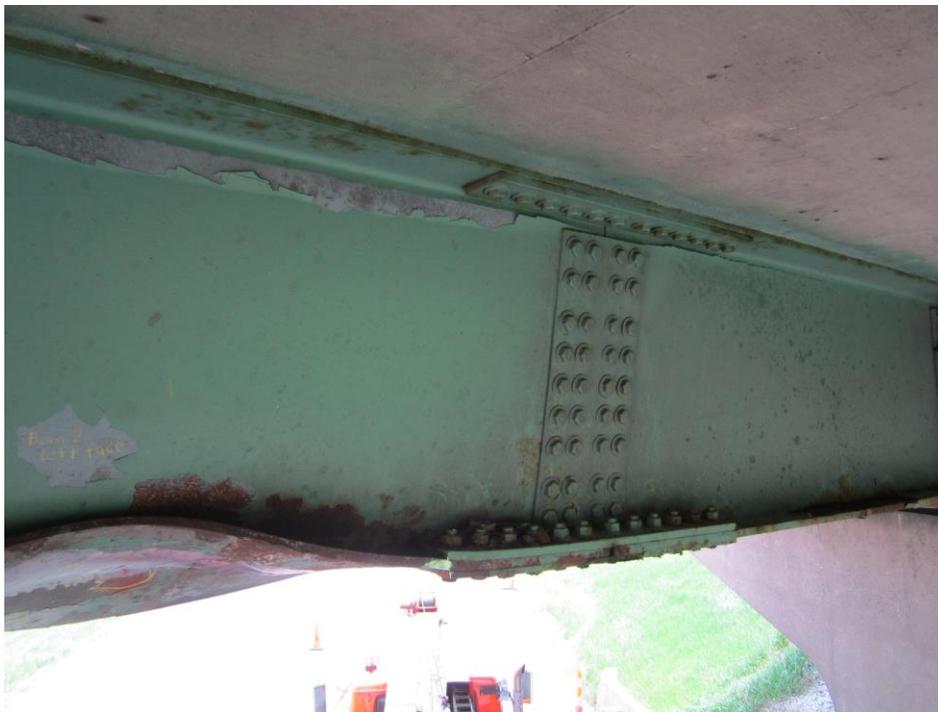
**Figure 2.9.3.1-2. Moderately Bent Bottom Flange with Some Web Distortion**

Figure 2.9.3.1-2 shows a moderately bent bottom flange with some web distortion. If this type of damage did not include any fractures or tears to the steel members and if the extent of the distortion was not too severe, often this type of damage would be repaired with heat straightening, which would combine controlled heat with some internal or external restraining forces to return the member to its original geometry. In general, heat straightening should only be used on the same damaged area of a beam for two heat straightening operations because of the tendency to reduce the ductility of the base metal with more than two heat straightening operations. Often heat straightening repair will require supplemental support of the steel beam during repair. In these cases, a strong back beam may be placed on the deck of the bridge to help support the damaged beam or temporary shoring towers may be employed during heat straightening operations.

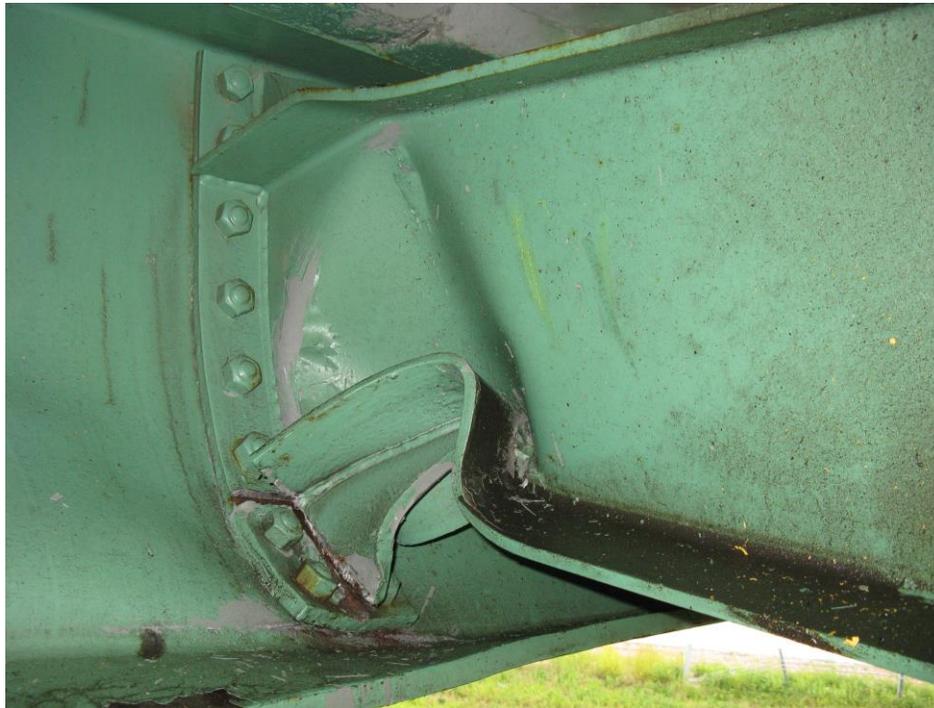
**Figure 2.9.3.1-3. Damaged Diaphragm Member**

Figure 2.9.3.1-3 shows a damaged and distorted diaphragm member. Although primary girder damage may need to be heat straightened or repaired by some other means, typically it is easiest to just replace damaged diaphragm members with the girder repairs rather than trying to repair or straighten them.

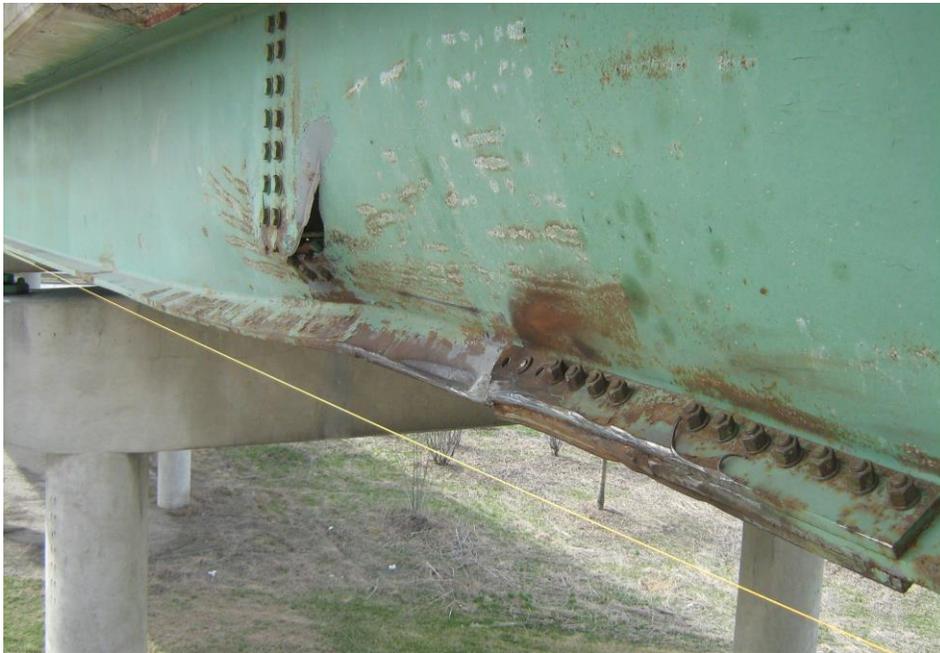
**Figure 2.9.3.1-4. Out of Plane Bending with Web Tear**

Figure 2.9.3.1-4 shows severe damage to an exterior beam line that has resulted in tearing and fracture of the steel beam. For this type of damage, often a strong back beam or temporary shoring towers would be used to support the damaged beam during repairs. Since the damage involves fracture to the beam, some level of beam replacement would be needed. One option would be to cut out and remove the bottom flange and the distorted and torn lower portion of the girder web between field splices and replace it in kind with a spliced section of web and a new bottom flange. Alternatively, if the damage also includes extensive cracking and spalling of the bridge deck, it may be necessary to remove portions of the deck above the damaged beam, remove and replace the entire steel beam between field splices, and replace the section of bridge deck that was removed.

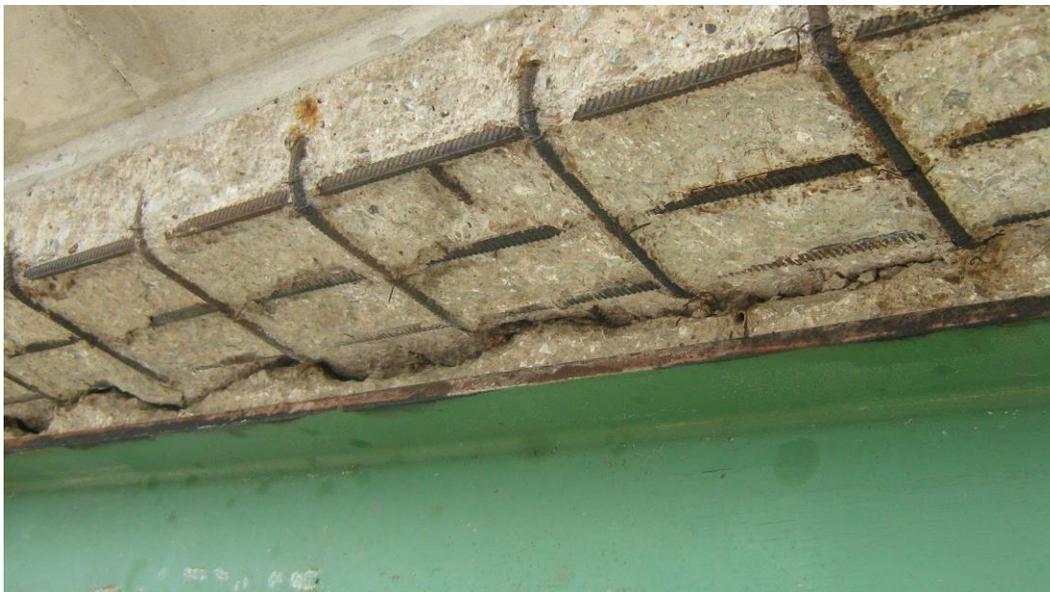
**Figure 2.9.3.1-5. Bottom of Deck Spalling with Crack at Girder-to-Deck Interface**

Figure 2.9.3.1-5 shows spalling to the underside of the bridge deck in the cantilevered section of the deck and cracking along the interface between the top flange of the steel beam and the bottom of the bridge deck. If no surface spalling to the top surface of the bridge deck is involved, a possible repair would be to epoxy inject the crack at the top flange/bottom of bridge deck interface and then repair the spall damage to the underside of the bridge deck. If extensive damage in the form of either cracking or spalling has occurred at the top surface of the deck, removal and replacement of a portion of the bridge deck may be needed.

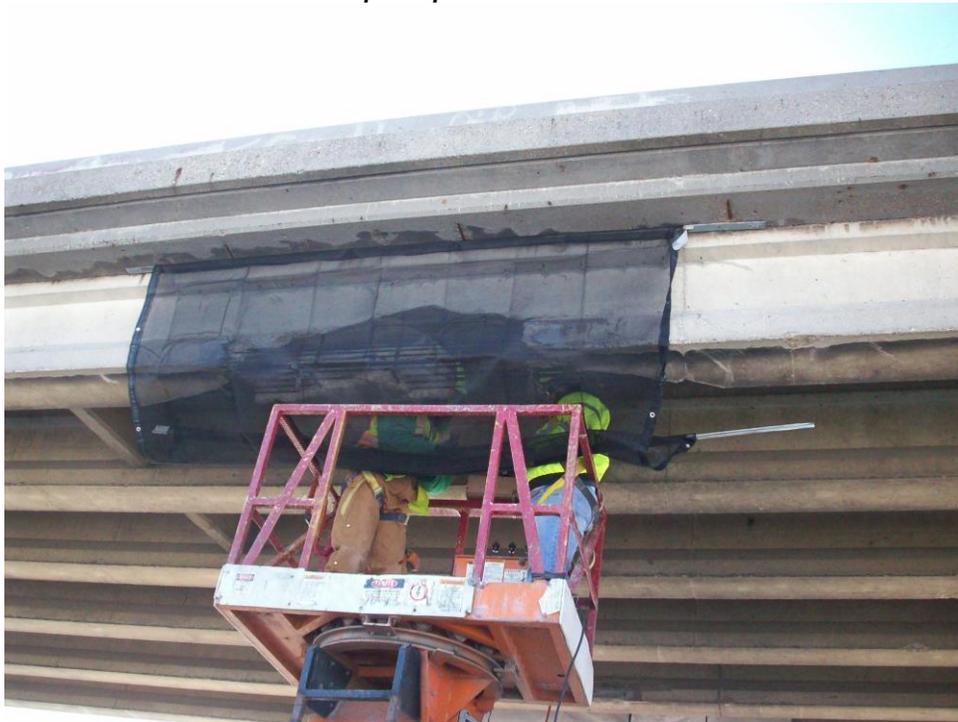
**Figure 2.9.3.2-1. Installation of Drape to Catch Loose Debris**

Over height vehicle damage to prestressed concrete beam bridges inevitably results in some degree of concrete spalling with loose concrete that could provide a hazard to traffic below. Figure 2.9.3.2-1 shows a typical drape that would be used to catch loose debris.

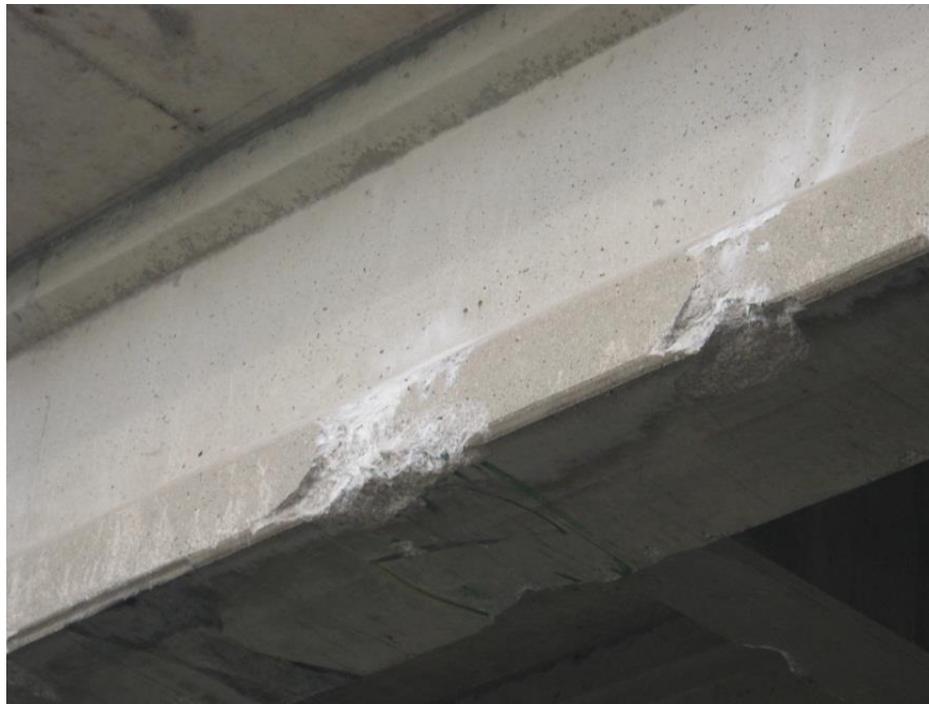
**Figure 2.9.3.2-2. Minor Bottom Flange Spalling**

Figure 2.9.3.2-2 depicts typical minor spalling that may occur along the bottom flange of a prestressed concrete beam. In a case such as this, no mild reinforcing steel or prestressing strands have been exposed or damaged. Iowa DOT does not typically patch this type of damage to restore the original cross section of the beam due to the potential for the patch to come loose and drop on traffic. However, it is recommended to seal these types of spalls with a grey paint-type sealer in order to better identify any future hits to the same area.

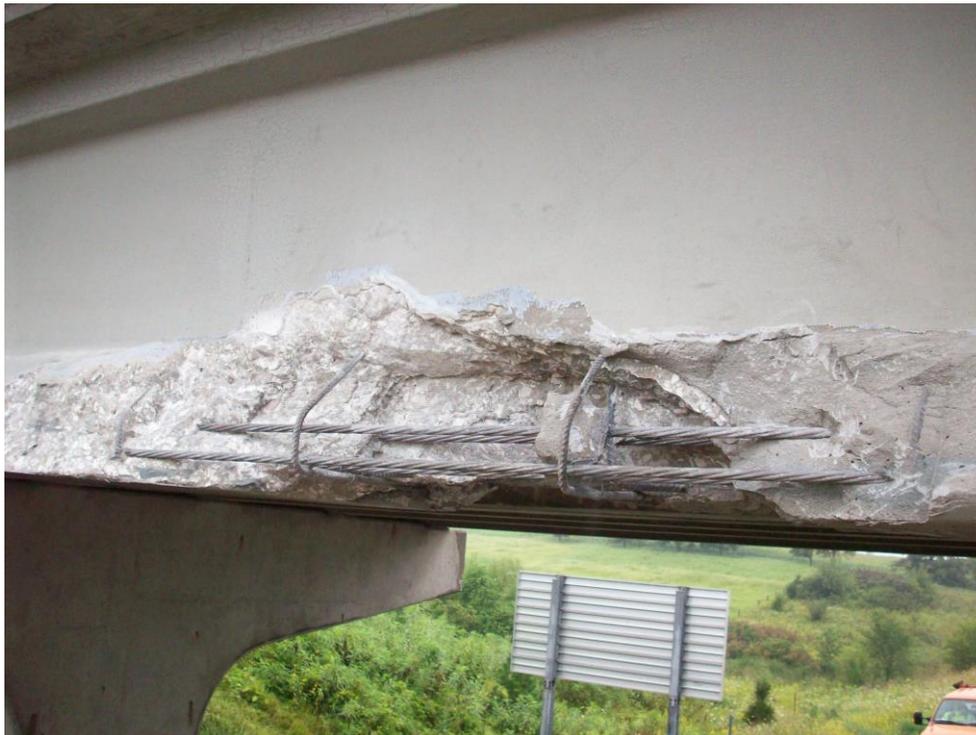
**Figure 2.9.3.2-3. Bottom Flange Damage with Mild Reinforcing and Prestressing Strands Intact**

As impact damage to a prestressed concrete beam bridge becomes more substantial, it can be expected that larger spalls may occur, often exposing mild reinforcing steel or prestressing strands as shown in Figure 2.9.3.2-3. Iowa DOT employs a few repair strategies for these types of damage to restore the damaged beam to its original properties.

One such repair would involve first patching the spalls to return the beam to its original cross section. Often, following spall repair, a FRP wrap would be placed around the bottom flange of the beam in the damaged area and up the sides of the beam web. The FRP wrap can provide added shear strength to the beam, but generally it also serves to confine and contain the spall repairs to prevent them from separating from the beam and falling onto traffic below.

A second repair strategy, and one that is often employed for exterior beams that may be subjected to repeated impacts by over height vehicles, is to repair the spalled areas, but then encase the bottom of the beam with a two-piece steel sleeve. The steel sleeve is anchored with concrete anchors into the beam and then the space between the concrete beam and the inside of the steel sleeve would be injected with epoxy to bind the sleeve to the concrete beam. The steel sleeve serves to armor the bottom of the beam and thus provide a greater degree of protection from future vehicle strikes.

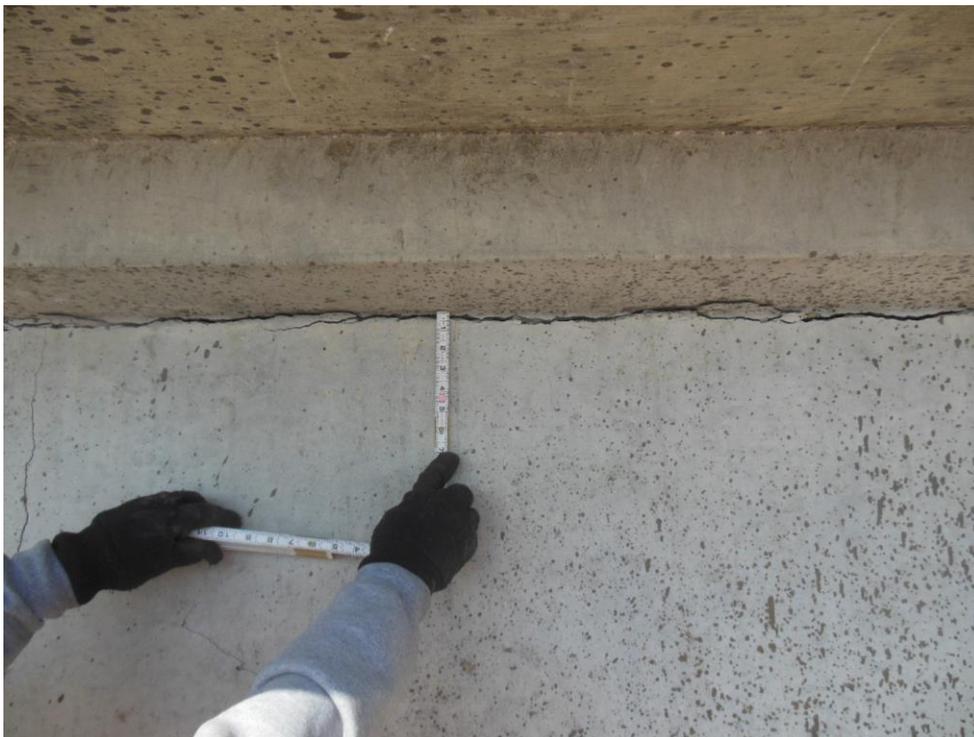
Figure 2.9.3.2-4. Cracking Along Web-to-Top Flange Interface

Over height vehicle impacts to prestressed concrete beam bridges may be severe enough to initiate displacement of a concrete beam. Often when the beam tries to displace, a crack may form at the interface of the beam web with the top flange of the beam as show in Figure 2.9.3.2-4. With this type of damage, the inspector should look at the top of bridge deck to determine if any cracking or spalling has occurred in the actual bridge deck. If not, and if the cracking is limited to the interface between the beam web and the top flange, or possibly the interface of the top of the beam and the bottom of the bridge deck, the crack can be epoxy injected to seal the crack from moisture intrusion. Other web cracking in the beam may be evident, such as diagonal cracking in the web that radiates downward from the terminus of the web-to-top-flange crack. These web cracks should also be epoxy injected to seal the cracks from moisture intrusion.

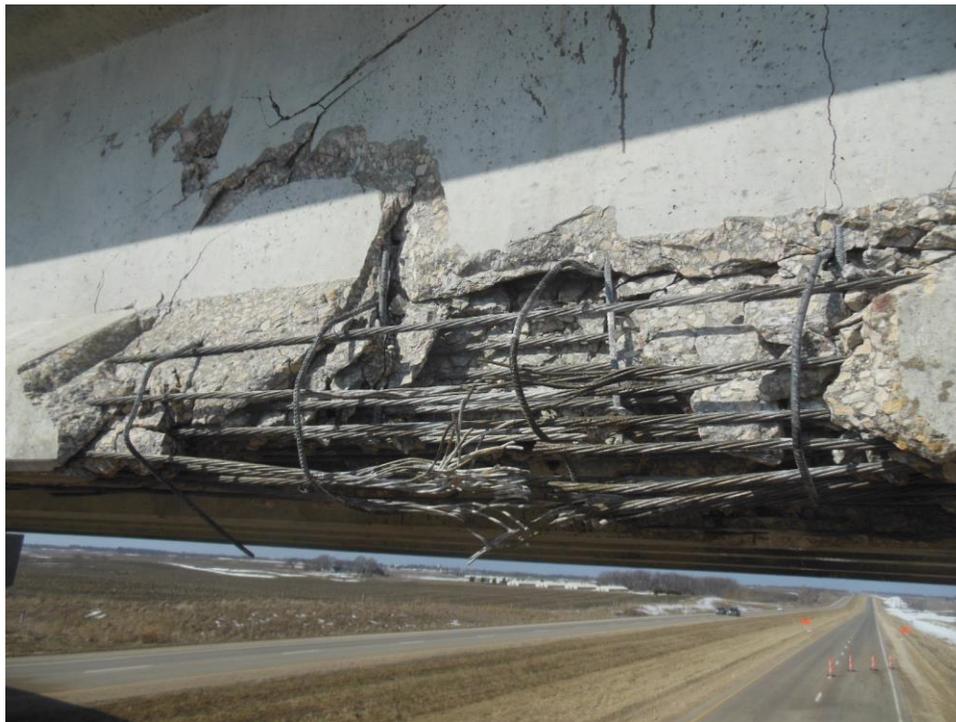
**Figure 2.9.3.2-5. Heavy Damage with Web Cracking and Severed Mild Reinforcing and Prestressing Strands**

Generally, the most severe damage to prestressed concrete beam bridges involves extensive spalls and girder cracking that severs mild reinforcing steel and prestressing strands as shown in Figure 2.9.3.2-5. If beam damage involves severing of two or more prestressing strands, a possible temporary repair alternative may involve patching of the beam spalls, epoxy grouting beam cracks, and either splicing the severed prestressing strands or supplementing the damaged strands with external prestressing. However, these types of repairs should only be considered temporary until the beam or the entire bridge can be replaced.

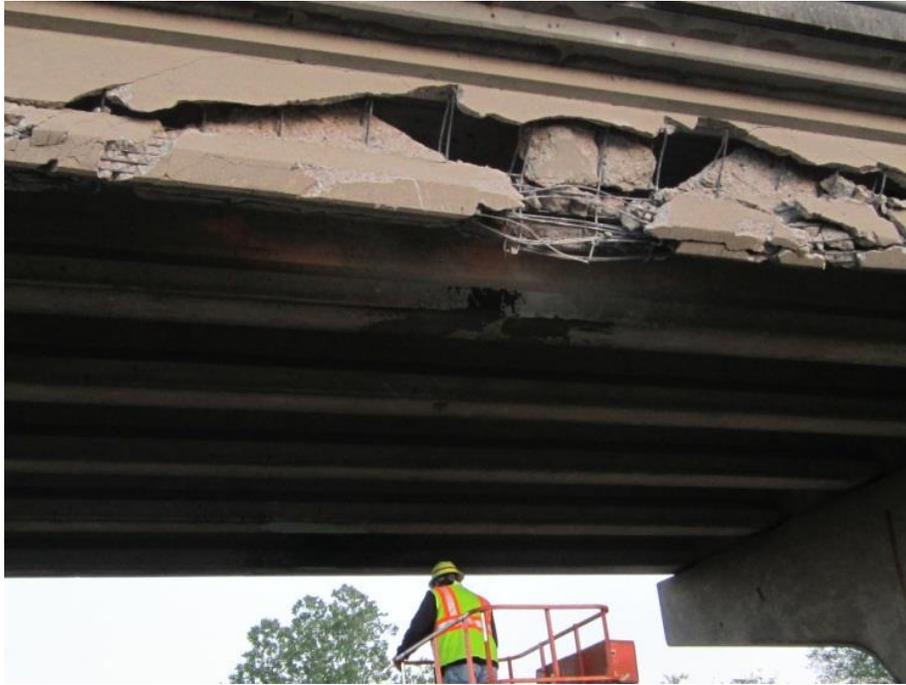
**Figure 2.9.3.2-6. Severe Prestressed Beam Damage with Excessive Concrete Section Loss**

Severe damage to prestressed concrete beam bridges might also involve excessive loss of concrete section as shown in Figure 2.9.3.2.6 or severe damage to multiple beams as shown in Figure 2.9.3.2.7. In most of these cases, the extents of the prestressed beam and bridge deck damage is so severe that removal of the bridge deck above the damaged beam and replacement of the beam is warranted or total span replacement is needed.

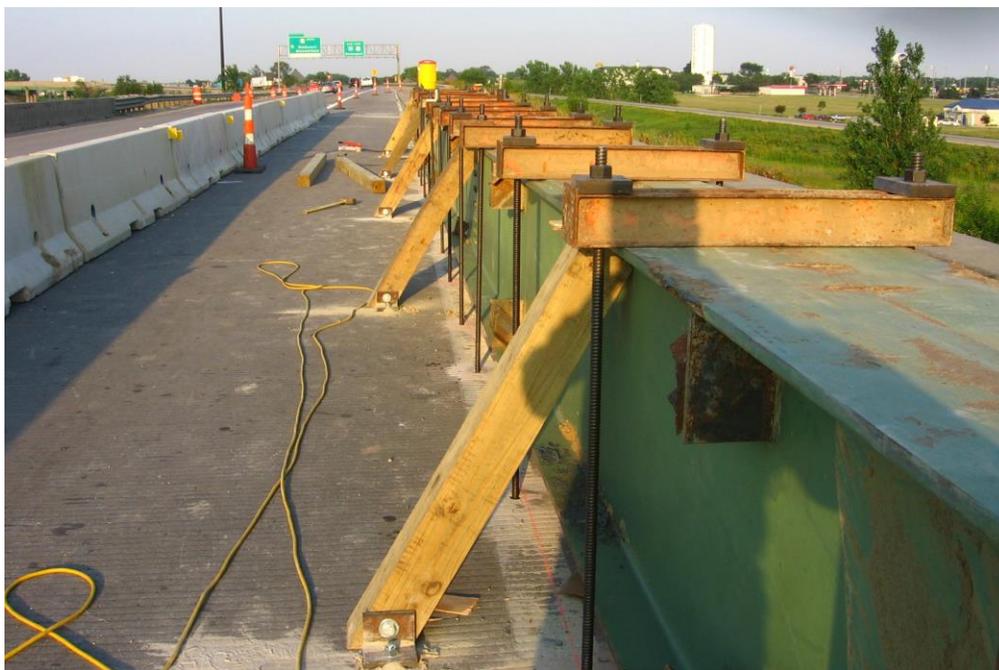
**Figure 3.1. Temporary Strong Back Beam**

Over height vehicle collisions to steel beam or steel plate girder bridges may result in damage to the steel beams or girders that may compromise the load carrying capacity of the bridge. This may be due to steel members being torn or members being severely bent such that the strong axis moment of inertia is compromised. In these cases, it may be necessary to install a temporary strong back member to provide supplemental support to relieve load from the damaged member(s). An example of a temporary strong back beam in use is shown in Figure 3.1

Iowa DOT has two steel beam components in storage that can be bolted together to provide auxiliary strong back support to a damaged steel beam. The 58-foot-long and 45-foot-long strong back beam components typically would be bolted together and supported on top of a bridge deck of a damaged steel beam/girder bridge to provide auxiliary support for a damaged beam/girder. With the strong back beam supported on timber cribbing near pier locations, threaded rods would be extended through holes in the bridge deck and connected to a secondary member under the deck. By tightening the hanger rods, load would be incrementally relieved from the damaged beam until the damaged beam/girder is supported adequately by the strong back beam. Then, repairs such as heat straightening or cutting out and replacing damaged portions of the beam could be made to the damaged beam.

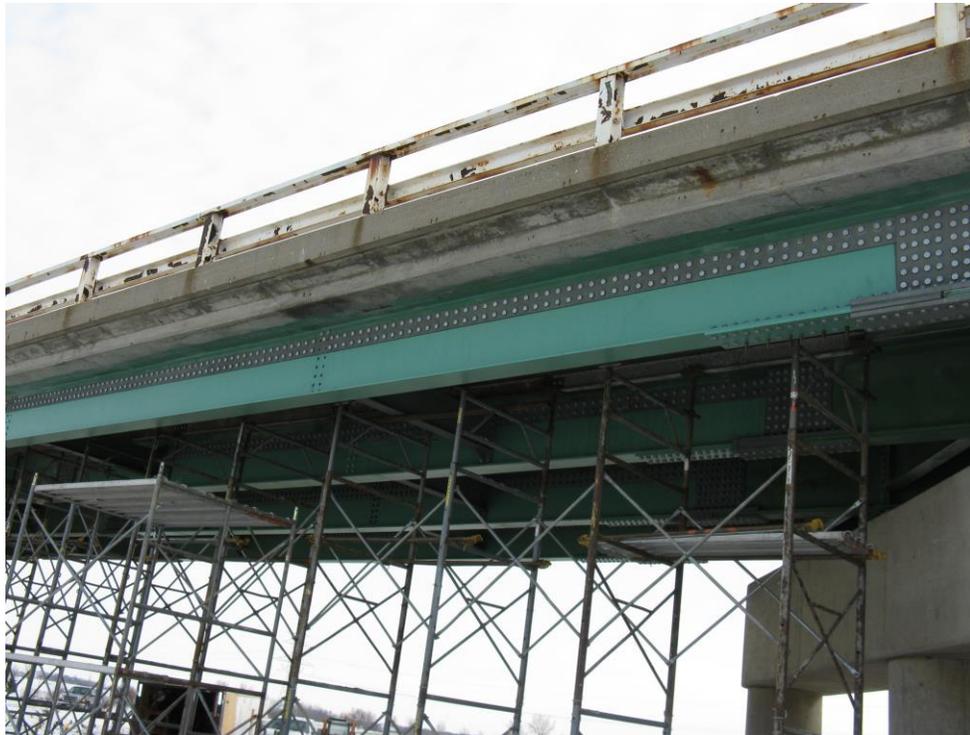
**Figure 3.2. Partial Steel Beam Removal and Replacement**

A photograph of a completed steel beam removal and replacement is shown in Figure 3.2.

For the longitudinal web splice depicted in Figure 3.2 that connects the existing top and the new bottom portions of the beam web, the spacing of 7/8-inch diameter A325 bolts in double shear was analyzed to satisfy horizontal shear of the beam at various locations. Iowa Department of Transportation English Bridge Standards (40-foot Roadways – 3 Span Rolled Steel Beam Bridges) were used for all sectional and geometrical properties in the analysis. Only the center span between field splices (that is, positive moment region) of each bridge was considered, as this is the most likely location that a steel beam would be damaged from traffic below. Minimum and maximum conditions were examined to develop an envelope of possible bolt spacings. The minimum condition examined was a minimum standard bridge length of 160 feet, which carried a 64-foot center span. The maximum condition examined was a 240-foot standard bridge length, which carried a 96-foot center span. This span length was deemed the maximum length for which Iowa DOT's 103-foot-long strong back beam could be utilized.

Once a strong back beam or shoring towers are in place to provide auxiliary support, often a guide angle is bolted to the web of the damaged beam to provide a straight guide surface to provide a uniform cut line for the girder web. Generally, the portion of beam removed will often extend between existing field splices. Since some areas of distortion may still remain in the portion of the girder web that remains, cold jacking against an adjacent beam line may be required to return distorted portions of the web that remains to a straight, uniform alignment. Continuous web splice plates are then bolted in place to connect the web of the existing beam with the new replacement web. In addition, the web and bottom flange are fully bolted into place at field splices. Typically, this type of repair will require replacement of damaged diaphragm members that fall within the impact zone.

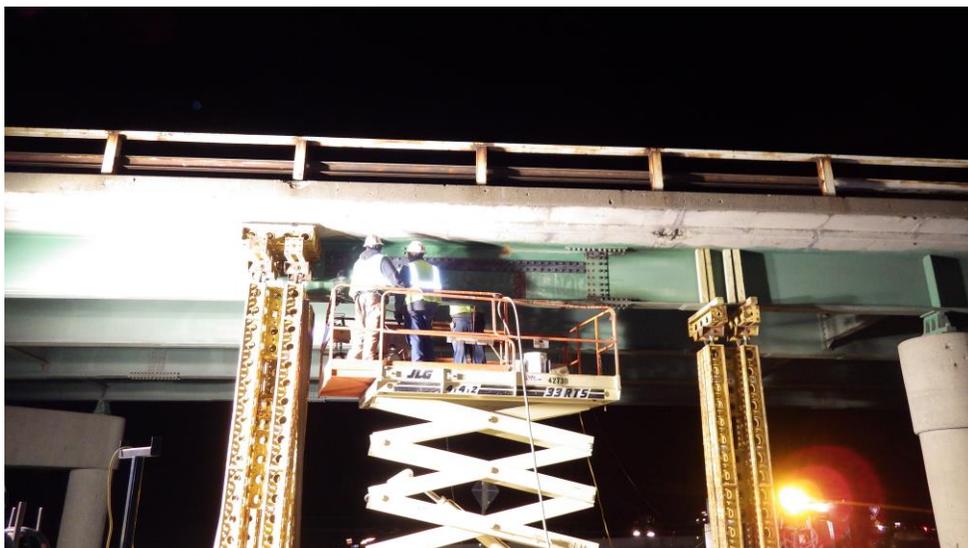
Figure 3.4-1. Shoring Towers on Each Side of Damage

Figure 3.4.1 shows two shoring towers that have been placed on either side of the damaged section of the exterior beam line, thus shortening the distance that the damaged beam must span and reducing the bending moment. In this particular case, the lower portion of the damaged steel beam (that is, bottom flange and lower half of the web) were removed between the towers and replaced with a new section of beam.

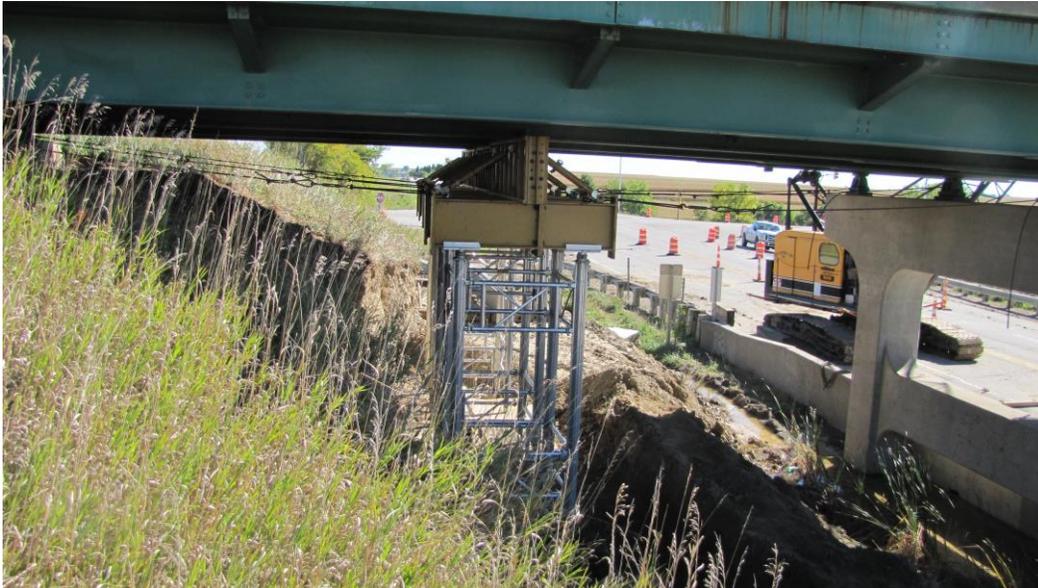
**Figure 3.4-2. Shoring Tower Providing End Span Support**

Figure 3.4-2 shows a shoring tower placed to support the end span of a three-span continuous steel beam bridge. In this particular case, a portion of the bridge deck in the damaged center span had to be removed to allow total replacement of the positive moment field sections for several damaged beam lines.

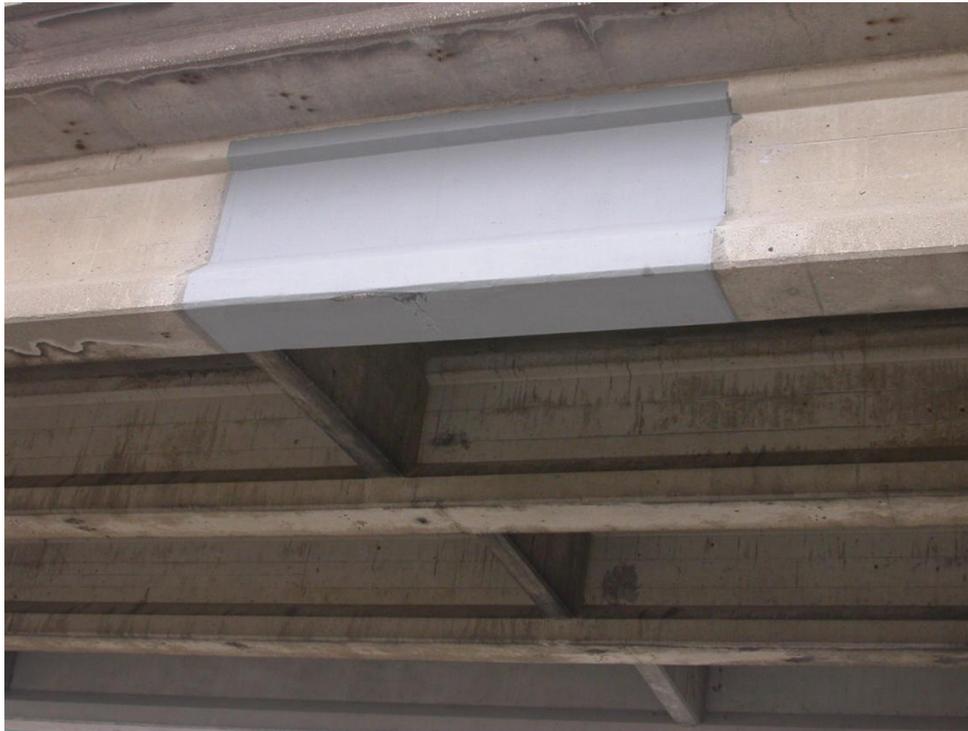
**Figure 4.2. Fiber Reinforced Polymer Wrapped Repair**

Carbon fiber and FRP wraps are commonly used to help contain damage to prestressed concrete beams and to restore structural integrity to the damaged beam(s). An example of an in-place FRP-wrapped repair for a prestressed concrete beam is shown in Figure 4.2.

Typically, for prestressed concrete beams that have been damaged by an over height vehicle collision, repairs begin with removing any unsound concrete around the spalled area of the beam followed by preparing and cleaning the concrete surface at the repair area. Care should be taken to prevent additional damage to surrounding concrete, mild reinforcing steel, or prestressing strands. The limits of the repair area should be defined with a 0.75-inch-deep saw cut to prevent feathered edges of repair, and loose concrete around mild reinforcing steel and prestressing strands should be removed to provide 0.75-inch exposure all around. Next, the damaged area of the beam is repaired with Class “O” Structural Concrete.

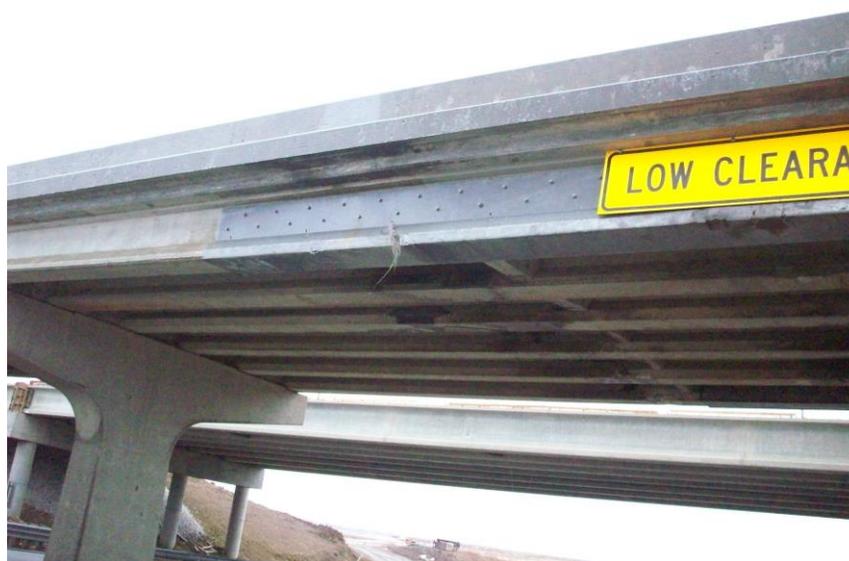
Figure 4.3. Grouted Steel Sleeve Repair

Another repair technique used for damaged prestressed concrete beams is to install a steel sleeve around the damaged bottom flange of a prestressed concrete beam and inject epoxy resin into the space between the sleeve and the face of the prestressed concrete beam. This type of repair is depicted in Figure 4.3.

For this type of repair, unsound concrete is removed from the spalled area, the area to be restored is cleaned, and the surface is prepared. Care should be taken to prevent additional damage to surrounding concrete, mild reinforcing steel, or prestressing strands. The limits of the repair area should be defined with a 0.75-inch-deep saw cut to prevent feathered edges of repair, and loose concrete around mild reinforcing steel and prestressing strands should be removed to provide 0.75-inch exposure all around.

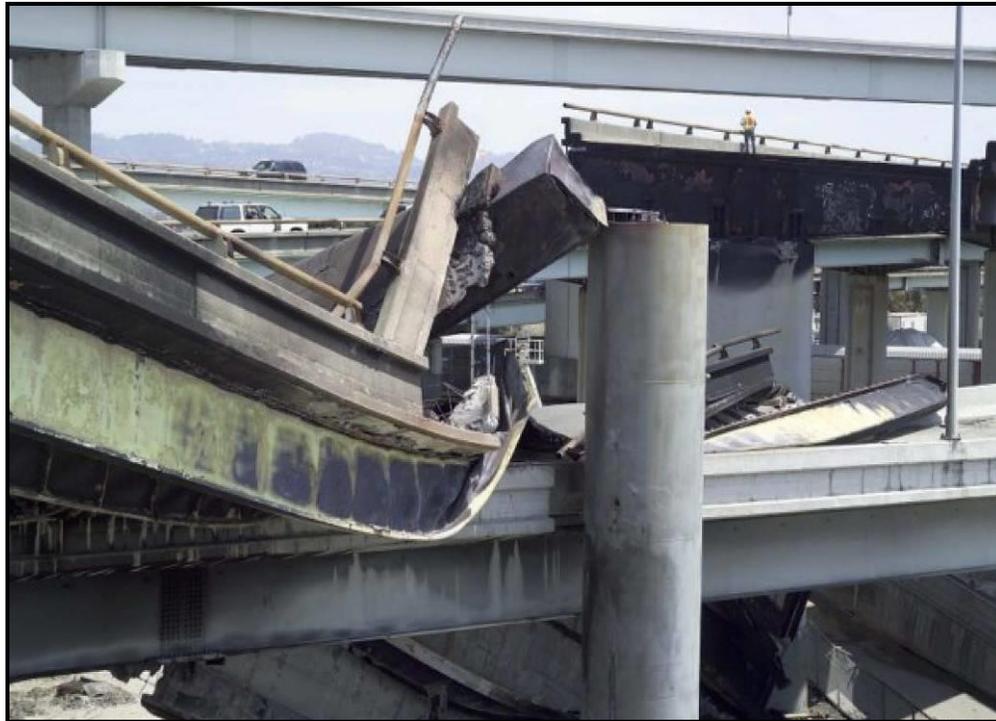
**Figure 5.1.1. Collapse of I-880 Bridge in San Francisco from Fire Damage**

Figure 5.1.1. depicts the collapse of a steel girder bridge due to the temporary reduction in steel strength during an intense fire.

Steel girders subject to the intense heat of a tanker fire could sustain damage or deform/deflect due to the heat. Structural steel typically will show only a gradual decrease in yield strength for temperatures up to approximately 500°C (932°F). However, at approximately 600°C (1,112°F), the yield strength of steel will be reduced to approximately 50 percent of its nominal yield strength. Steel also undergoes a phase transformation above approximately 725°C (1,337°F), where the grain structure may change through heating and cooling. Heat cambering and heat straightening operations typically limit the temperature of steel to below 650°C (1,202°F) so that the steel does not experience conditions worse than what it might see during a typical fabrication process. Steel heated to below the phase transformation stage and then cooled will return to its previous properties without detrimental long-term reduction in yield strength, toughness, or fatigue resistance. However, even though a steel member may return to its original properties after a fire, the member may undergo distortion, may sag, or may experience rapid thermal expansion during the fire due to the intense heat. During a fire, the temperature of a steel girder may be substantially below the maximum gas temperature of the actual fire. The bridge deck may be at an even lower temperature because of its added distance from the heat source and the lower thermal conductivity of concrete. A composite steel girder bridge exposed to intense heat from fire is susceptible to web buckling because the cooler composite deck would impose restraint to the top of the girder while the bottom of the girder is attempting to expand.

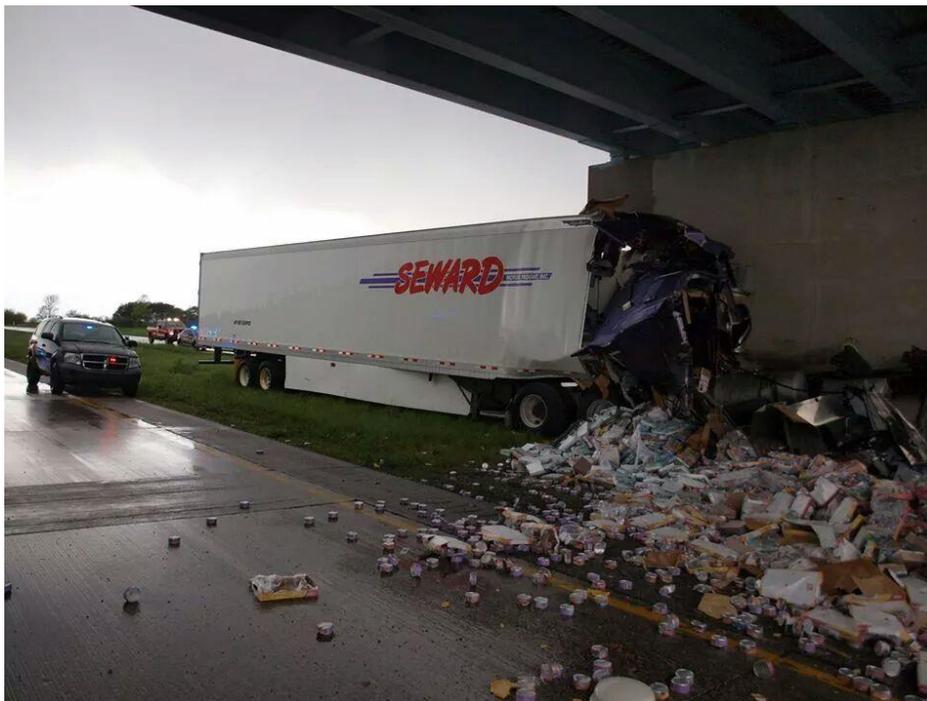
Figure 5.1.2. Truck Collision with Bridge Pier

As is evident in Figure 5.1.2 below, this type of incident could trigger a similar type of emergency response as an over height collision, requiring lane closures for accident clean-up and emergency personnel, the need to inspect the bridge for damage, and potentially the need to stabilize or repair the bridge for carrying traffic loads.

Another type of incident that may warrant an emergency response for a bridge is when a truck or other vehicle crashes into a bridge pier or pier column. Although the current AASHTO LRFD Bridge Design Specifications require bridge piers adjacent to roadways to be designed for a 600 kip impact load, previous bridge design specifications did not require such a robust design, and a direct impact with a bridge column could jeopardize the stability of an existing bridge.
