*Office of Bridges and Structures*

# ***Emergency Response Manual for Over Height Collisions to Bridges***

*Issue Date: September 11, 2014*

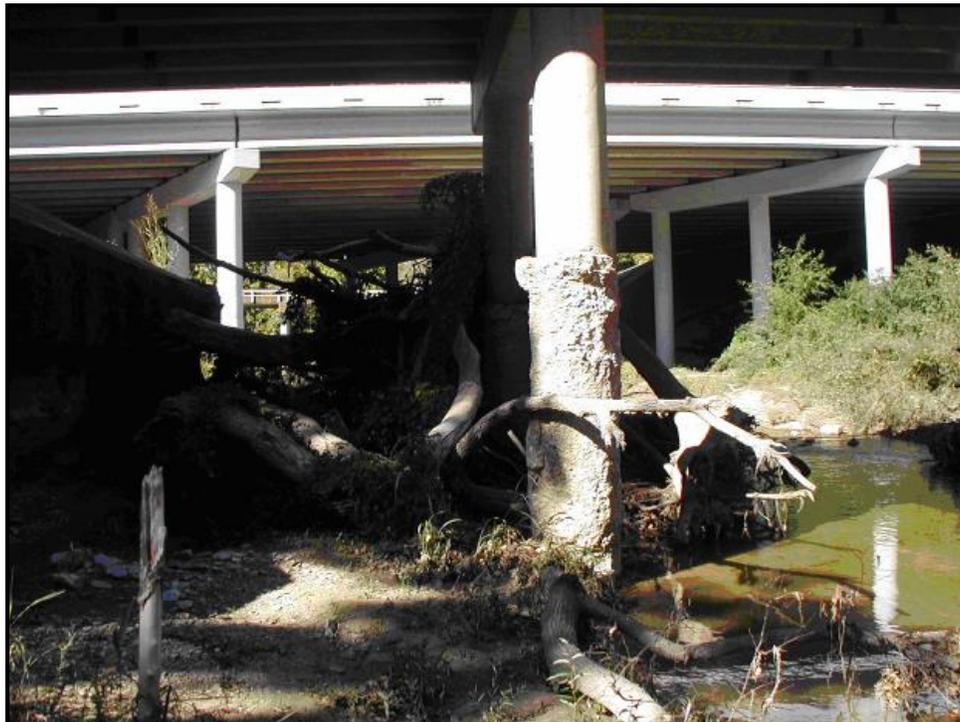
Figure 5.1.4. Bridge Pier Scour Damage

However, a significant flood event could cause major scour to a bridge with little advance notice. A post-event inspection or signs of settlement could require emergency corrective action and thus require an emergency response for a critical route similar to an an over height collision event. Figure 5.1.4. shows an example of a bridge affected by flood scour.

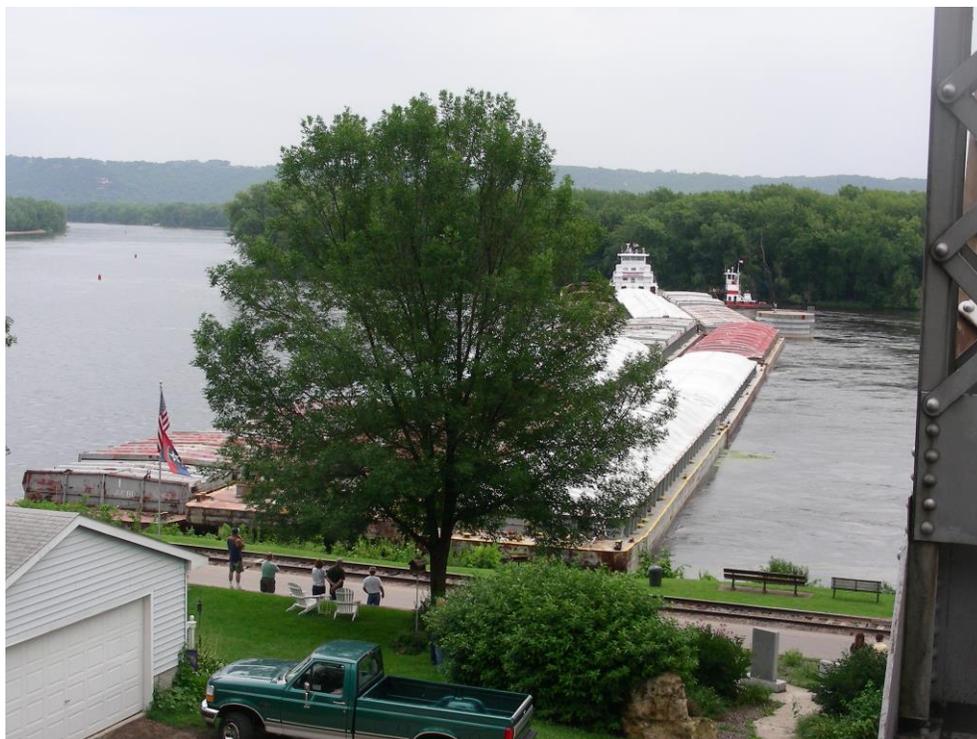
**Figure 5.1.5. Barge Lodged Across the Mississippi River Channel  
Parallel to IA-9 Lansing Bridge**

With major bridge structures located over navigable rivers such as the Mississippi and Missouri rivers, there is potential for damage to highway bridges in Iowa due to barge impact. Most, if not all, of the bridges carrying State and U.S. routes over these rivers are high-level structures with adequate vertical clearance to protect bridge superstructures from a barge impact. Nevertheless, the potential for damage to a bridge due to impact with a substructure component is very real, as shown in Figure 5.1.5 for the IA-9 Bridge over the Mississippi River near Lansing, Iowa.

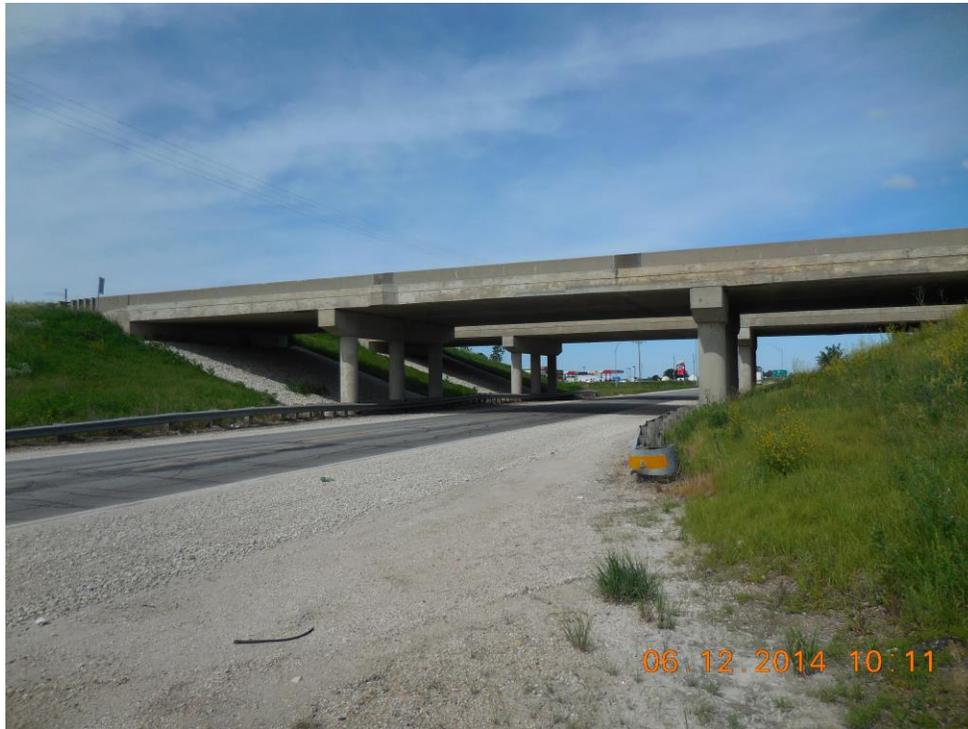
**Figure 5.2.2. Continuous Concrete Slab Overpass**

A number of cast-in-place concrete bridges remain on the State and U.S. highway system inventory in Iowa that could experience damage from an over height vehicle impact. These may include continuous concrete slab bridges, concrete frame or arch bridges, or concrete T-beam bridges. Figure 5.2.2 shows continuous concrete slab overpasses carrying I-35 over County Road D25, north of US 20 in Hamilton County.

Reinforced concrete bridges subjected to an over height vehicle strike typically would experience concrete spalling and cracking as a result of the collision. Of particular concern would be extensive damage to primary load carrying members such as a concrete arch rib for a concrete arch bridge or the web stems of a concrete T-beam bridge. Typical repairs may include patching concrete spalls, splicing damaged reinforcing steel to replace damaged or severed reinforcing steel, or epoxy injecting concrete cracks. Depending on the severity of the repairs, temporary shoring may be needed to support the damaged bridge and formwork for the repairs.

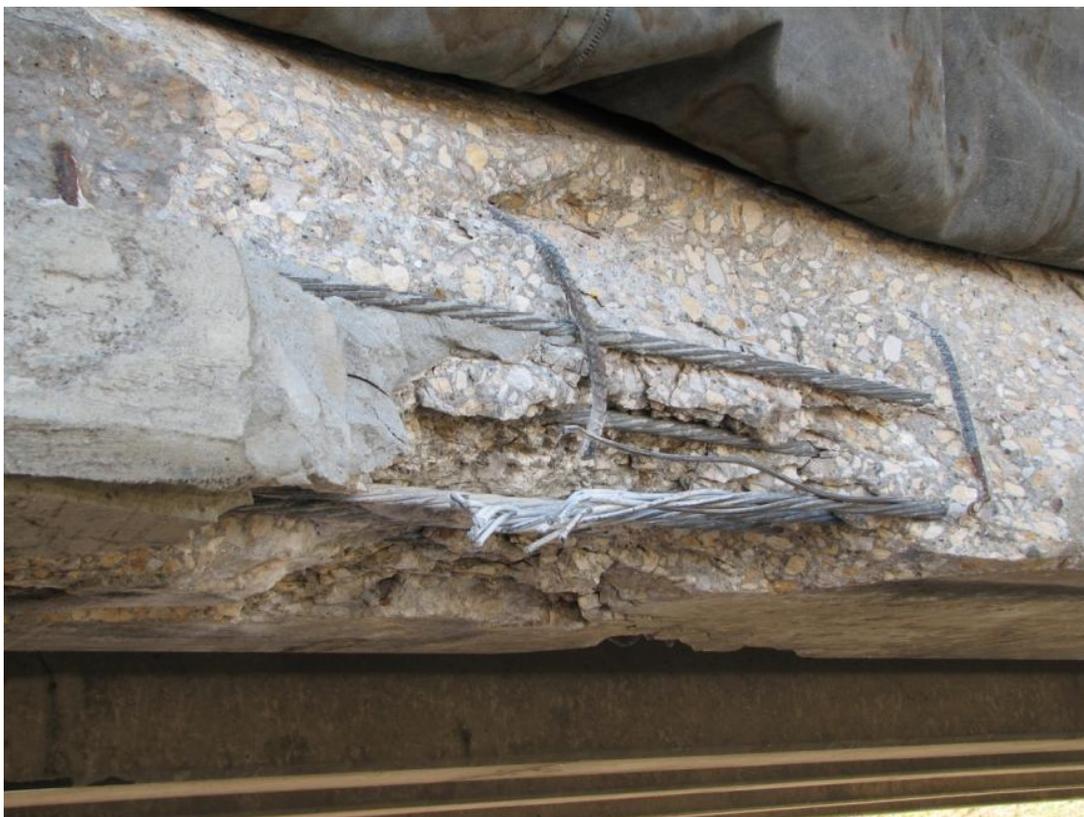
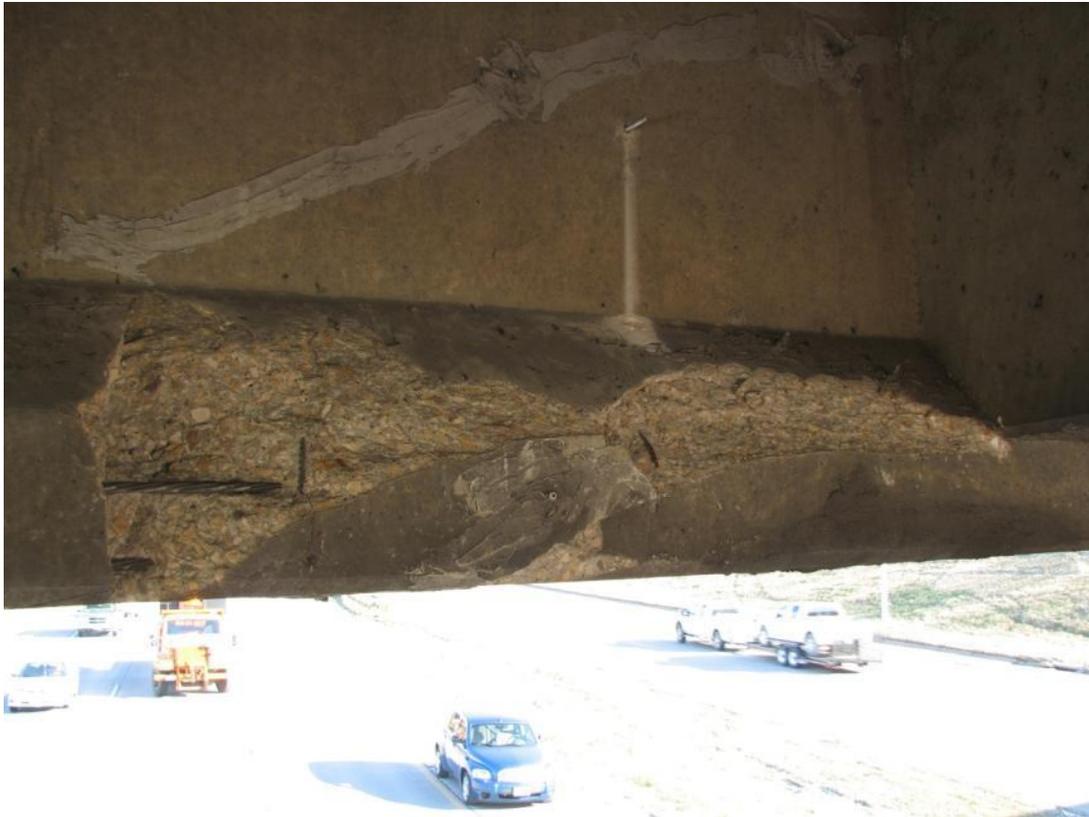
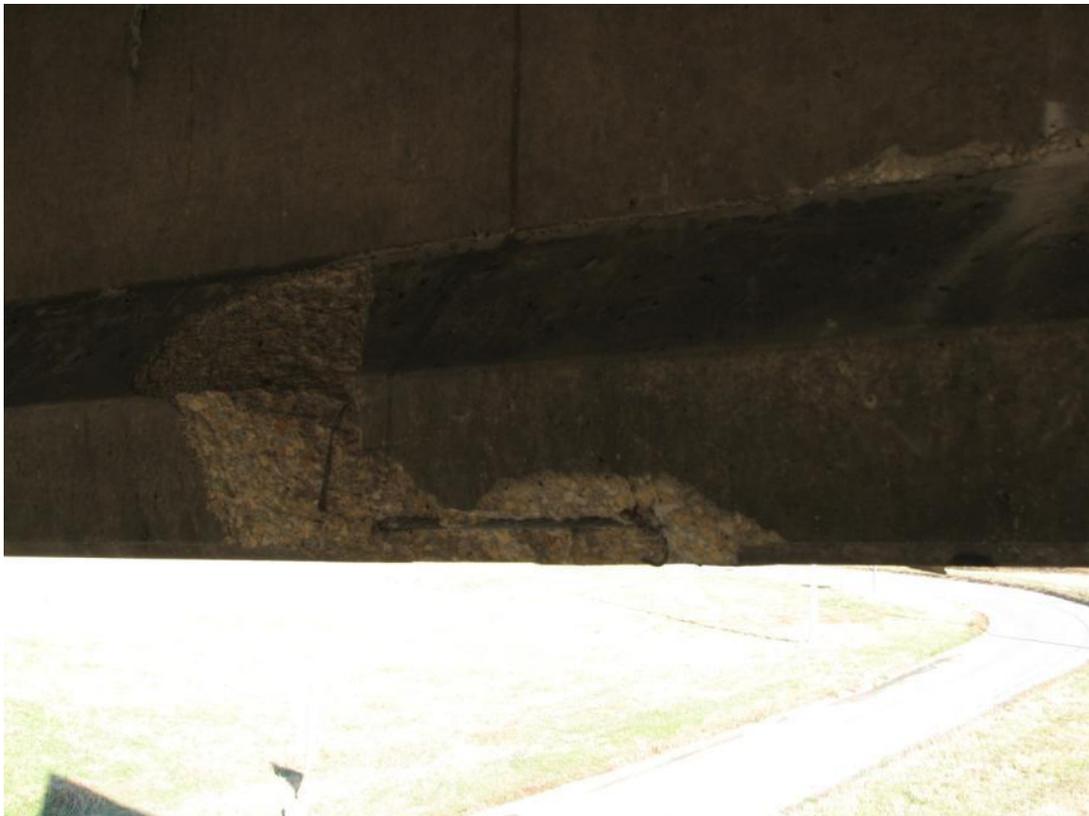
**Photo 2: North Exterior Beam, North Side.**

**Photo 3: North Exterior Beam, South Side.**

**Photo 4: North Exterior Beam, South Side.**

There are spalled and delaminated concrete areas for a distance of approximately five feet on the beam bottom flange. (Photo 2, 3, and 4). The bottom flange has one broken stirrup, two broken strands, and three exposed strands on the north side of the beam; two exposed stirrups and two exposed strands on the south side of the beam; and three exposed strands on the bottom of the beam (Photo 5). On the south side of the beam, there is a crack, approximately 4'-11 long, between the junction of the web and bottom flange fillet.

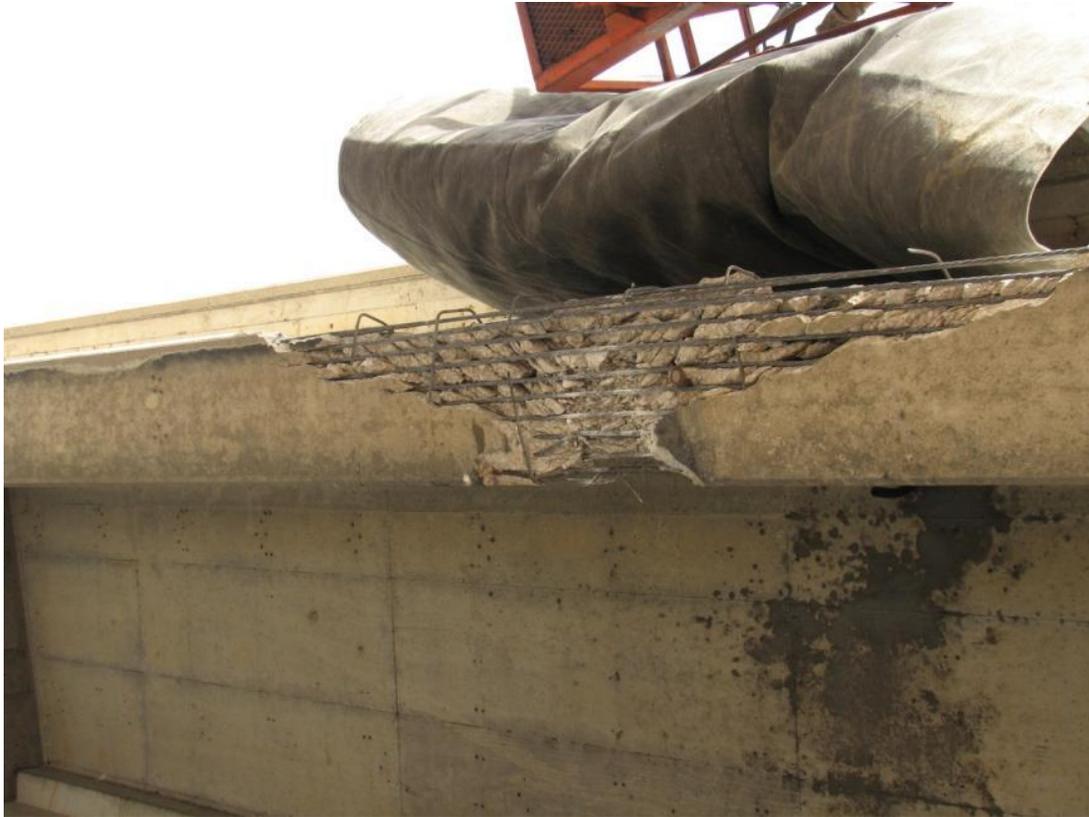
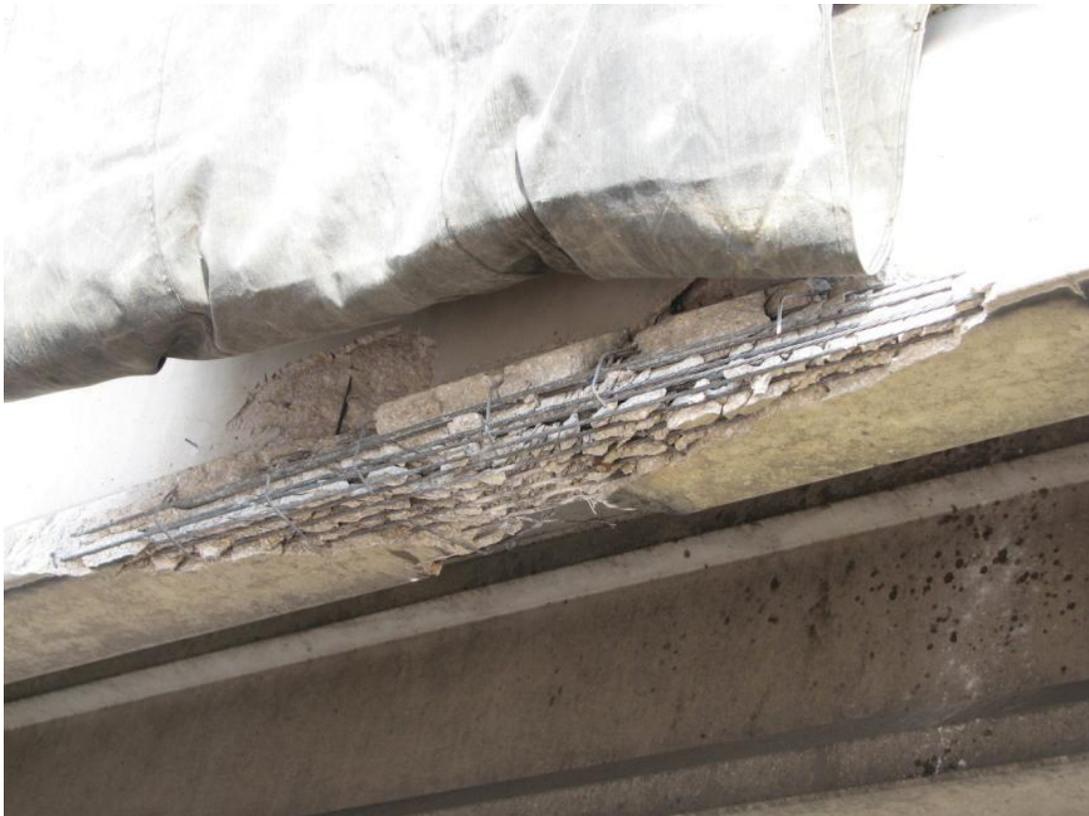
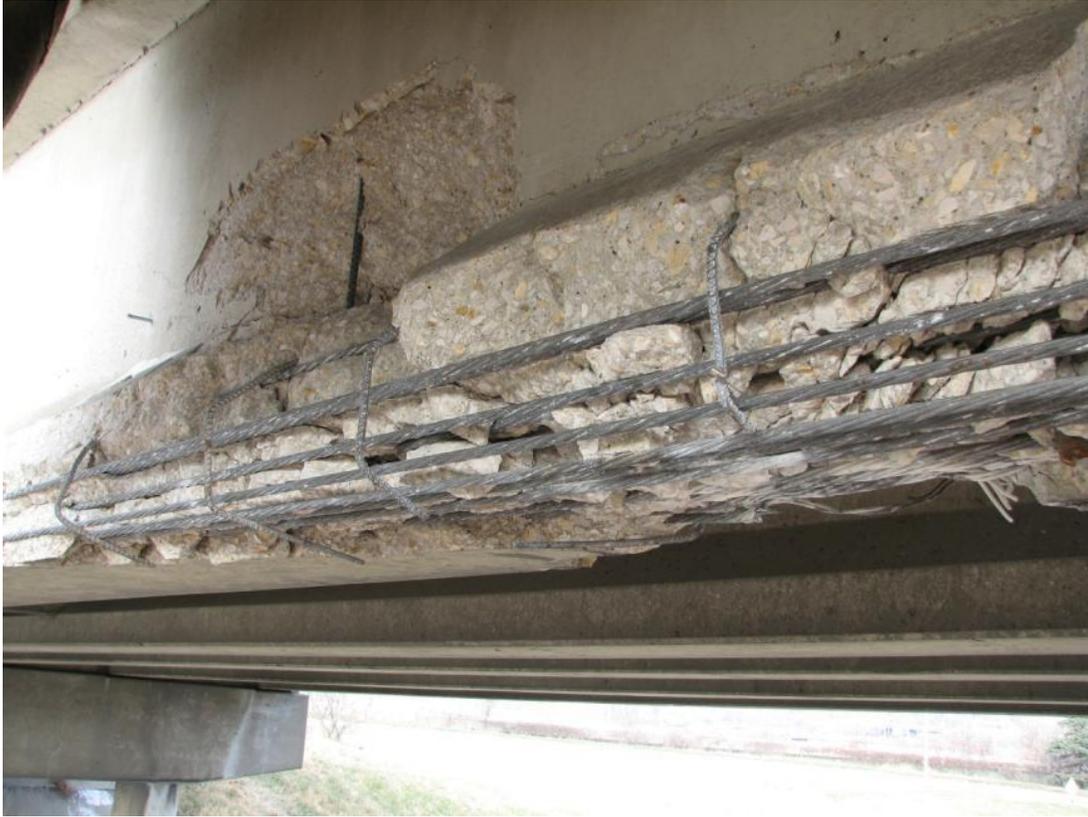
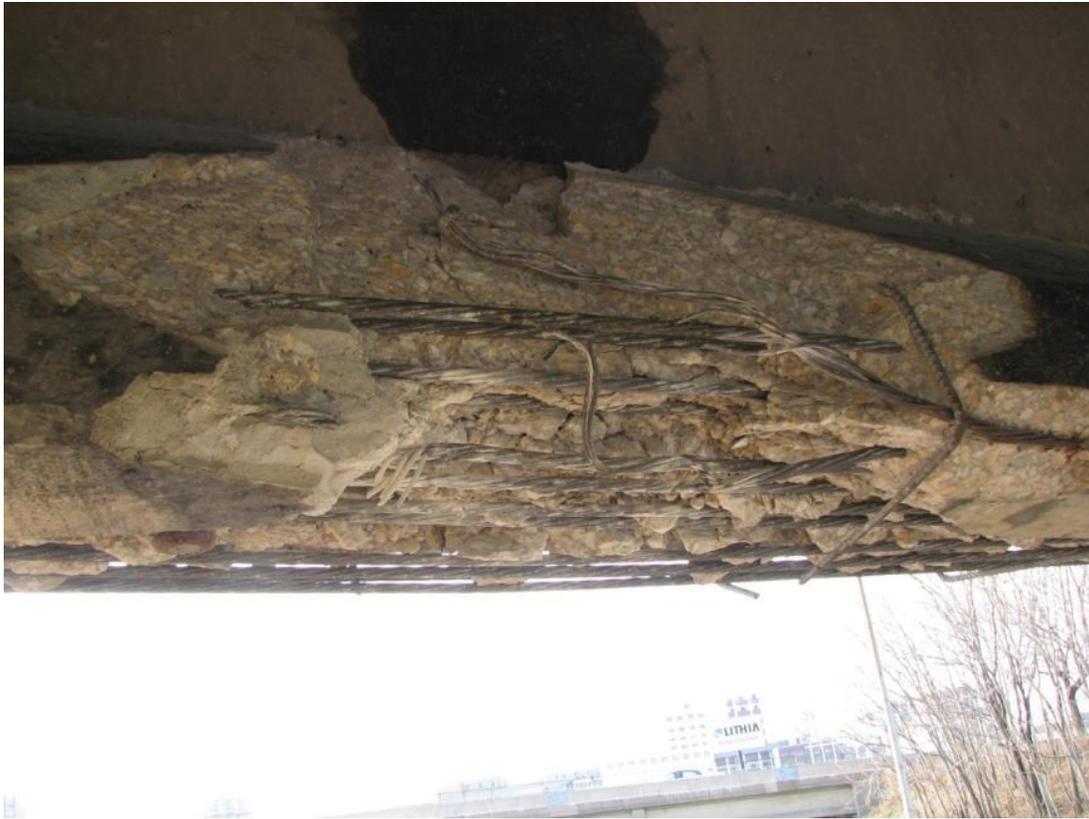
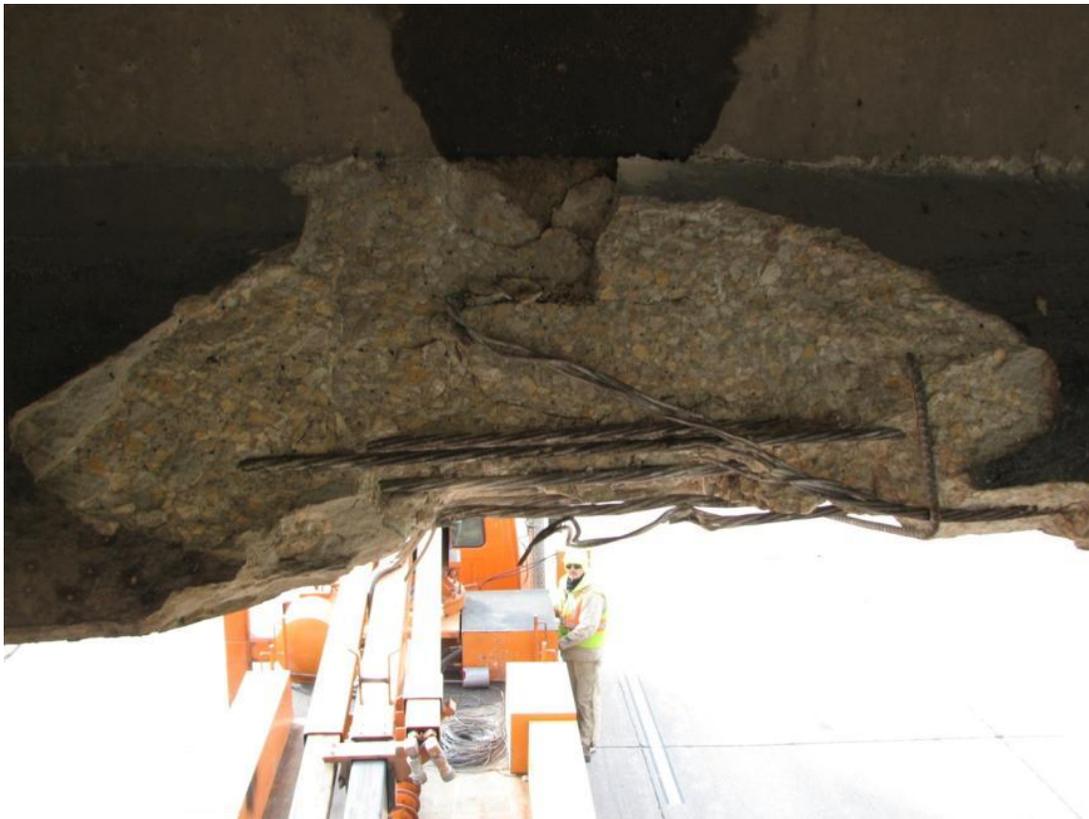
**Photo 7: South Exterior Beam, Bottom Flange.**

**Photo 8: South Exterior Beam, South Side.**

**Photo 9: South Exterior Beam, South Side.**

**Photo 11: South Exterior Beam, North Side.**

**Photo 12: South Exterior Beam, North Side.**

There are spalled and broken areas of the flange concrete throughout the impact location. The damage to the bottom flange extends for a distance of approximately three feet on the north side of the beam and eleven feet on the south side of the beam (Photo 7, 8, 9, 11, and 12). The bottom flange has six broken stirrups, three broken strands, and three vertical rows exposed strands. There are two spalled areas on the beam web, south side, approximately three feet wide by two feet high (Photo 10). There is also a hollow area on the south web face of the beam above the collision area. The area is approximately four and a half feet wide and extends to the top flange fillet.

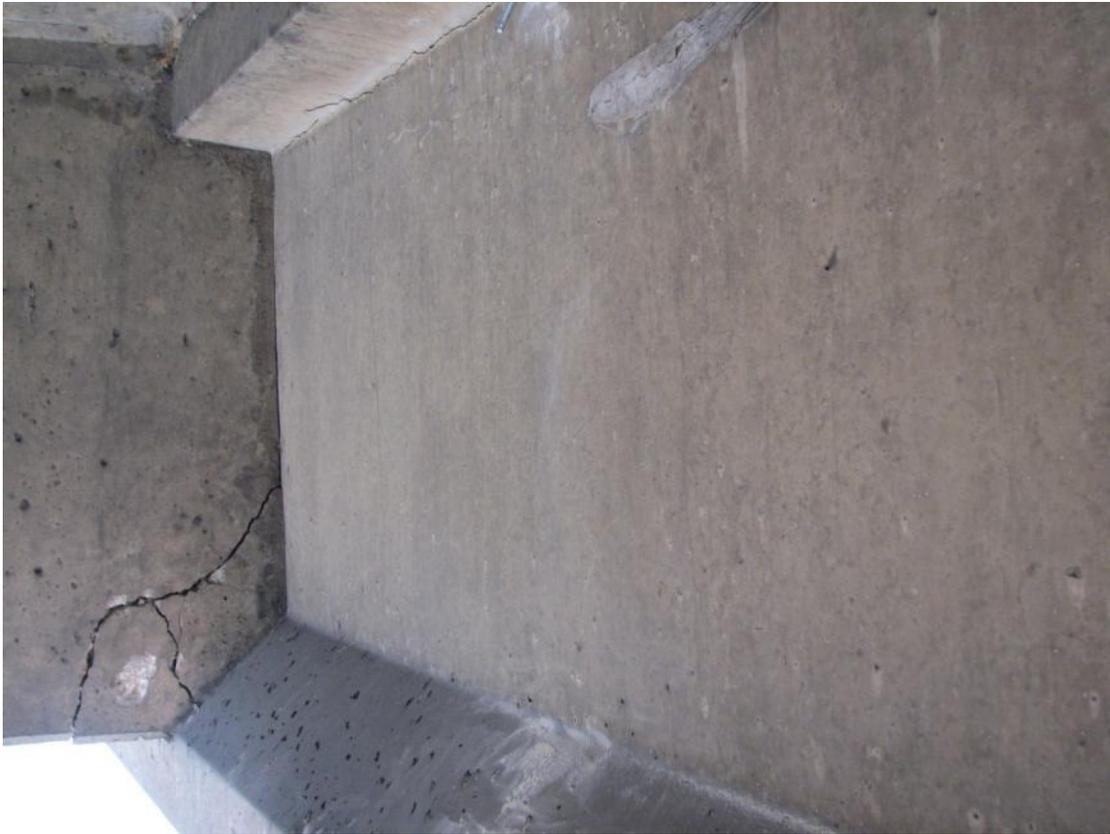
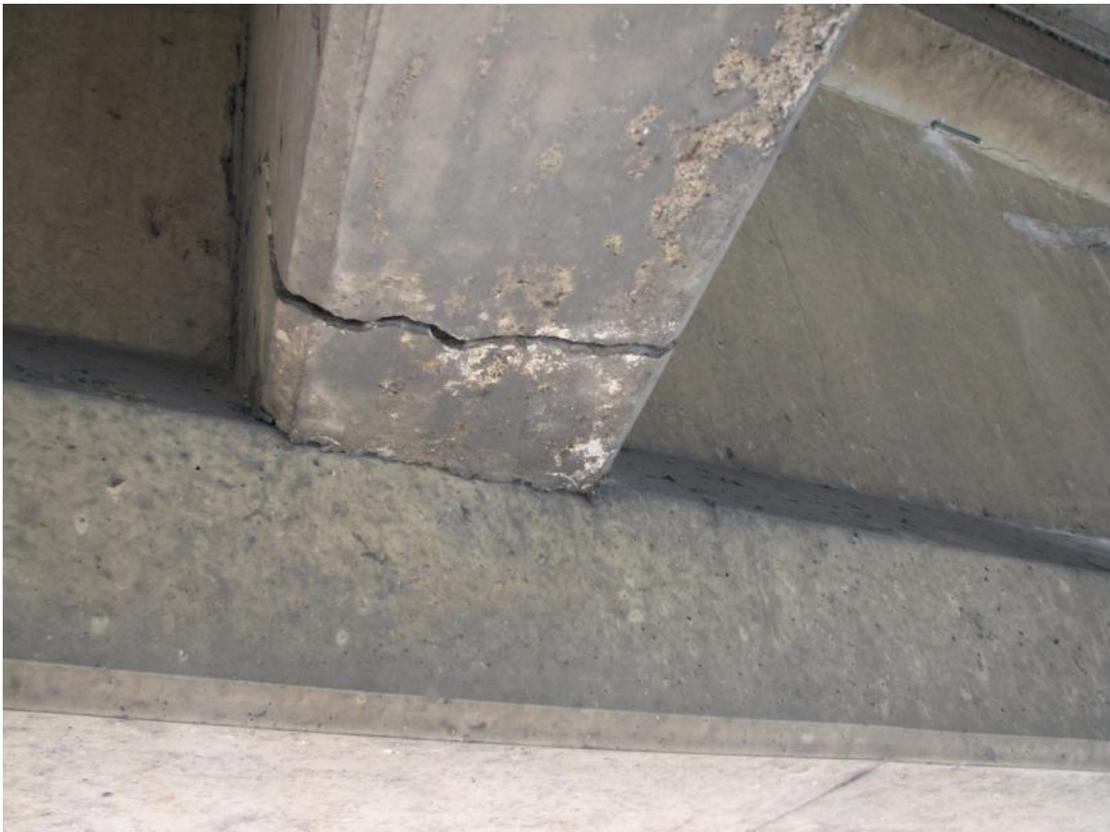
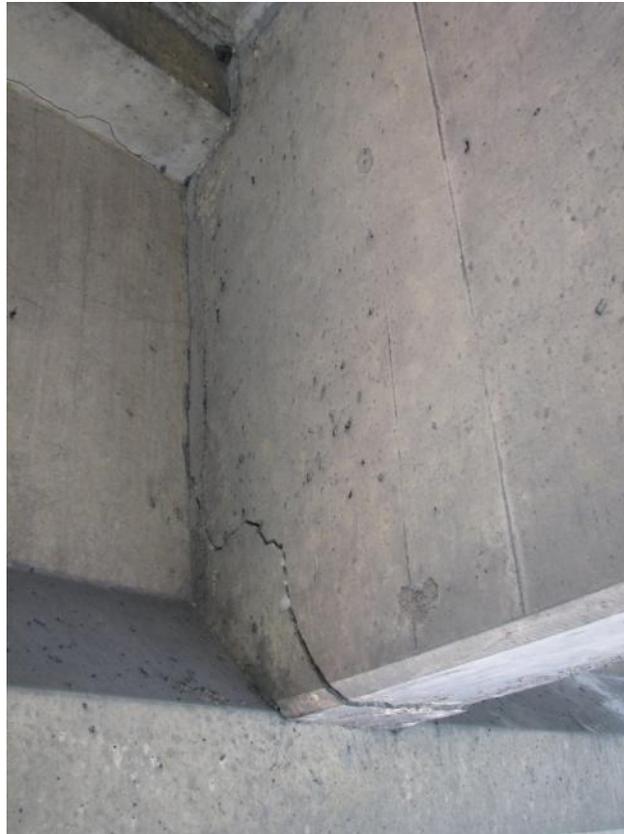
**Photo 13: South Exterior Beam, North Side, Looking East.**

**Photo 14: South Exterior Beam, North Side.**

**Photo 15: South Exterior Beam, North Side, Looking West.**

The east intermediate concrete diaphragm between the south exterior beam and first interior beam is cracked (Photo 13, 14, and 15). The south exterior beam is also cracked along the junction of the web and top flange fillet from the pier no.2 diaphragm to the west undamaged intermediate concrete diaphragm.
