**SPECIAL PROVISIONS  
FOR  
VIDEO INSPECTION**

**Fremont County  
STP-333-1(030)--2C-36**

**Effective Date  
October 17, 2023**

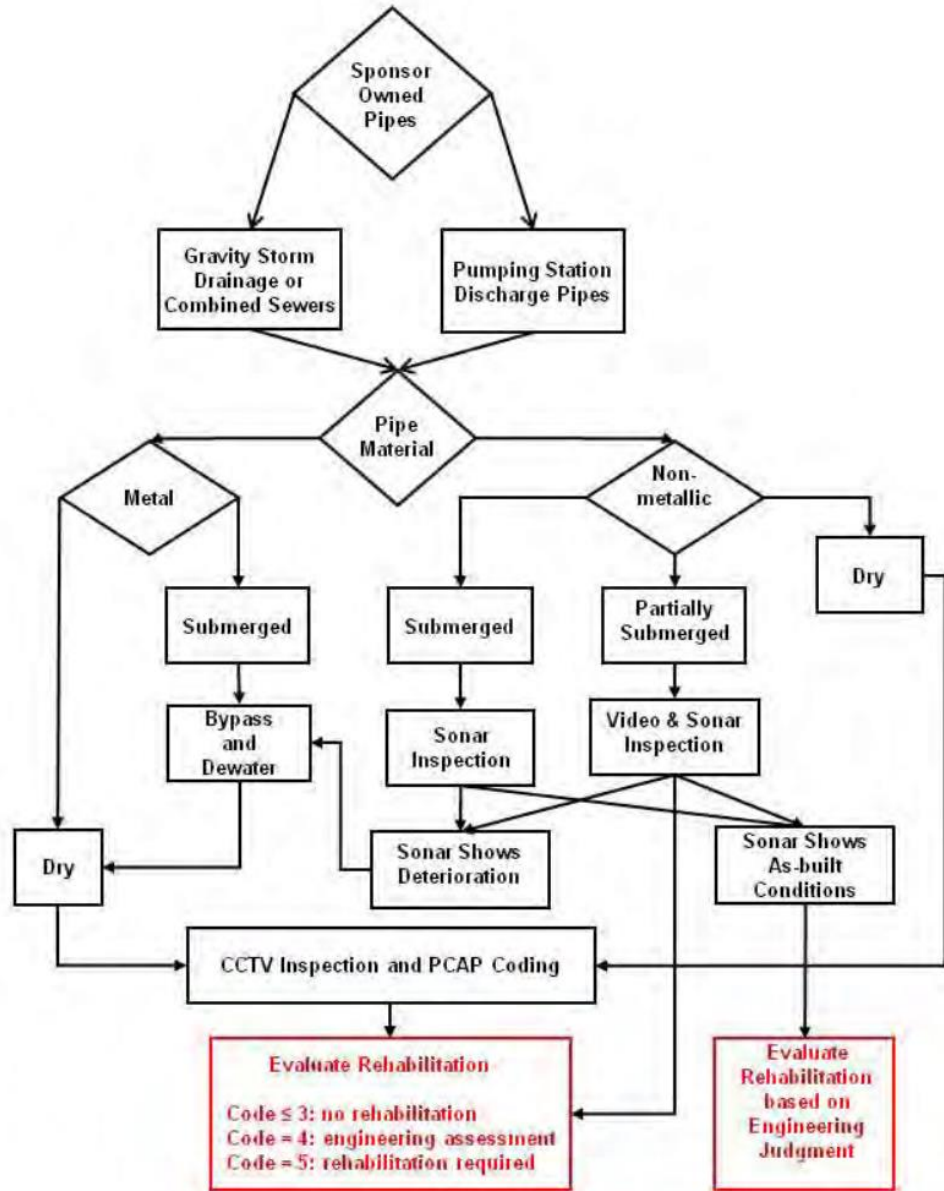
Figure 1. Pipe Condition Assessment Procedure for Gravity Pipes and Pump Station Discharge Pipes.

and illustrated in Figure 1 is used to determine proper inspection protocols.

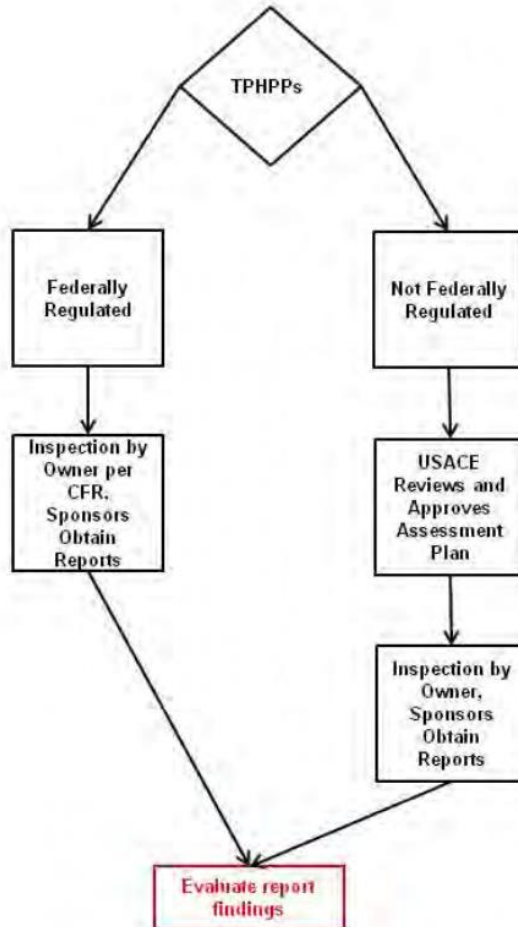
Figure 2. Pipe Condition Assessment Procedure for Third-Party High-Pressure Pipes (TPHPPs).

The primary types of third-party high-pressure pipes (TPHPPs) are water distribution lines, natural gas pipelines, and hazardous liquid transmission lines. The inspection protocol for TPHPPs used to determine pipe suitability is illustrated in Figure 2.

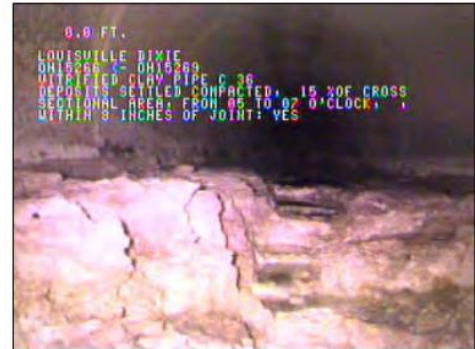
Photo: OH15269\_OH15266124326\_05112009\_A.JPG, VCR  
No.: FLOOD WALL#2, 01:42:36  
0FT, Deposits Settled Compacted, 15 %of cross sectional area, from 05 to 07 o'clock, within 8 inches of joint: YES

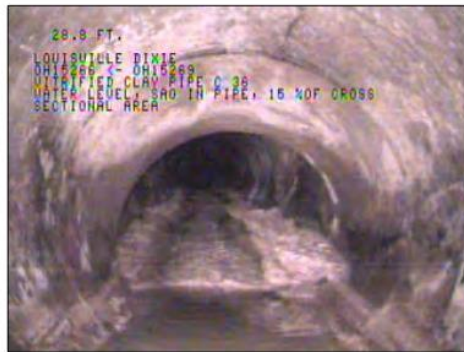
Photo: OH15269\_OH15266124455\_05112009\_A.JPG, VCR  
No.: FLOOD WALL#2, 01:43:58  
28.8FT, Water Level, Sag in pipe, 15 %of cross sectional area

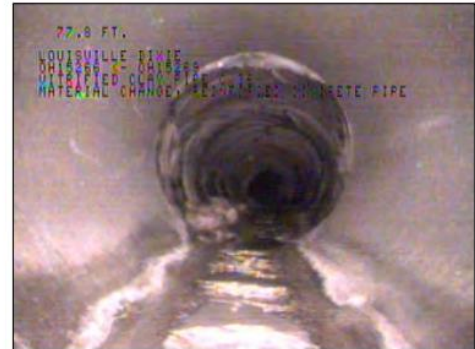
Photo: OH15269\_OH15266124720\_05112009\_A.JPG, VCR  
 No.: FLOOD WALL#2, 01:45:49  
 77.8FT, Material Change, Reinforced concrete pipe

77.80	MMC	Material Change, Reinforced concrete pipe	00:04:24	65_7A		
	83.60	MMC	Material Change, Vitrified clay pipe	00:04:43	65_8A		
	83.60 <b>S1</b>	CM	Crack Multiple, from 09 to 03 o'clock, within 8 inches of joint: YES, Start	00:04:50	65_9A	S 3

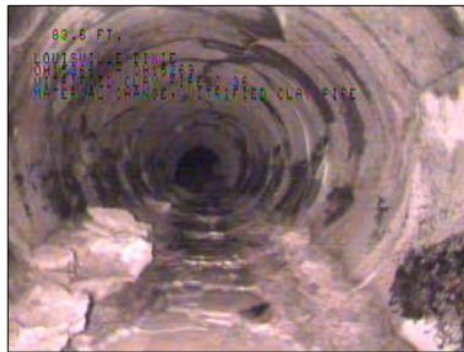
Photo: OH15269\_OH15266124748\_05112009\_A.JPG, VCR  
 No.: FLOOD WALL#2, 01:46:07  
 83.6FT, Material Change, Vitrified clay pipe

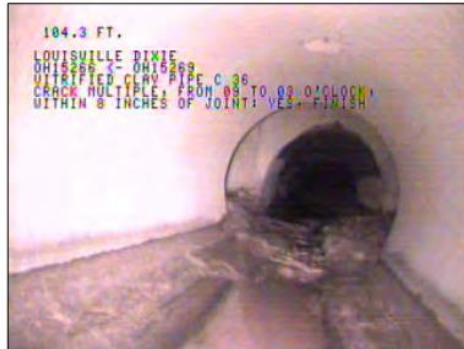
Photo: OH15269\_OH15266124848\_05112009\_A.JPG, VCR  
 No.: FLOOD WALL#2, 01:46:48  
 104.3FT, Crack Multiple, from 09 to 03 o'clock, within 8 inches of joint: YES, Finish

104.30 <b>F1</b>	CM	Crack Multiple, from 09 to 03 o'clock, within 8 inches of joint: YES, Finish	00:05:27	65_10A	S 3	
	104.30	MMC	Material Change, Reinforced concrete pipe	00:05:34	65_11A		
	<b>OH15269</b> 115.30	AMH	Upstream Manhole, Survey Ends / OH15269	00:06:07	65_12A		
<b>Summary of Inspection:</b>							
Str Scores:		Gr1:0000	Gr2:0000	Gr3:0015	Gr4:0000	Gr5:0000	Worst Str Grade: 3
O&M Scores:		Gr1:0000	Gr2:0004	Gr3:0003	Gr4:0000	Gr5:0000	Worst Maint Grade: 3
QSR	QMR	SPR	MPR	OPR	SPRI	MPRI	OPRI
3500	3122	15	7	22	3.00	2	3

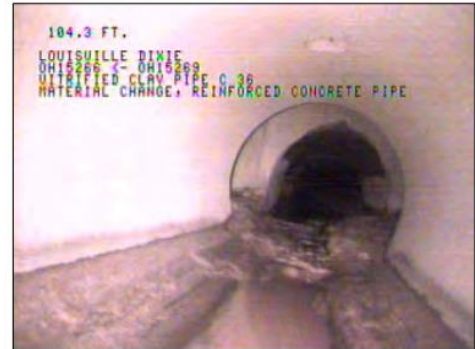
Photo: OH15269\_OH15266124907\_05112009\_A.JPG, VCR  
 No.: FLOOD WALL#2, 01:46:54  
 104.3FT, Material Change, Reinforced concrete pipe

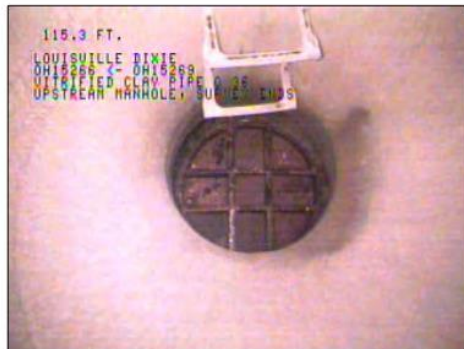
Photo: OH15269\_OH15266124956\_05112009\_A.JPG, VCR  
 No.: FLOOD WALL#2, 01:47:25  
 115.3FT, Upstream Manhole, Survey Ends
