Prediction and Monitoring of a Superload Passage

Iowa State University Terry J. Wipf Brent M. Phares

The Bridge Engineering Center at the Center for Transportation Research and Education-Iowa State University

August 15, 2003

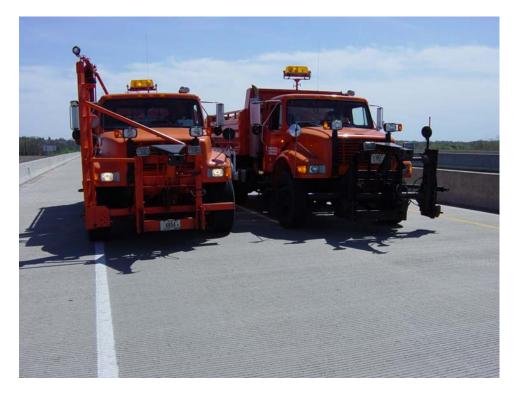
Figure 1. Test trucks used to perform preliminary testing of Bridge.

To assist the DOT in assessing this bridge, the BEC conducted a traditional load test on the bridge using various combinations of one and two loaded tandem axel dump trucks (see Fig. 1). Strain data was collected at three cross-sections of the critical span: near the west abutment, at mid-span, and near the first pier (see Fig. 2). Four girders were instrumented with 2 strain gages each (one each on the top and bottom flanges) at the sections near the abutment and pier and all six girders were instrumented with 2 strain gages each (one each on the top and bottom flanges) at the section near the top and bottom flanges) at the section near midspan.

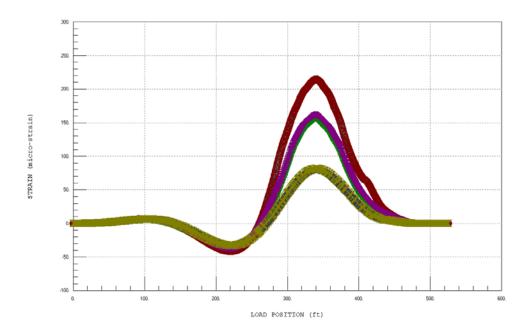
Figure 3. Predicted response at midspan to first superload passage.

From the data collected during the above mentioned test, a finite element model was created and calibrated. The final model had less than a 9% error at predicting the field test results. This model was then used to predict the response of the bridge to the first superload expected to cross the bridge (approximately 640,000 lbs). Typical strain results from this prediction are shown in Fig. 3. It was assumed for this analysis that the truck crossed the bridge centered on the bridge (not the roadway). As one would expect, a symmetric behavior was predicted as shown in Fig. 3. From this model, and further consultation with the DOT, it was determined that the bridge did have sufficient strength (both flexural and shear) to allow passage of the loads.

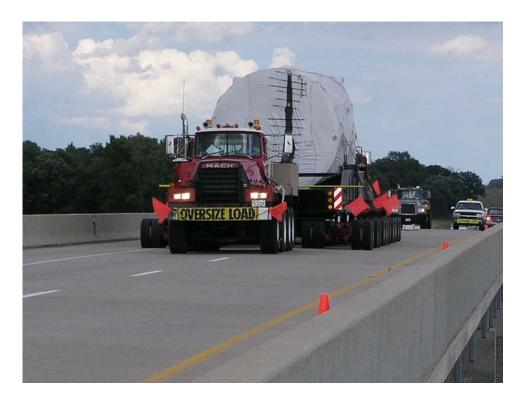
Figure 4. Photograph of superload passage.

During passage of the first superload (see Fig. 4), the same instrumentation scheme was installed on the bridge prior to the load arriving. The response of the bridge was then measured as the load crossed the bridge. Typical results from this can be seen in Fig. 5 which shows the response at the same locations shown in Fig. 3 (note that the "truck position" scale in figures 3 and 5 are different as the monitoring and modeling were initiated from different locations). As one can see in comparing Figs. 3 and 5, there is very good correlation between the predicted and actual response at midspan. In Fig. 5 one can note, however, that the response does not appear to be symmetric (i.e., strain levels are different in symmetric girders). However, it should be pointed out that the truck did not track down the centerline of the bridge. This may be the source of some of the behavior seen in Fig. 5. Although not shown here, the predicted strain at the pier was not as accurate as that predicted near midspan and near the abutment. A brief post-loading visual inspection of the bridge reveled that additional cracking in the barrier wall and deck had occurred. This may account for the generally less accurate prediction.

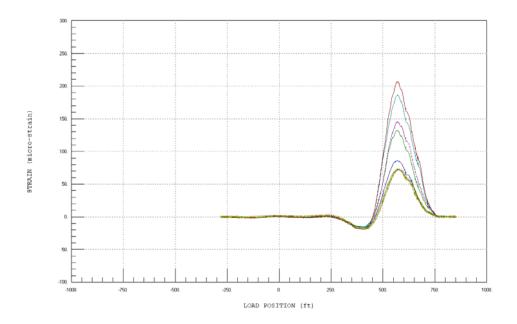
Figure 5. Actual response at midspan to first superload passage.
