## **ACCELERATED CONSTRUCTION IN IOWA**

### **ABSTRACT**

## **MACKEY BRIDGE**

## MADISON COUNTY BRIDGE

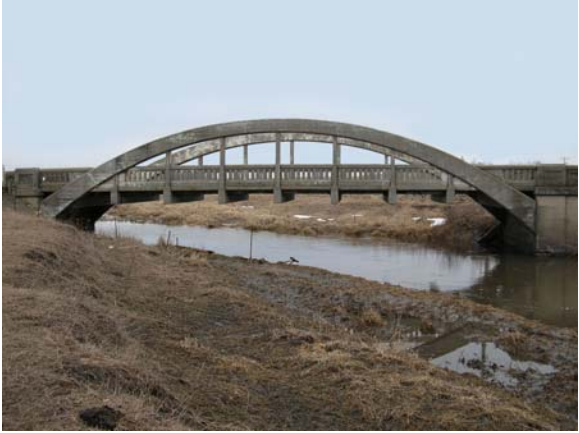
Figure 1 - Marsh Arch Bridge

Completed in December 2006, the new Mackey Bridge replaced a Marsh Rainbow Arch Bridge located on 120<sup>th</sup> Street, over Squaw Creek, in Boone County, Iowa (See Figure 1).

The Marsh Arch was built in 1917 and featured a single 76-foot long span with an 18 foot wide roadway. The new Bridge has three spans, two 47'-5 end spans, and a 56'-6 center span, with a 30 degree right ahead skew. It was built with integral abutments, two fixed piers, a precast deck situated on four precast girders, and measures 151'-4 feet long with a 30'-6 foot wide roadway (See Figure 2).

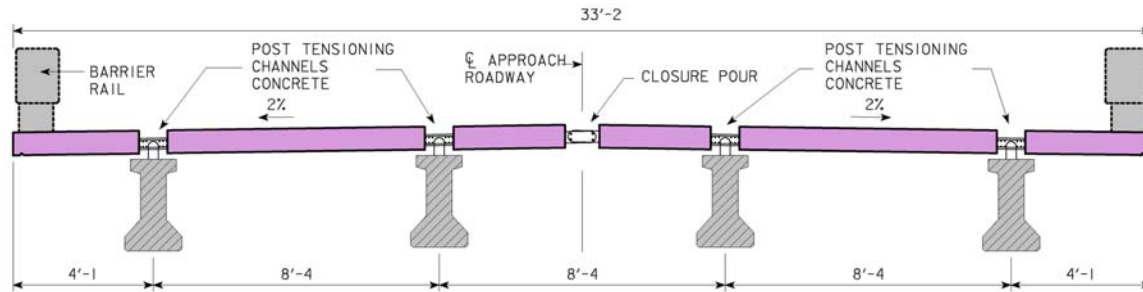
Figure 3 - Bridge Cross-section

The deck panels are supported by standard pre-tensioned precast beams that are placed on 8'-4 centerlines with a post applied cast-in-place post and beam barrier rail. The barrier rail system used is a county standard and future applications of this system may consider precast barrier rails (See Figure 3).

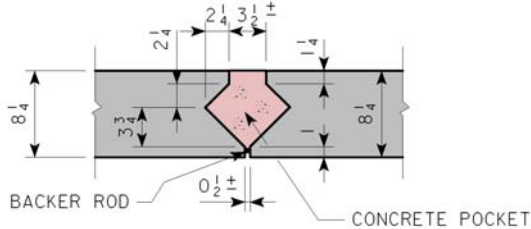
Figure 4 - Transverse Joint

The construction sequence called for the panels to be placed on the girders, with the transverse joints (See Figure 4) filled with concrete and allowed to cure overnight. Next, the panels were post-tensioned together by running 12 - 0.6 inch diameter, 270 ksi Low-Lax strands through the longitudinal channels over the girders (See Figure 5). The channels were then filled with concrete and the closure joint and ends of the deck were poured (See Figure 6).

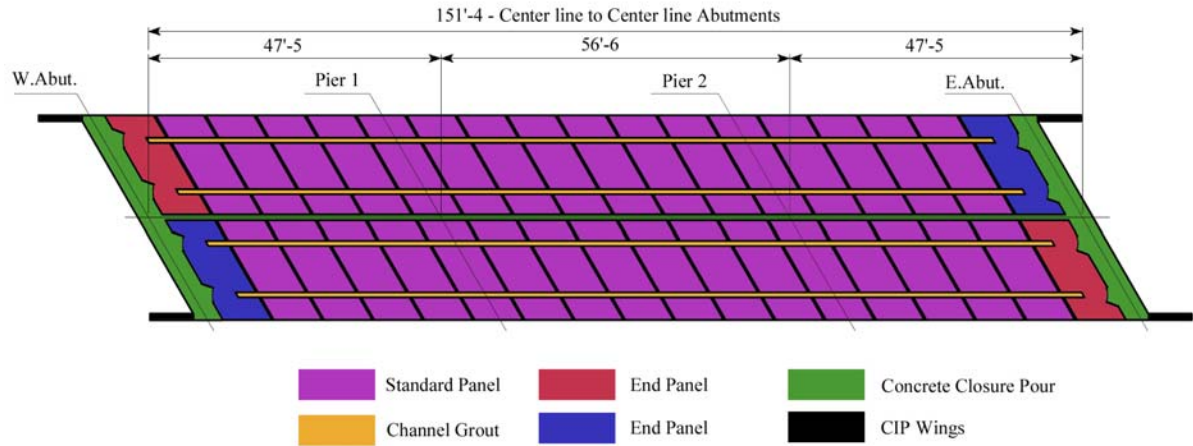
Figure 6 - Deck Panel Layout

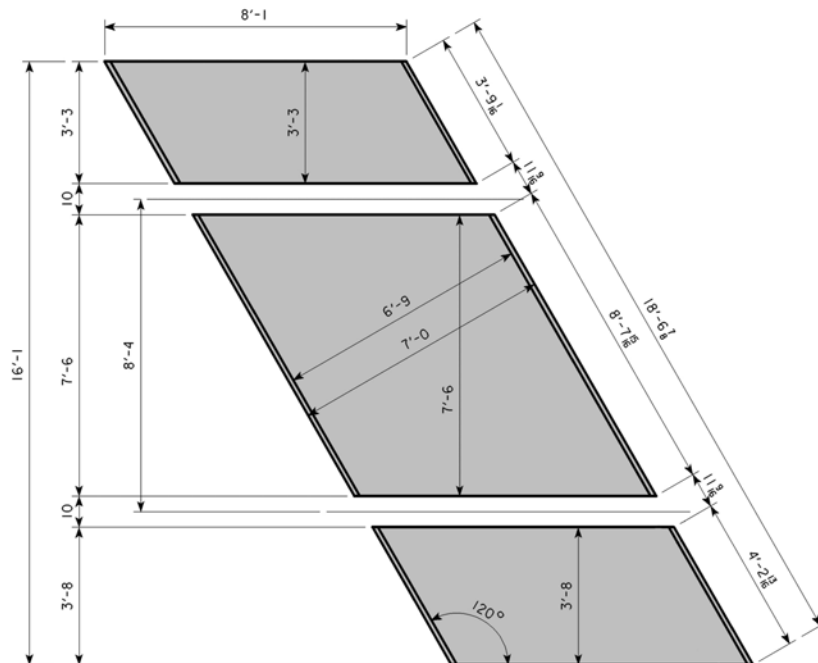
Figure 7 - Standard Deck Panel

The precast panels are 8 1/4" inches thick, 18'-6 7/8 feet long, with thirty two main panels and four end panels. The four end panels were split into two mirrored designs (See Figure 7). Each standard panel has 8 - 1/2 inch diameter 270 ksi Low-Lax steel pre-stressing strands. High strength steel coils were placed around the ends of the strands to resist bursting forces and aid in development lengths. In addition, each panel had 16 - #7 longitudinal bars and 23 - #6 transverse bars (See Figure 8 and Figure 9).

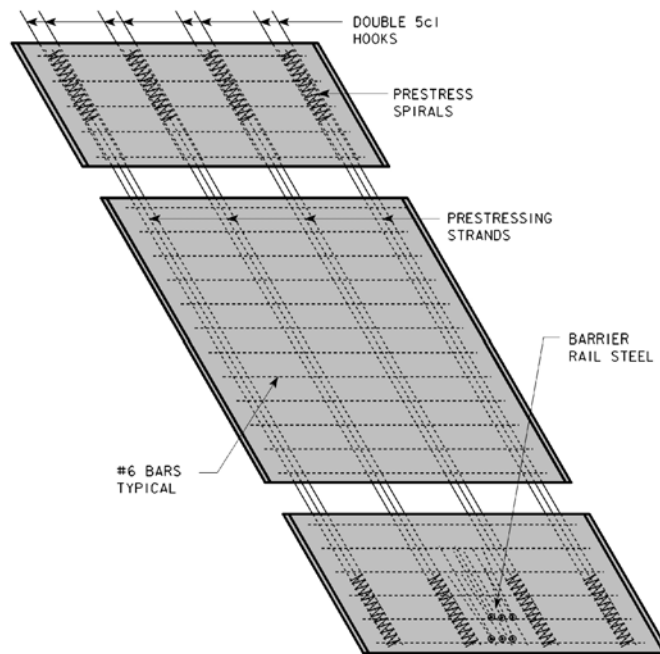
Figure 8 - Steel Layout Standard Panel

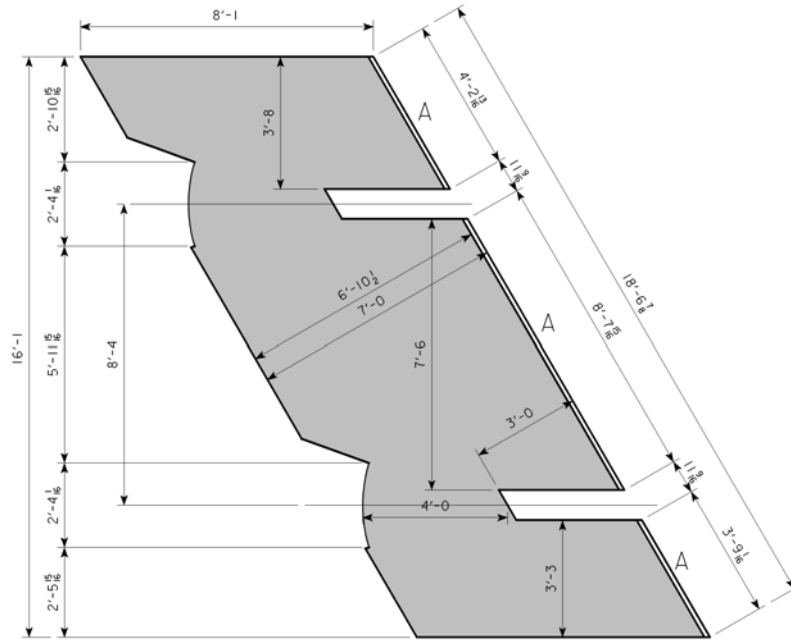
Figure 10 - Precast End Panel

The precast end panels are similar to the standard panels except for the shortening of the channel along the top of the beam (See Figure 10). The four foot length of full depth concrete is required to resist the post-tensioning anchorage stresses applied to the end panels. Steel stirrups protruding from the top of the precast beams were cut to accommodate the closed section of the panel. The strands also flare out in the closed channel, which required welded wire reinforcement instead of the pre-stressing strands because of spacing limitations (See Figure 11).

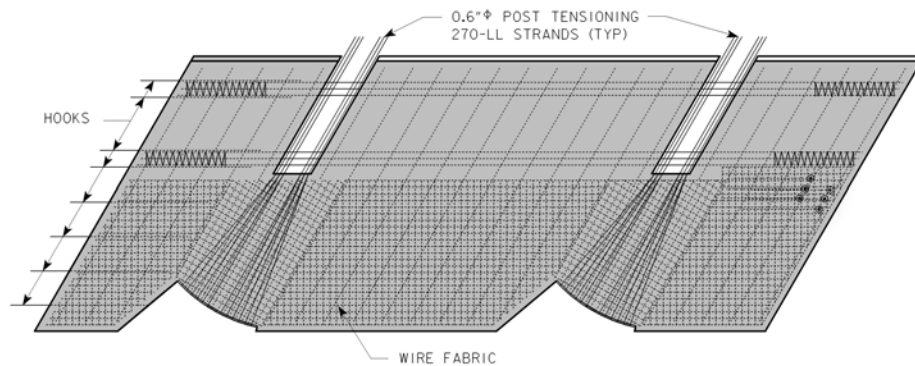
Figure 11 - End Panel Steel Layout

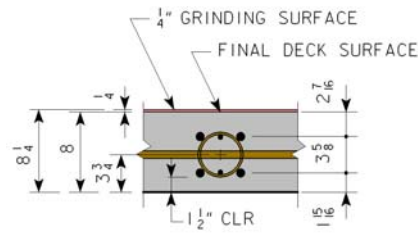
One of the difficulties in designing a full-depth panel, based on the NUDECK system, was the location of the transverse steel. The Skyline Bridge had a 150 mm (6 inch) thick panel with the steel pre-stressing strands placed around the centroid of the panel. Because of cover requirements, for the Mackey Bridge deck, prestressing strands could not be placed in the center of the panel (See Figure 12). This design feature coupled with the uneven lengths of the wings of the precast panel led to some concerns that the panel may experience camber or uneven bending issues during installation, but no camber issues were experienced during the project.

Figure 12 - Panel Steel Location      Figure 13 - Barrier Rail Connection

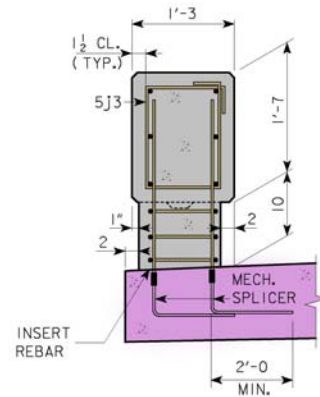
The cast-in-place barrier rail system was placed after the bridge deck was finished. Each panel incorporated a pre-set mechanical splice system to allow the barrier rail to tie into the panels (See Figure 13).

For the vertical reinforcing connection to the coral style barrier rail, the contractor was given the option to project the reinforcing bars from the deck or use pre-set mechanical splicers. The contractor and fabricator chose the mechanical splicer option shown in figure 19. The end panels with the welded wire reinforcing in the anchorage zone were cast in two stages due to the difficulty vibrating and consolidating the concrete with two layers of welded wire reinforcing present. A lift of concrete was placed in the form and vibrated without the top layer of welded wire reinforcing in place (shown in Figure 20). While the concrete remained plastic the top layer of reinforcing was installed and the remaining lift of concrete was placed and vibrated.

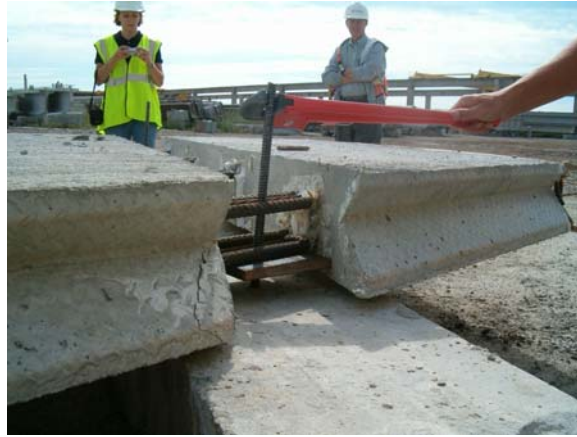
Figure 14 – Leveling Device Test

Andrews initially cast three test panels that were purchased by Iowa State University – Bridge Engineering Center (ISU-BEC) for their laboratory testing program. Prior to shipment of the test panels to ISU, one of the test panels was used by the contractor to conduct a leveling device test. The test was required by the contract documents. The leveling device, shown in Figure 14, was designed by the contractor. The leveling device operates as a screw jack. The deck panel exposed transverse reinforcing in the channel bears on a steel plate with a nut welded to the bottom of the plate and a screw passing thru the plate and nut. A pipe wrench was used to turn the screw to raise and lower the deck panel. The contractor demonstrated that the device was stable while supporting the deck panel over the PPC beam and could be adjusted to the correct elevation and deck cross slope. Once the leveling device was accepted, the production deck panels were fabricated.

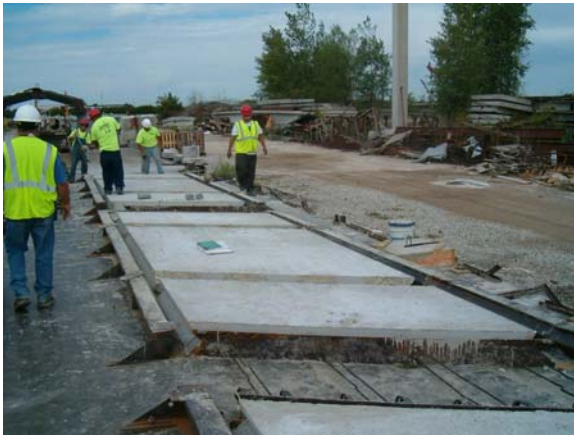
Figure 15 – Panel Form Release

Three deck panels could be cast in one casting operation every other day with a maximum of nine panels cast per week. (See Figure 15 – Panel Form Release). Andrews fabricated re-usable steel forms shown in Figures 15 and 16. The panels were cast on a steel casting bed in the open.

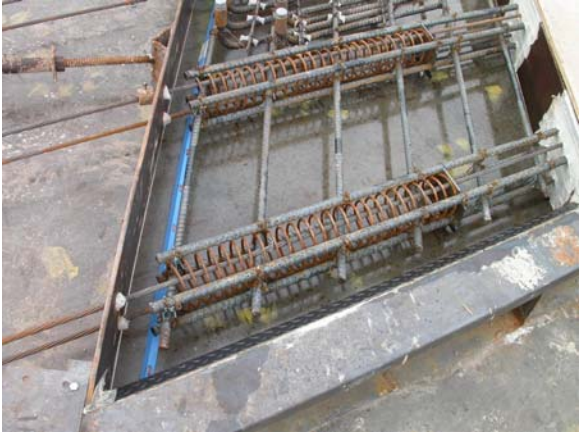
Figure 17 – Spiral Reinforcing

Spiral reinforcing was used for a dual purpose. The first purpose was to reinforce the bursting zone, and the second purpose was for improved strand development with spiral confinement shown in Figure 17.

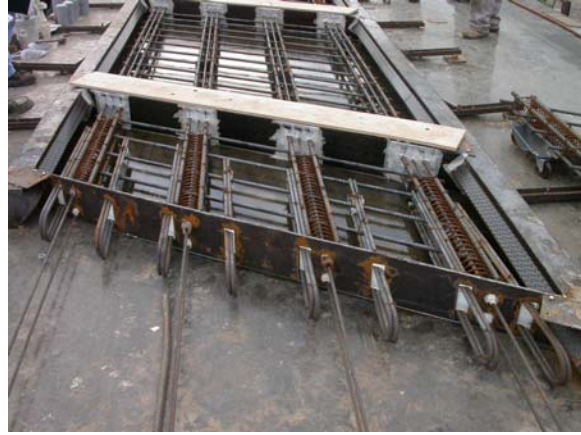
Figure 18 – Longitudinal Joint Reinforcing

At the centerline of the bridge a longitudinal joint was cast. The longitudinal joint was reinforced with double hairpin bars projecting from the panel (shown in Figure 18) and field installed straight bars threaded longitudinally. One benefit of including the longitudinal joint at the centerline was to allow the panels to be cast flat and introduce the bridge crown in the longitudinal joint. The longitudinal joint at the centerline of the bridge did not add any construction time to the critical path because the longitudinal joint was cast concurrently with the open channels over the beams for the post-tensioning.

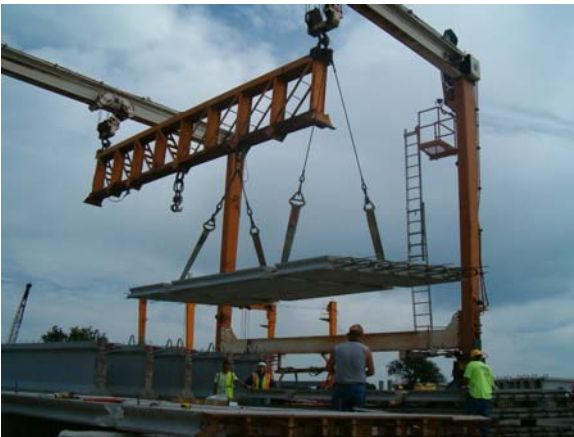
Figure 21 – Deck Panel Stockpiling

The panels were released from the forms and stockpiled as shown in Figure 21 at the precasting yard to await shipment to the bridge site. Andrews was also the fabricator for the PPC beams shown in Figure 22. The beams were Iowa Standard “B” beams modified for a wider spacing than the typical standard beam spacing.

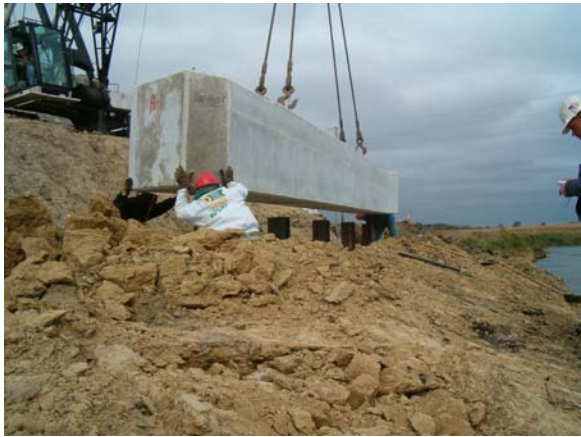
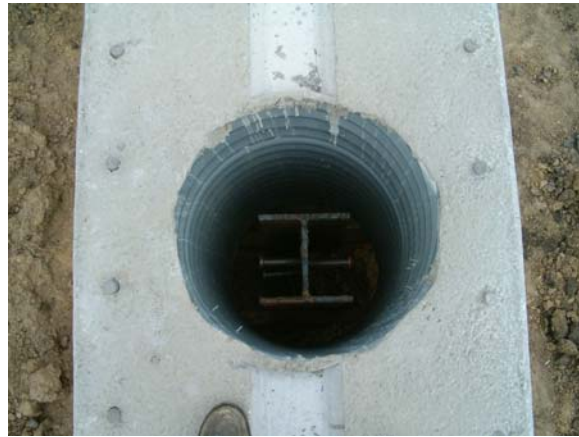
Figure 23 – Setting Precast Abutment

Figure 24 – Abutment CMP Blockout

The contractor had an end-of-driving tolerance of 3 inches in any direction for each H-piling. Although, in order to fit the precast abutment footing over the H-piling the Iowa DOT standard specifications typically specify a start of driving tolerance for H-piling. Special plan notes were included to specify the end of driving tolerance. The contractor took care with the pile driving operation and had no problem meeting the end of pile driving tolerance or fitting the precast abutment footing over the H-piling shown in Figures 23 and 24.

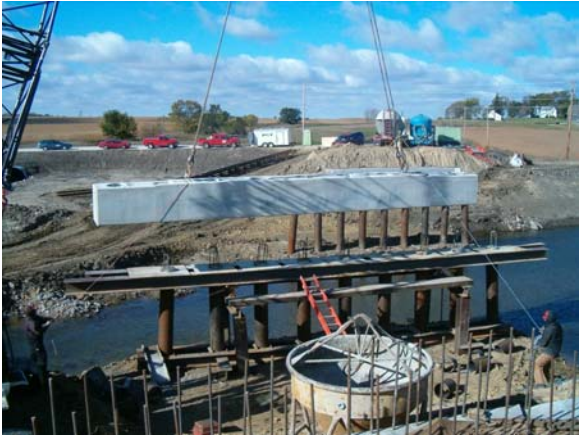
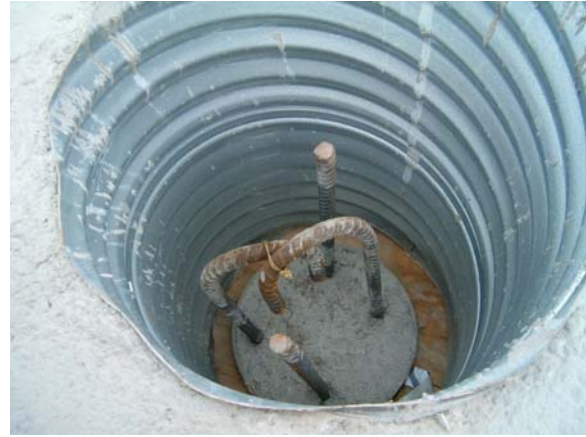
Figure 25 – Setting Precast Pier Cap

Figure 26 – Pier CMP Blockout

There were five H-piling supporting each abutment footing and nine 16 inch diameter pipe piling supporting each pier cap. The pier cap end of driving tolerance was 2 ½ inches. A driving template was fabricated that helped the contractor to meet the end of driving tolerance in order to fit the precast unit over the piling. No problems were encountered, and the pipe piles were all well centered within the pier cap, see Figures 25 and 26.

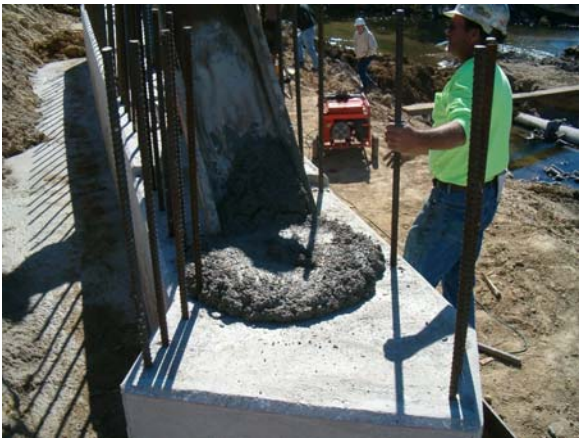
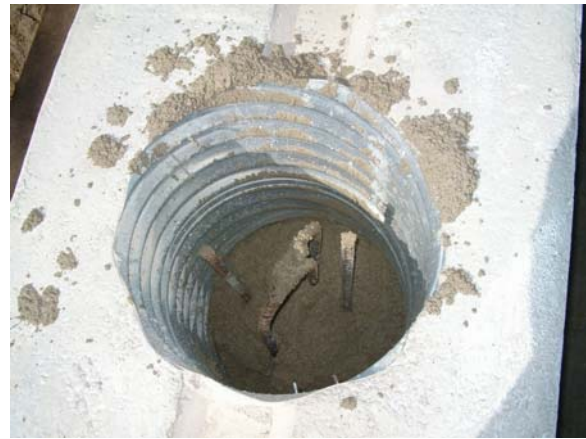
Figure 27 – Filling Abutment Blockout

Figure 28 – Filling Pier Blockout

A high early strength concrete mix was used for filling the substructure blockouts, shown in Figures 27 and 28. The concrete was cast with a maximum slump of 2 inches prior to adding a High Range Water Reducer (HRWR) to improve workability. With the HRWR the maximum slump allowed was 7 inches. Prior to beam placement the concrete was required to achieve a 3500 psi compressive strength.

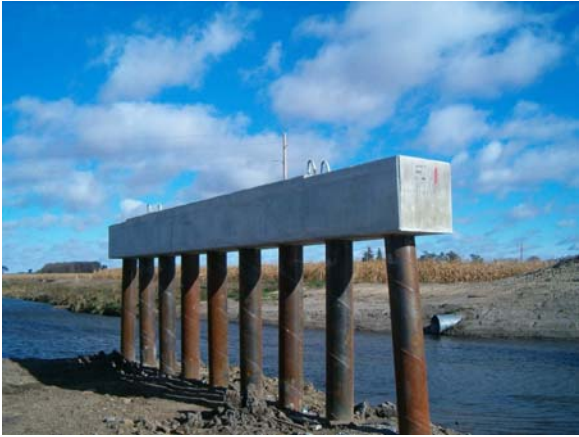
Figure 29 – West Pile Bent

The substructure utilized precast abutment footings and precast pier caps founded on H-piling and pipe piling respectively. The units were reinforced with mild reinforcing and included a blockout for the piling that was created with Corrugated Metal Pipe (CMP). To overcome the lack of data in regard to bond or development of resistance between the concrete and the CMP, a fairly conservative connection design was used and later validated by testing.

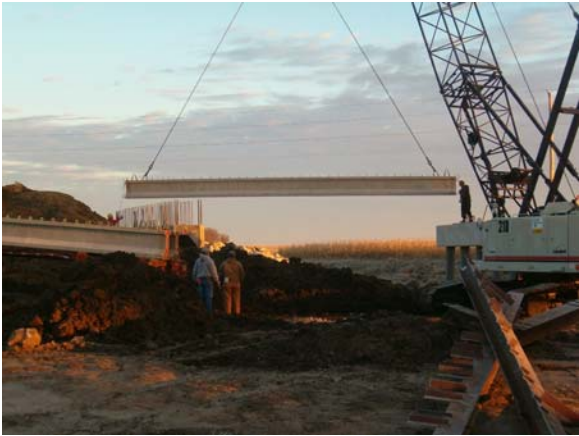
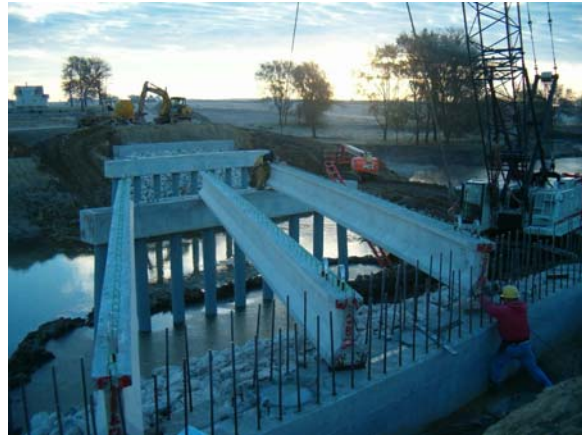
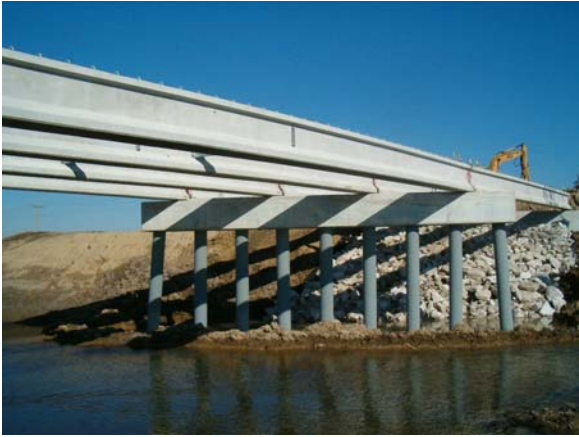
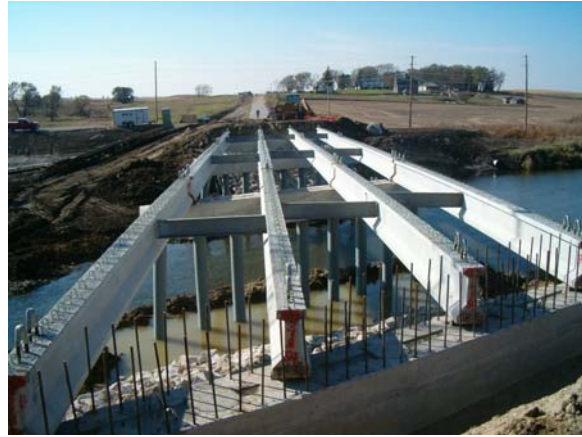
The superstructure for the bridge utilized traditional PPC beams. The beams were modified from the standard design in order to eliminate a beam line. The county standard bridge five-beam cross section was reduced to a four-beam cross section (see Figure 34) by placing additional prestressing strands and increasing the concrete release and 28 day strengths.

Erection of the PPC beams was started early in the morning and completed shortly after noon, shown in Figures 31, 32, 33 and 34.

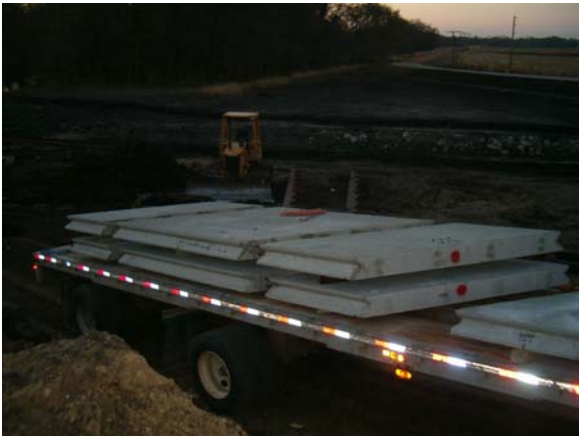
Figure 35 – Deck Panel Delivery

The deck panels were delivered three per truckload, shown in Figure 35. The first half of the deck panel erection took the whole day. Panels were erected from the centerline of the bridge working outward, see Figures 36 and 37. The second half of the panels took half of the day to erect. The primary difficulty erecting the deck panels is the alignment of the first deck panel erected. Once the first panel is properly positioned each remaining panel was uniformly offset  $\frac{3}{8}$  inch and maintained the correct alignment. Panel leveling devices were installed the same day as the deck panel erection, shown in Figure 38 and 39.

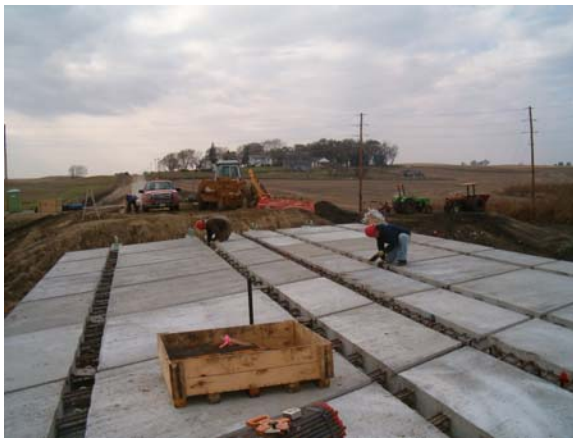
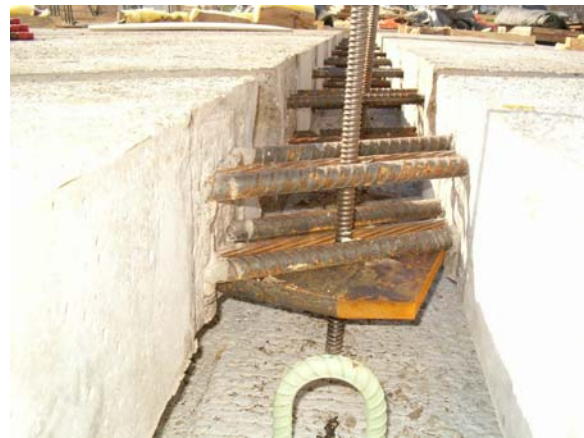
Figure 38 – Leveling Device Installation

Figure 39 – Leveling Device

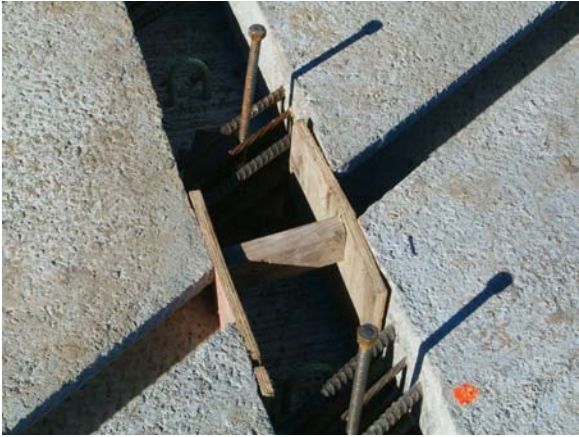
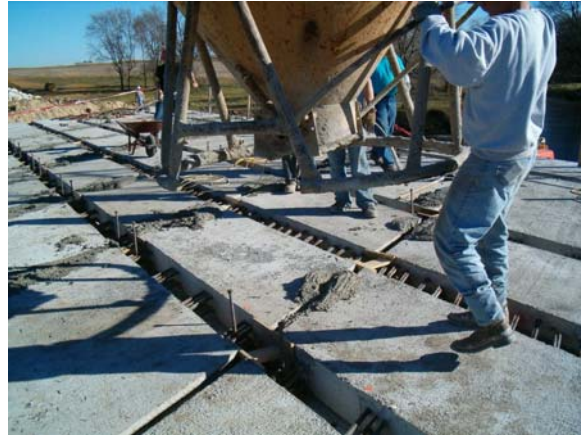
Figure 40 – Transverse Joint Form

Figure 41 – Casting Transverse Joints

The transverse joints were filled in place with a high early strength concrete mix. Due to the tight opening between deck panels, a small aggregate size was used with a maximum top size of 3/8". The slump of the concrete mix was increased using a HRWR to allow a maximum of 8 inches. A retarding admixture was used as well to extend the life of the HRWR for workability. See Figure 40 for forming of the transverse joints and Figure 41 for the transverse joint casting operation.

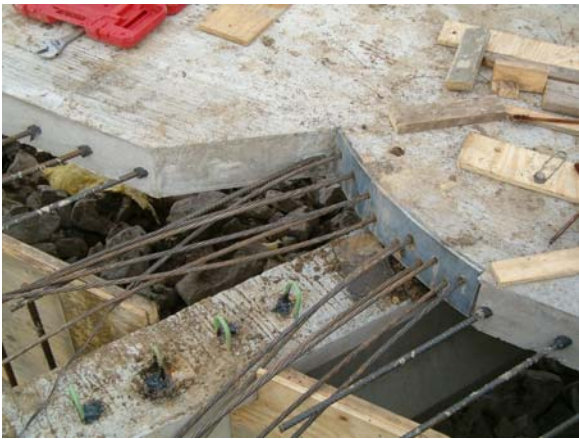
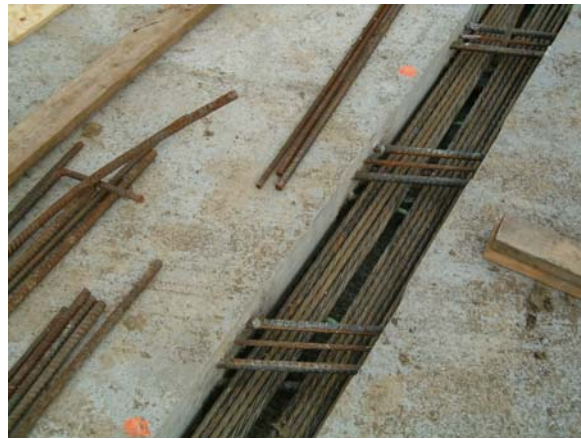
Figure 42 – PT Strand Anchorage

Figure 43 – PT Strands

During the curing of concrete in the transverse joints, the post-tensioning strands were threaded thru the end anchorages and the channels as shown in Figure 42.

There were a total of 48 - 0.6" diameter strands, 12 in each of the channels to post-tension, shown in Figure 43. The bridge was short enough to allow post-tensioning from one end only. The entire post-tensioning operation was completed in less than 4 hours. All the strands except one were post-tensioned with no problems. One strand became pinched between an adjacent strand and deck panel concrete projection. The pinched strand was released and fully post-tensioned by switching to the opposite end of the bridge and applying the post-tensioning force. The correct post-tensioning force application in that strand was doubly verified by gage pressure and summing the total strand elongation at each end.

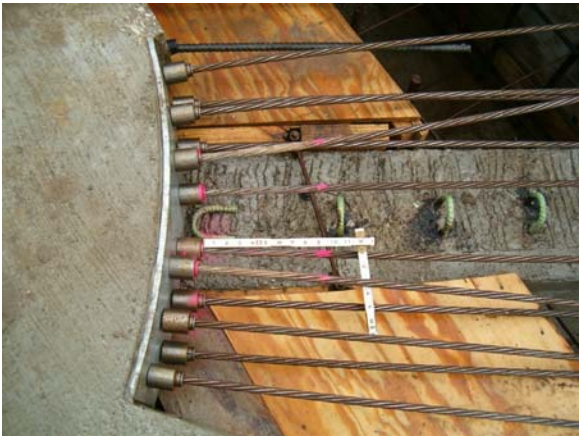
Figure 44 – Strand Elongation

Post-tensioning forces were verified by calibrated gage. Strand elongation was checked as a final confirmation, shown in Figure 44. The jack stroke length was monitored during post-tensioning as a safety precaution against over tensioning.

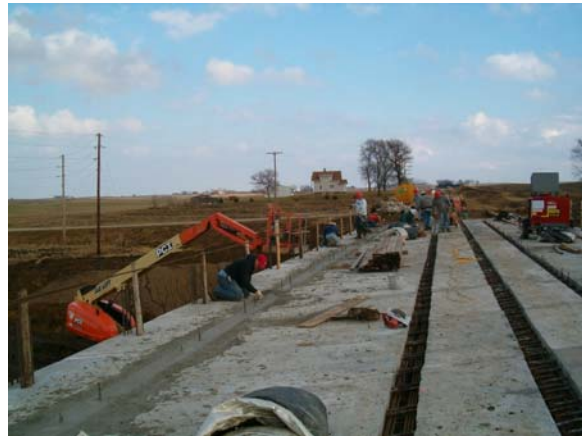
Figure 45 – Casting Long. Joints

Concrete was cast in the longitudinal joints on the same day the post-tensioning force was applied, shown in Figure 45. The same concrete mix used for the transverse joints was used for the longitudinal joints. The longitudinal joints were congested with post-tensioning strands, transverse mild reinforcing, transverse prestressing strands, stirrups, and leveling plates with leveling screws, as shown in Figure 46. The HRWR was very effective in aiding in the placement of the concrete. The consolidation observed in the longitudinal channel haunch area, shown in Figure 47, and between the strands and reinforcing was excellent.

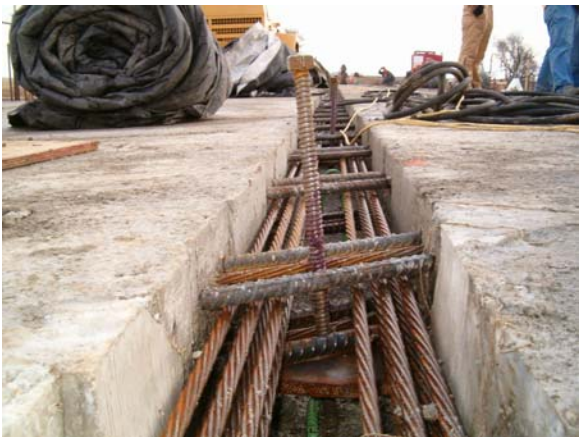
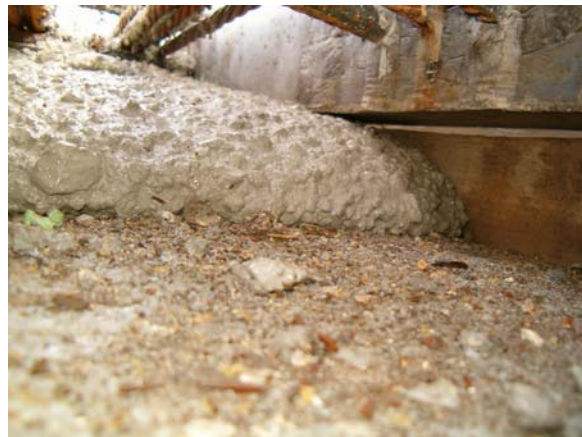
Figure 46 – Channel Congestion

Figure 47 – Concrete Consolidation

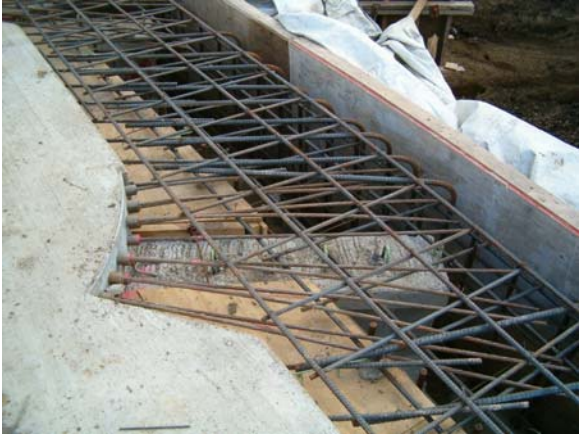
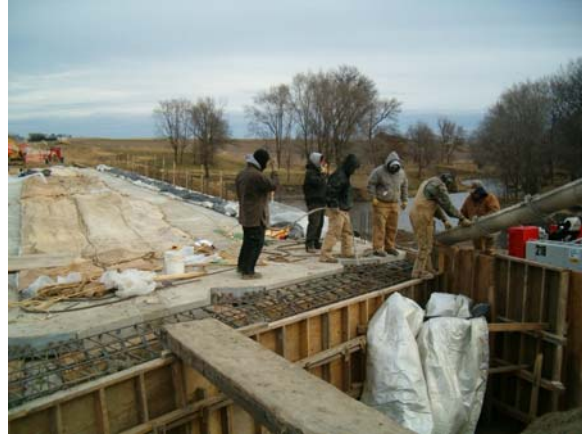
The concrete diaphragm and deck end section were cast in place to complete the integral abutment, shown in Figures 48 and 49. The cast in place end section also allowed for panel erection tolerance. The total length of the deck panel portion was nine inches longer than anticipated in the plans, as the panels were fabricated on the high end of the dimensional

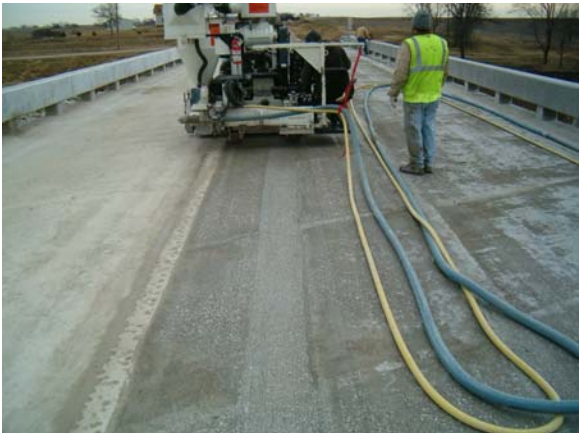
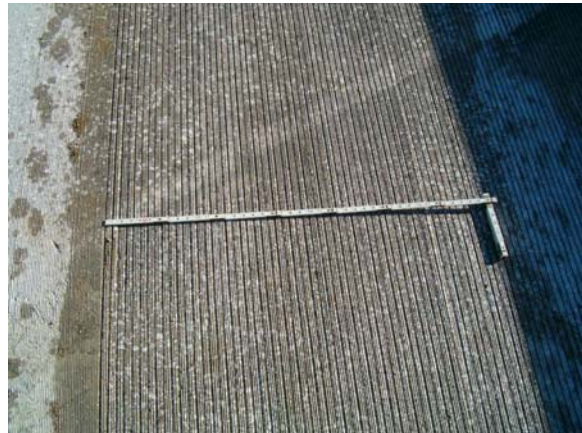
fabrication tolerances. The deck was ground for smoothness and grooved for texture, shown in Figure 50, prior to opening to traffic. There is a light contrast between the concrete used in the deck panels and the concrete used for the transverse and longitudinal joints, shown in Figure 51.

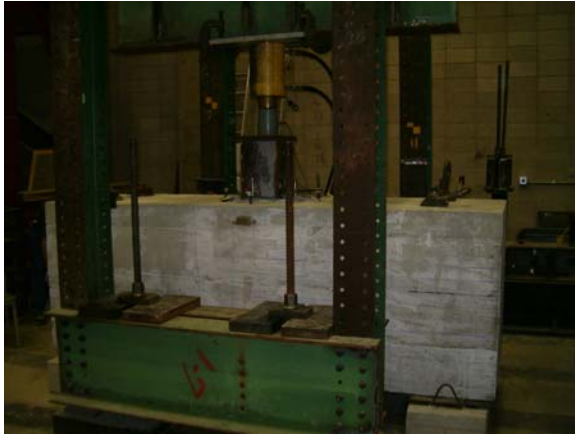
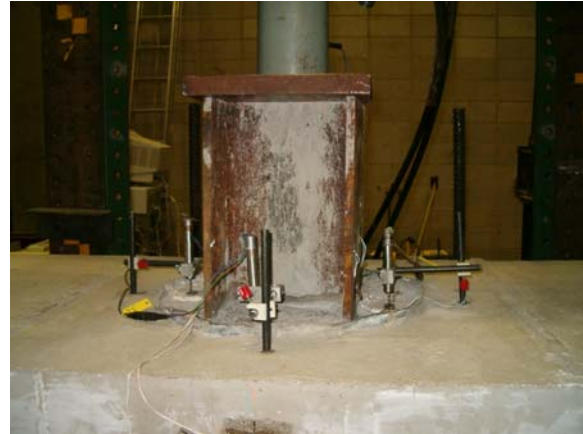
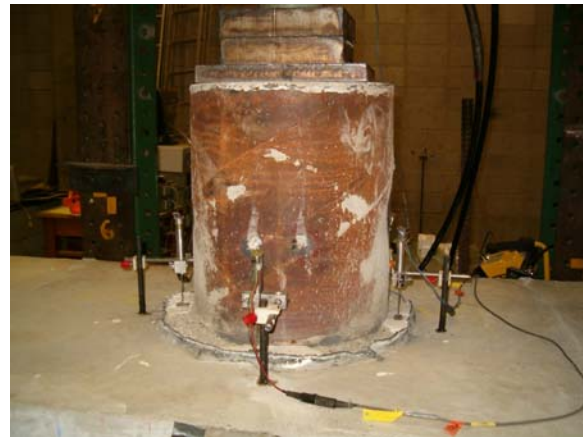
Figure 52 – Abutment Testing

Figure 53 – Loading H-Pile

Figure 55 – Loading Pipe Pile

A considerable amount of full scale testing was performed on various components of the bridge by ISU-BEC. The H-pile to abutment footing connection and the pipe pile to pier cap connection were load tested, shown in Figures 52, 53 and 55. Due to the limited capacity of the load frame, the testing of these connections was terminated at 400 kips without failure. Testing modeled various unfavorable construction conditions including offset of the piling in the CMP blockout and a reduction in the amount of concrete cast in the CMP blockout. Cracking in the test specimen was first observed at 160 kips. Figure 54 shows the crack

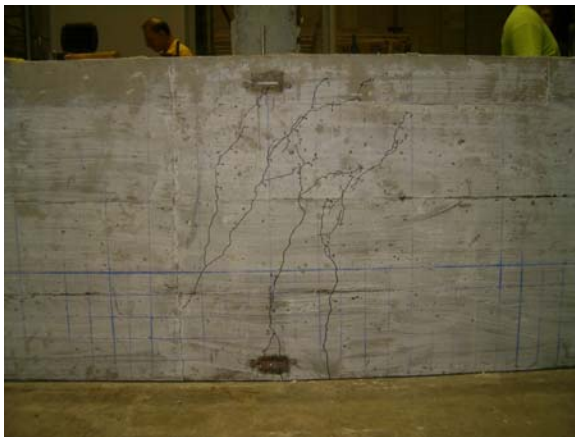
Figure 54 – Abutment Cracking

pattern observed at 400 kips. It is interesting to note that the structural capacity of the pile connection details exceeded the geotechnical capacity by a factor of over ten.

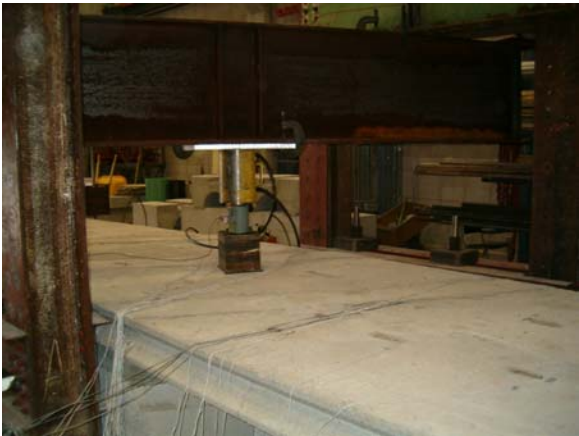
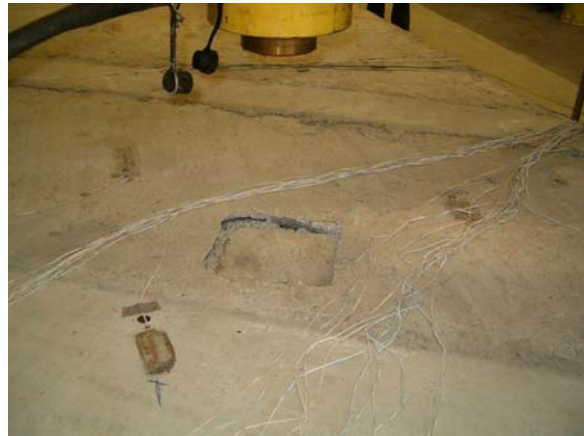
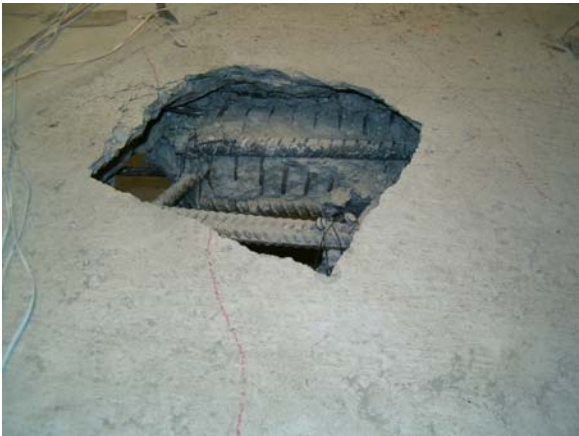
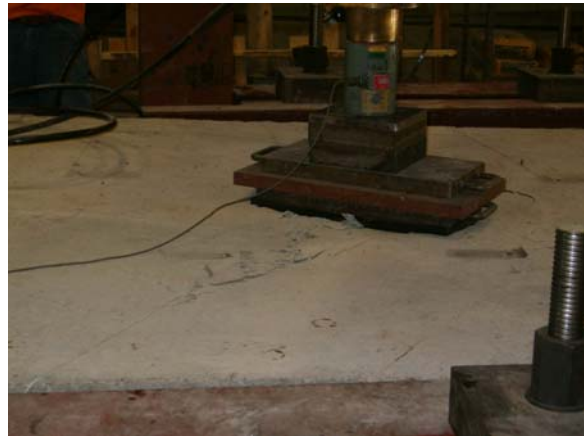
Figure 56 – Deck Panel Testing

Figure 57 – Panel Punching Failure

Figure 58 – Panel Punching Failure

Figure 59 – Panel Failure

Full scale deck panel testing was performed on the three deck panels purchased by ISU. Two panels were set up and the longitudinal joint at the center line of the bridge was cast modeling the full bridge width. For the full width configuration, three load tests were run (one in each span) to failure, shown in Figure 56. The load applicator footprint was varied and three different modes of failure were induced. The first was a pure punching shear failure at 150 kips, shown in Figures 57 and 58. The second failure was a combination of punching shear and flexural failure, shown in Figure 59. The final failure mechanism was a purely flexural failure mode induced by the application of a line load, shown in Figure 60. The flexural failure occurred at 196 kips of force being applied in a line load. When the line load was removed the panels rebounded to an undeflected shape due to the transverse prestressing.

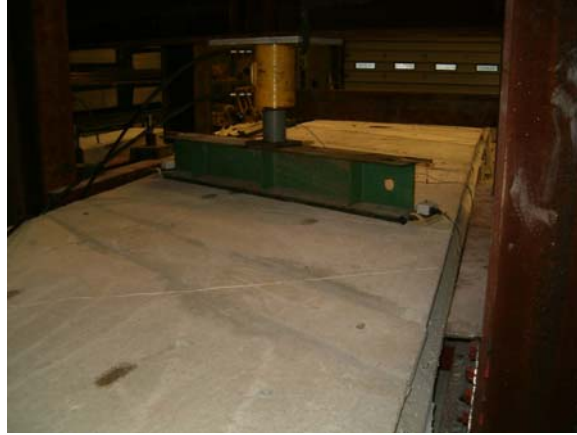
Figure 60 – Panel Line Load

A single panel was also tested to failure at mid span between two beams. The lack of restraint of the beams caused panel cracking at a line load of 153 kips and then continued to deflect and shed load. Deflection of up to 3 inches was observed before the test ended.

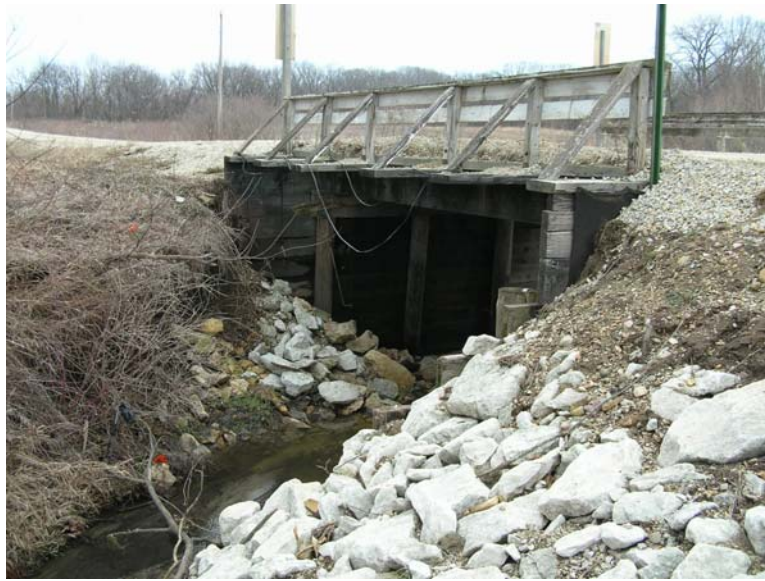
Figure 61 - Existing timber bridge carrying secondary road over small stream

Madison County selected a bridge site that carried a secondary road over a small stream, as shown in Figure 61. The existing bridge was a 21 ft single span structure with an out-to-out roadway width of 18 ft. The bridge, constructed in 1940, was founded on timber piles and had a timber backwall. The superstructure consisted of timber girders with a timber deck overlain with gravel. The railings were also timber.

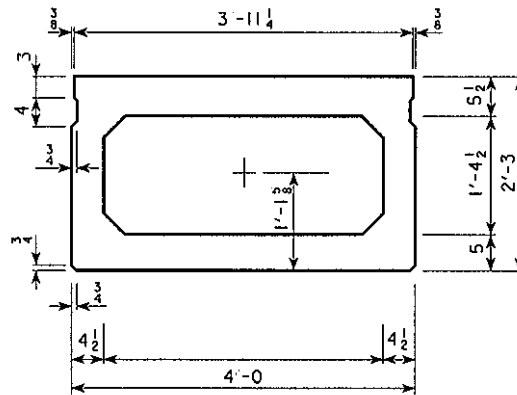
Figure 62 - Dimensions of the box beam section.

state's standard bridge design details, as shown in Figure 62. Box beams measured 4 ft wide by 2 ft – 3 in. deep. The deck cross-section was designed with a six box girder system, as shown in Figure 63, for an overall bridge width of 24 ft. The centerline to centerline of bearing was designed as a 46 ft – 8 in. simple span per AASHTO Standard Specifications for Highway Bridges, 17<sup>th</sup> Edition. The box beams were designed with a longitudinal keyway between adjacent box beams that would later be filled with a non-shrink grout, creating a mechanism to transfer load from one beam to another.

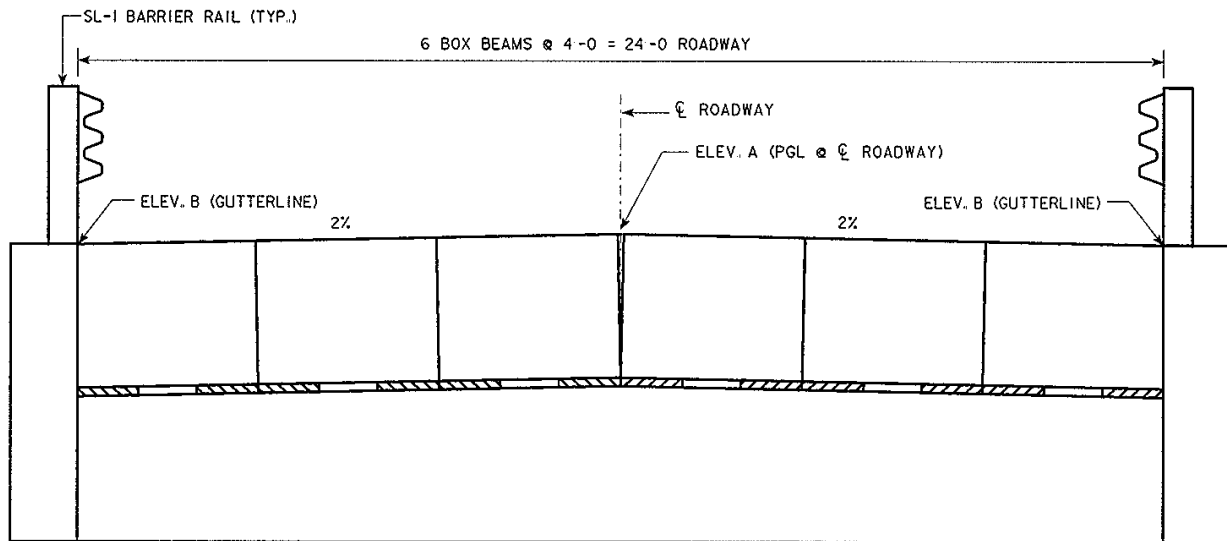
Figure 63 - Cross-section of the replacement bridge

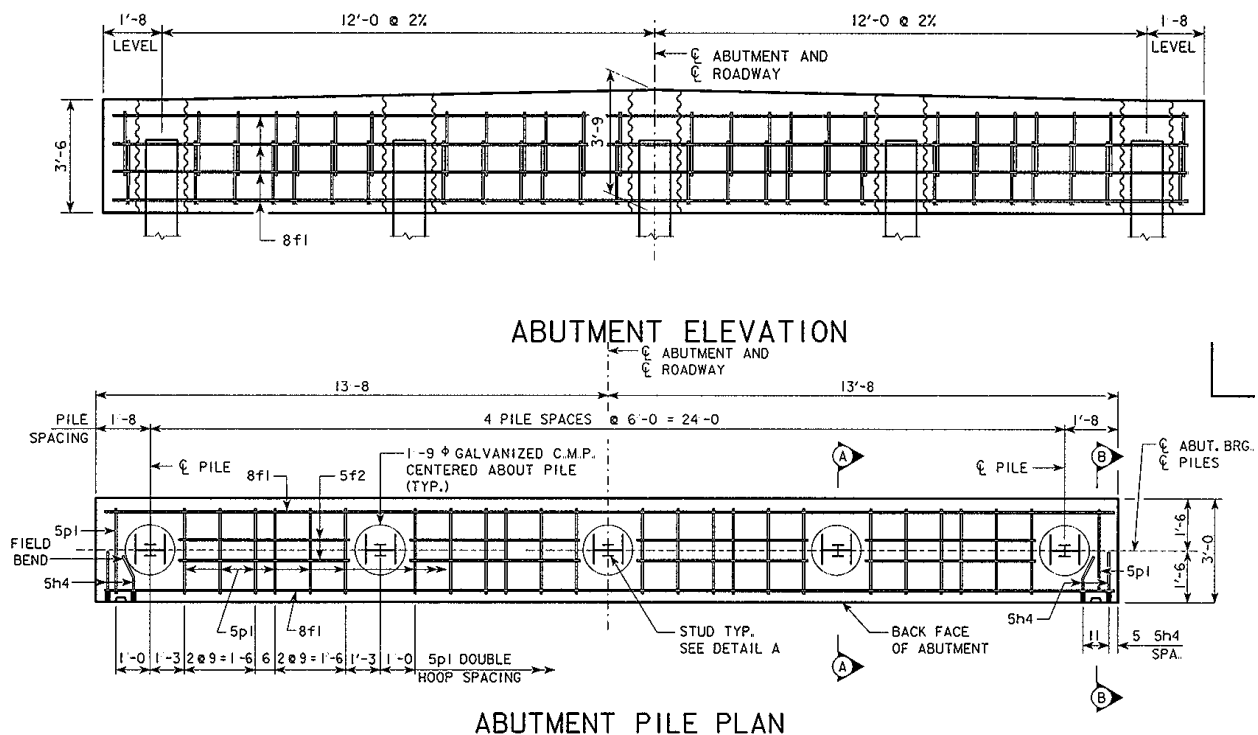
Figure 64 - Plan and elevation views of the precast abutment footing

The bridge abutments were adapted from the Iowa Department of Transportation's standard integral abutment details with the exception that 21 in. diameter corrugated metal pipe (CMP) were inserted in the precast concrete abutment at the pile locations as shown in Figure 64. The design then called for shear studs to be welded to the steel pile and the void in the 21 in. diameter CMP to be filled with a concrete mix specially designed for high early strength. This detail was similar to the one used for the Mackey Bridge..

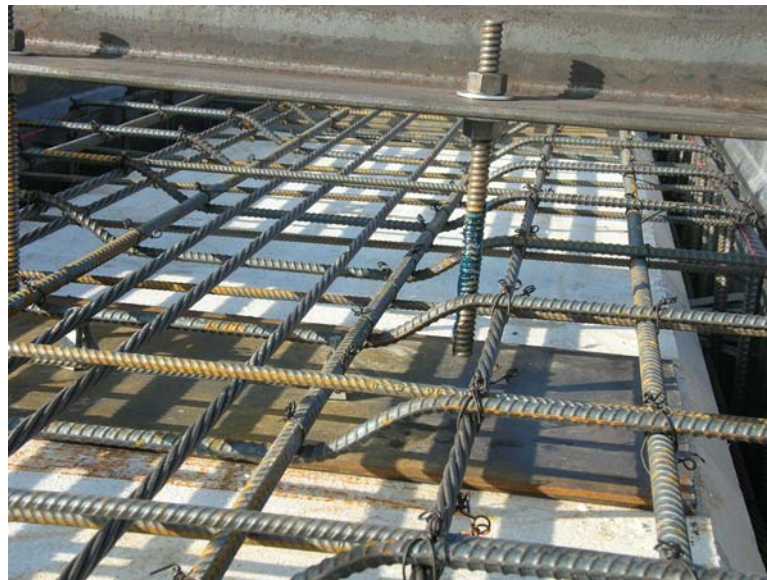
Figure 65 - Detail of Styrofoam insert and hold down system developed by the precaster

Shop drawings for the precast concrete elements, the box beams and abutments, were approved on October 3, 2006. The precaster then created two forms for the box beams and a single form for the precast abutment. The first two box beams were cast on November 17, 2006, with the remaining castings done in the weeks thereafter. The box beams were cast in steel forms on an outdoors casting bed. Styrofoam was used to create the void in the box beams, which led to the precaster having to construct heavy framing to prevent the Styrofoam from floating during casting, as shown in Figure 66. A high slump concrete mix was used to ensure that the concrete would fill the void beneath the foam insert, as shown in Figure 66. A textured surface was raked in to form the riding surface of the box beams.

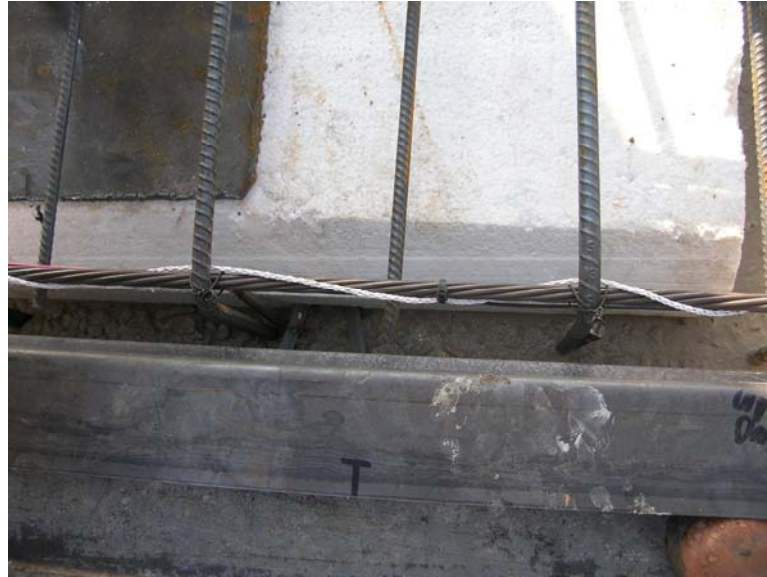
Figure 67 - Corrosion sensor installed on production box beam

Iowa State University installed numerous corrosion sensors on the precast box beam prestressing strands, as shown in Figure 67, to monitor their performance in the field. Other states have had box beam failures due to the corrosion of prestressing strands and have increased inspections of box beam bridges. Documented box beam section failures typically occur on paved roadways where heavy use of deicing chemicals is common. Given that the bridge is being built on a low volume secondary road, the use of deicing chemicals is not expected.

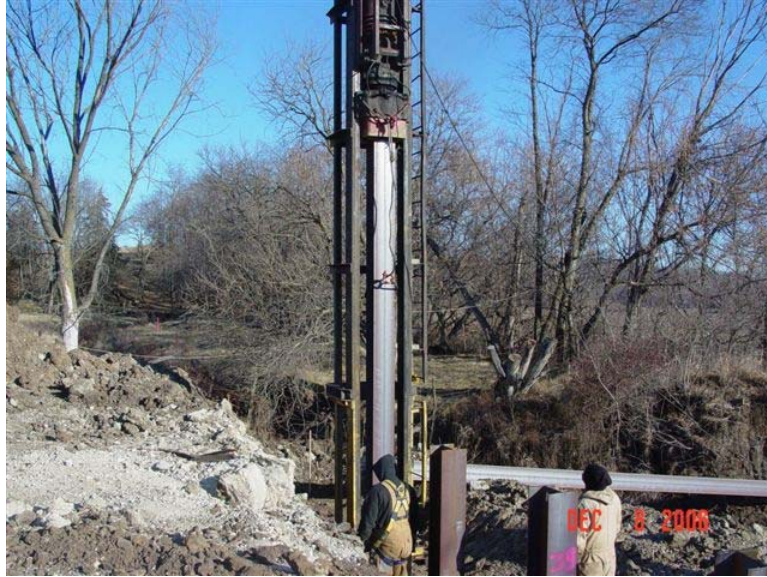
Figure 68 - Driving of steel H-pile at the west abutment

Steel bearing H-piles were driven at the east abutment on December 5, with the piling being cutoff to the proper elevation and shear studs installed the following day. The east precast abutment was also placed at this time. The steel H-pile driving for the west abutment occurred on December 8, as shown in Figure 68. Following placement of the precast abutments, the voids under the abutment footing were filled with flowable mortar to create a solid platform between the precast abutment and the earth below it. The CMP voids, shown in Figure 69, for the pile to precast abutment footing were cast the week of December 11. Following the casting of the CMP voids, final shaping of the berm slopes was completed and engineering fabric and rip rap were placed to protect the berms.
