## **ACCELERATED CONSTRUCTION IN IOWA**

### **ABSTRACT**

## **MACKEY BRIDGE**

## MADISON COUNTY BRIDGE

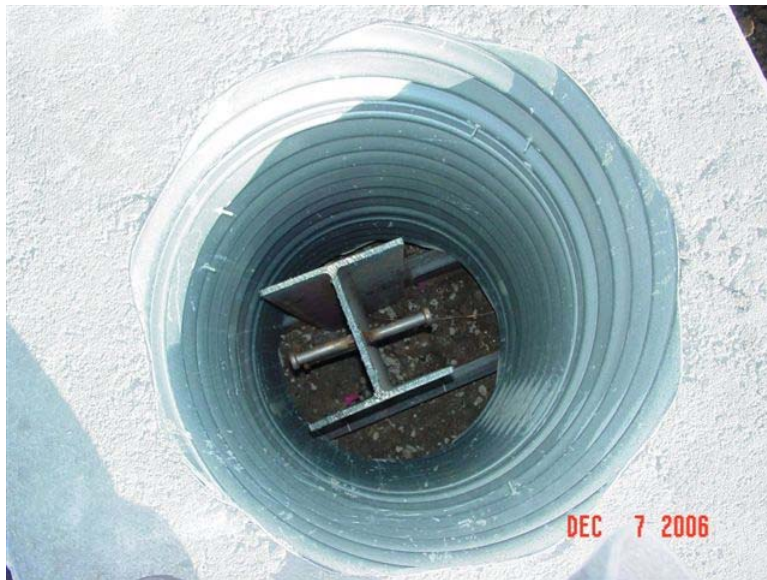
Figure 69 - Detail of the pile to abutment connection

Steel bearing H-piles were driven at the east abutment on December 5, with the piling being cutoff to the proper elevation and shear studs installed the following day. The east precast abutment was also placed at this time. The steel H-pile driving for the west abutment occurred on December 8, as shown in Figure 68. Following placement of the precast abutments, the voids under the abutment footing were filled with flowable mortar to create a solid platform between the precast abutment and the earth below it. The CMP voids, shown in Figure 69, for the pile to precast abutment footing were cast the week of December 11. Following the casting of the CMP voids, final shaping of the berm slopes was completed and engineering fabric and rip rap were placed to protect the berms.

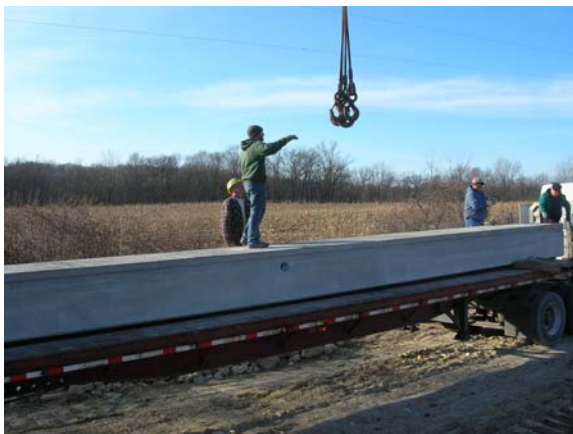
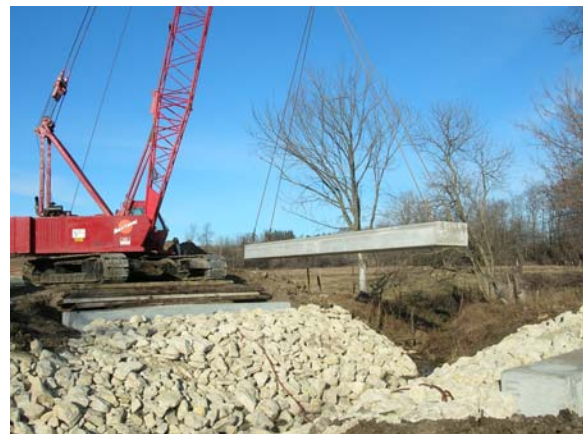
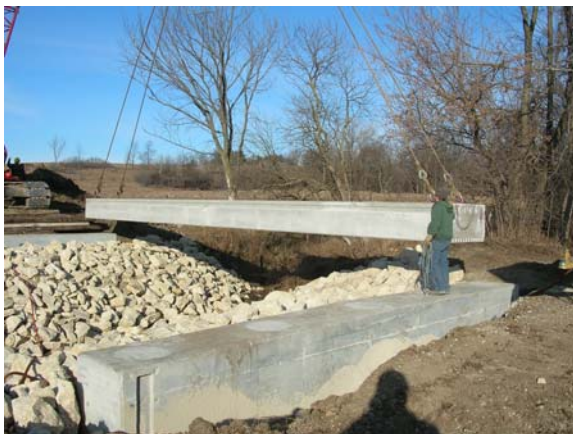
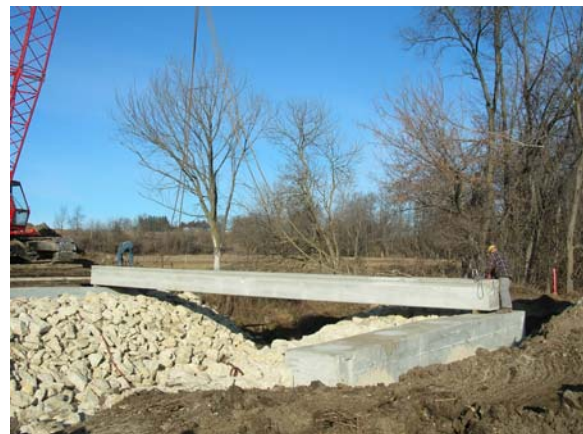
Figure 70 - Photographic timeline of typical box beam placement

By December 15, the precaster had completed casting four of the box beam sections and shipped them to the job site. The contractor was able to pick and place a box beam in 15 minutes, as illustrated in Figure 70. With time built in for detailed placement of the box beam sections, all four sections were placed in their final position in a matter of 90 minutes.

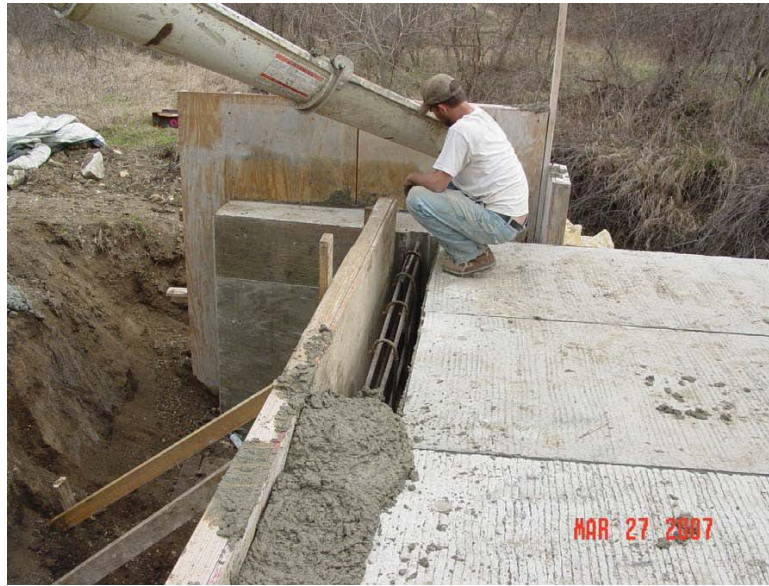
Figure 71 - Contractor placing backwall on the precast abutment

The contractor moved back on to the job site March 26, 2007. During the winter, Madison County requested that a cast-in-place backwall be placed on top of the precast abutment. The designer developed details for this plan change and the contractor began this work their first day back on site. The contractor formed and placed the backwall on March 27, as shown in Figure 71.

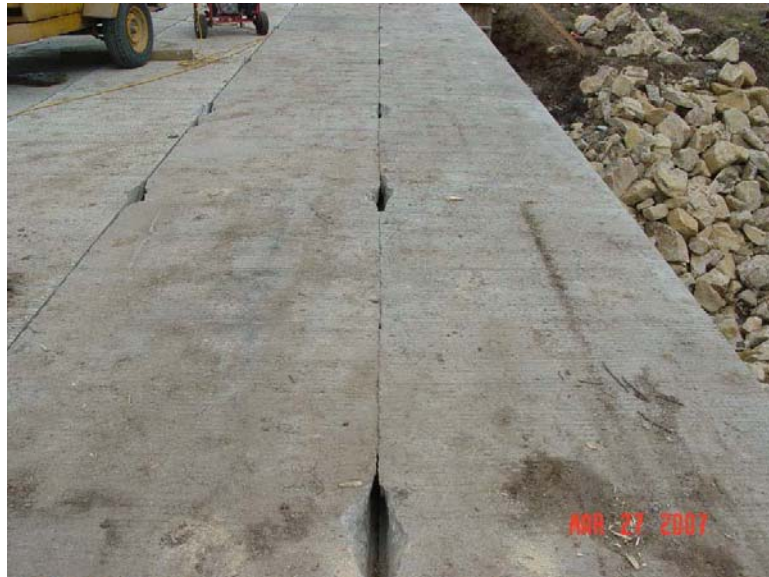
Figure 72 - Longitudinal joint showing contractor's increased width along span

Longitudinal joint grouting was complicated due to the tight fit of the precast box sections. The contractor elected to “widen” the longitudinal joints at regular intervals along the length of the span, as shown in Figure 72, to assist in the placement of the non-shrink grout. The contractor completed longitudinal joint casting March 29.

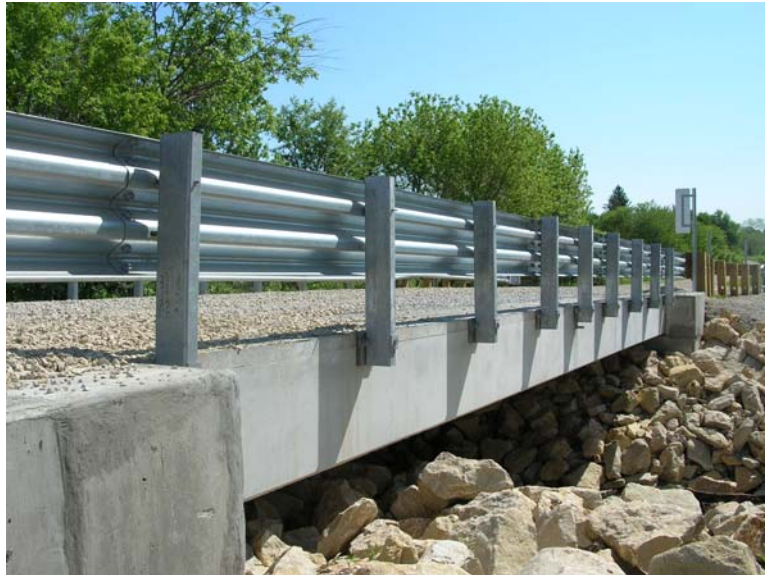
Figure 73 - Profile view of completed bridge

The final bridge, as shown in Figure 73, was the result of a collaborative effort of many individuals from many different fields. While the time from start of construction to opening of road may have been four and a half months, the actual time the contractor spent on the site and working was only four and a half weeks. Traditional construction for a continuous concrete slab or beam bridge of this size would typically be two months. Everyone involved with the project was pleased with the outcome and the final bridge project.
