Identification of Practices, Design, Construction, and Repair Using Trenchless Technology

Final Report
October 2010

IOWA STATE UNIVERSITY
Institute for Transportation

Sponsored by
Iowa Highway Research Board
(IHRB Project TR-570)
Iowa Department of Transportation
(InTrans Project 07-288)

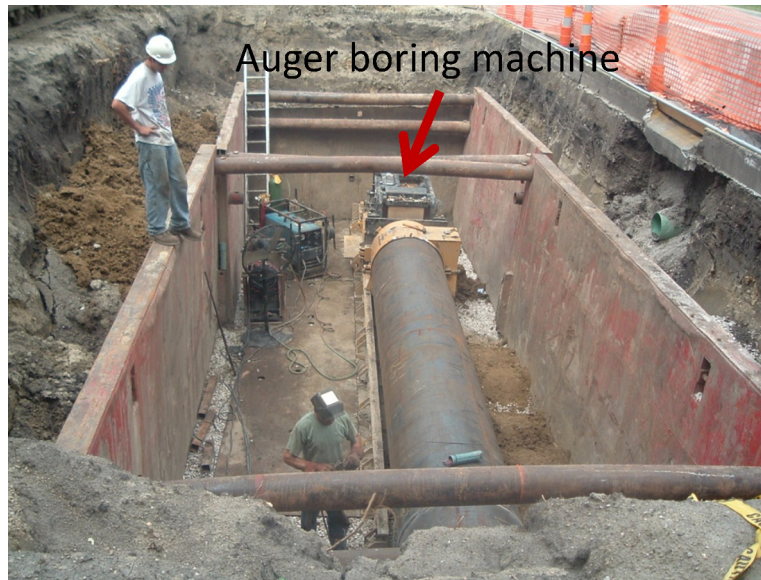
Figure 2.2. Launching pit with auger boring machine installing pipe

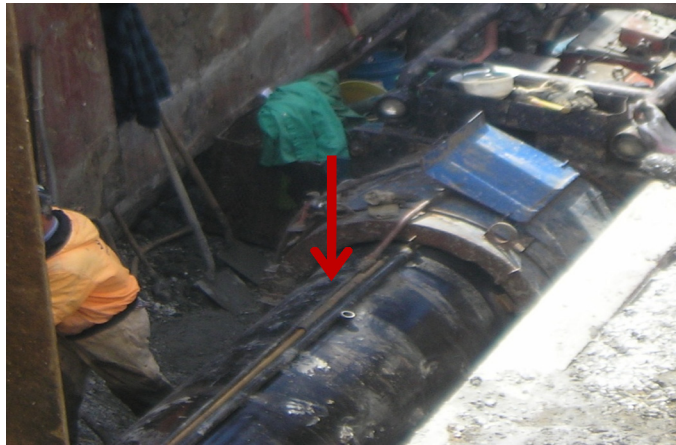
Figure 2.4. Waterline grade measurement pipe, steering rod, and fluid supply pipe attached to top of casing

The machinery may possess varying degrees of steering capability. The most basic types of auger boring operations have limited line and grade control and rely heavily on the initial setup of the track to launch the bore in the proper direction. This operation requires constructing a stable thrust block and foundation for the track. Generally, three small-diameter metal pipes are attached to the top of the casing as it is augered into the soil (see Figure 2.4). The first small pipe is used for a basic waterline system to measure grade. The second small pipe is a fluid supply line that can be used in case it becomes necessary to deliver grout or water to the cutting face. Water may be needed if sticky clay is encountered, and grout may be necessary to fill voids outside of the casing caused by the excessive inflow of water and sand into the pipe. The third small pipe is a steering rod that allows the cutting head to pivot up and down. The steering rod is the most common method used to steer during installation (ASCE 2004), although it allows little horizontal maneuvering. Some horizontal steering can be achieved by attaching a piece of metal

called a “wing” to the side of the casing to induce the pipe to veer in the desired direction as it is jacked.

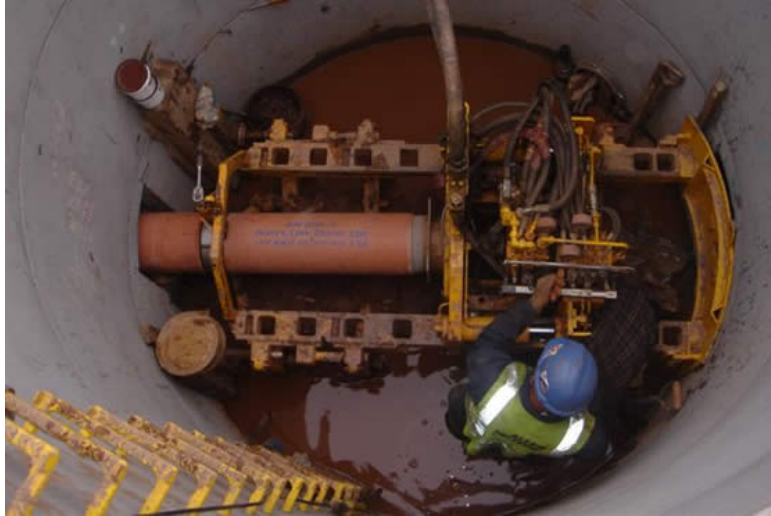
Figure 2.5. Vitrified clay pipe being installed using guided auger boring (from Allen Watson, Ltd.)

Once the cutting head has emerged in the retrieval pit, a larger diameter auger boring system is connected to the last section of drill rod and jacked into the soil. Attaching the auger boring cutting head to the pilot bore drill string ensures that the path followed by the pilot bore will also be followed by the auger bore. As with conventional auger boring, no drilling fluid is necessary. Additional sections of casing and auger are connected in the launching pit as the bore progresses. The auger bore enlarges the hole to a diameter slightly larger than that of the pipe to be installed. Once the cutting head emerges in the retrieval pit, a section of product pipe is connected one by one to the casing and jacked into place, while the auger and casing sections are simultaneously removed at the retrieval pit (see Figure 2.5).

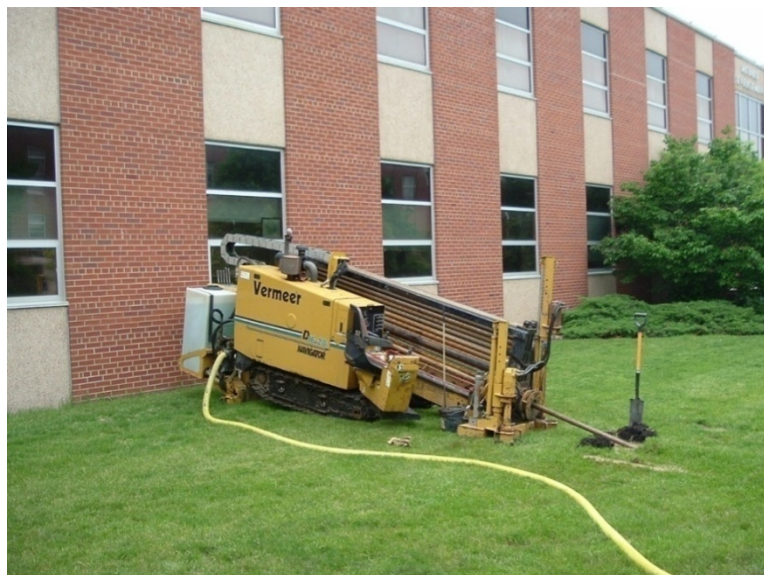
Figure 2.10. Directional drilling machine

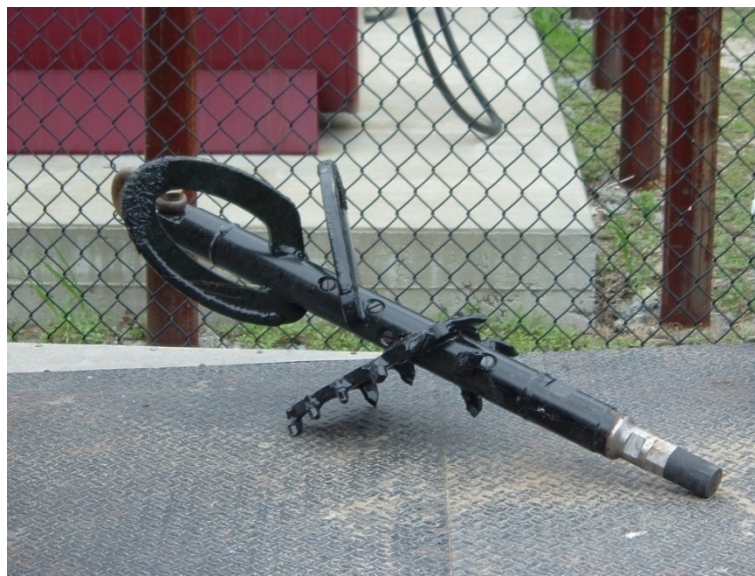
Figure 2.13. Reamer with 14-inch-diameter

Once the initial pilot hole has been completed and the drill bit has emerged into the exit pit, it will be replaced with a reamer (also called a “back reamer”) (see Figure 2.13) that will be rotated and pulled back toward the drilling machine. This process will both enlarge the hole and smooth any sharp bends that may have occurred while drilling the pilot hole. The back reaming may be completed in one pass or in several passes with reamers of progressively larger diameters. The product pipe will be attached to the reamer before the final pullback to complete the installation of the pipe (see Figure 2.14). Typically, product pipe pullback is the operation that causes the highest pullback stresses, due to the friction between the product pipe and the wall of the borehole. (Najafi, 2005)

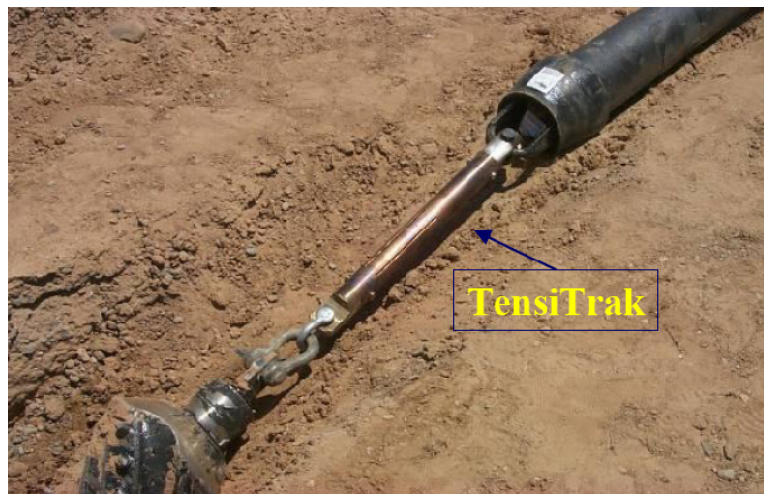
Figure 2.15. Weak-link device (trade name “TensiTrak”) (NASTT 2005)

Project specifications require a weak-link device to be attached between the reamer and product pipe during installation. A weak-link protects the pipe from excessive tensile stresses. Newer equipment is also available, such as the “TensiTrak” device, that measures the pullback forces and reports the results to the operator (see Figure 2.15). American Society for Testing and Materials (ASTM) pipe standards are used to determine the allowable tensile load for setting weak-link devices.

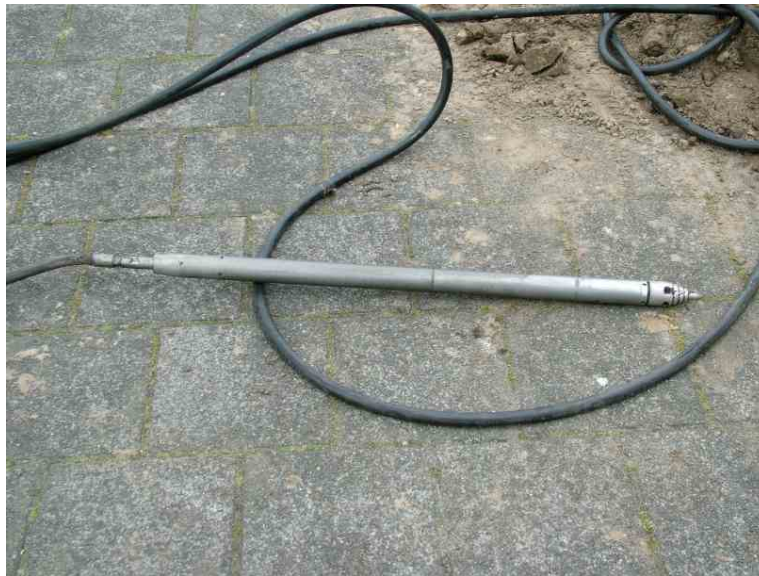
Figure 2.18. Impact mole

No soil is removed during impact moling. Instead the mole compresses the soil in front of the device, resulting in lateral soil deformation as the bore is advanced (see Figure 2.18). This makes impact moling suitable for compressible soils. Similarly, impact moling can be inappropriate in stiff soils that resist deformation and unsuitable for loose sands and gravels because of the

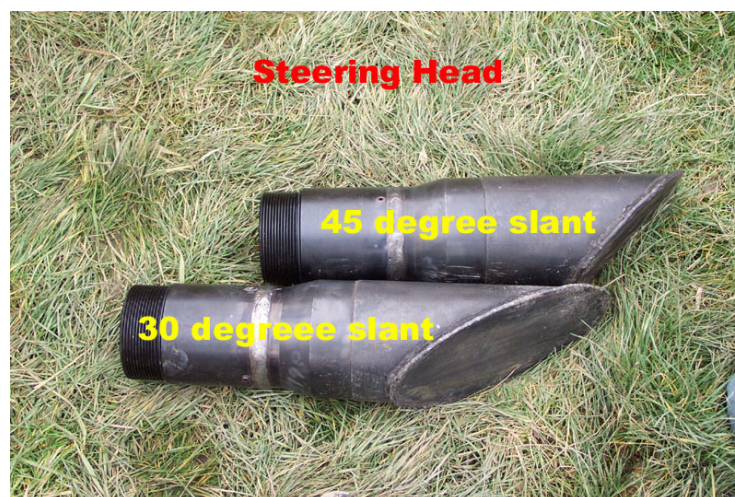
Figure 2.20. PTMT steering heads (Purdue University)

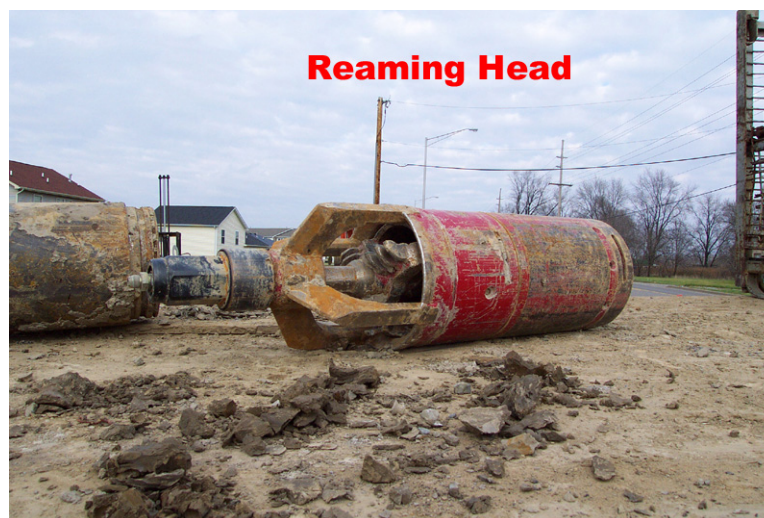
Figure 2.21. PTMT reamer (Purdue University)

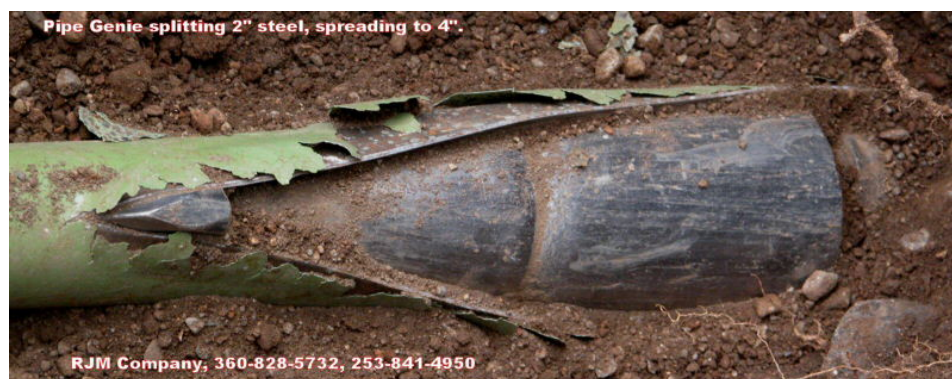
Figure 2.25. Pipe splitting (RJM Company)

Pipe splitting is a variation of pipe bursting used for ductile pipes, such as steel and ductile iron. Instead of using a bursting head that fractures the pipe radially, pipe splitting uses a splitter, which cuts the existing pipe along one line on the bottom side, slicing it open rather than fracturing it (see Figure 2.25). The pipe is then expanded outward as the tapered splitter is pulled through (Chapman et al. 2005).

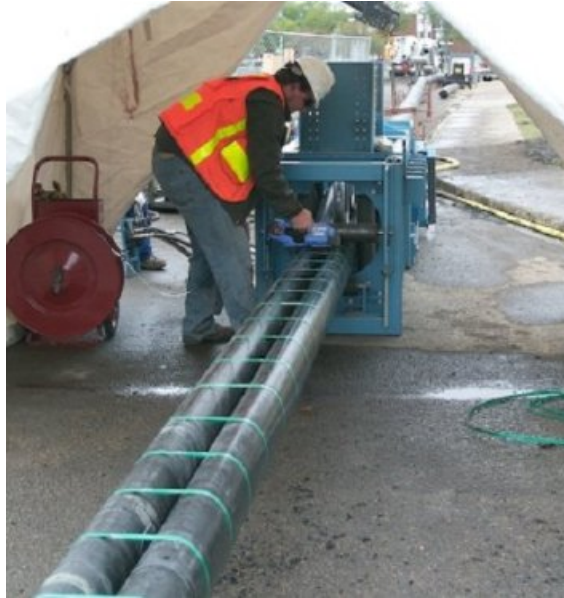
Figure 2.26. Close-fit pipe (Insituform Technologies Inc.)

This method reduces the size of the new pipe before it is installed inside the damaged pipe (see Figure 2.26). After installation, the new pipe is expanded back to its original size and shape to provide a close fit with the original pipe. The new pipe can be designed to serve either structural or nonstructural purposes. (Barber et al. 2005)

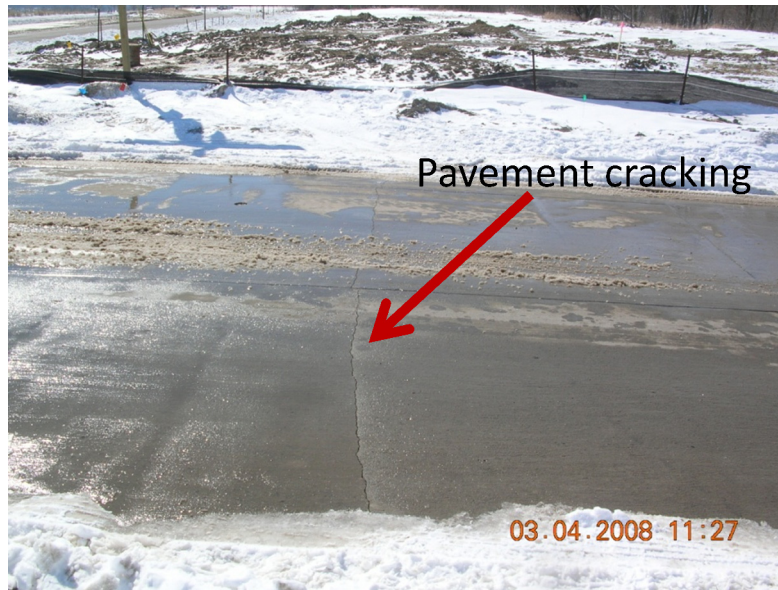
Figure 3.15. Pavement cracking caused by HDD installation

On another HDD project, a problem was encountered when a reamer was lost 15 feet underground. An example of pavement cracking resulting from a shallow HDD bore is shown in Figure 3.15.

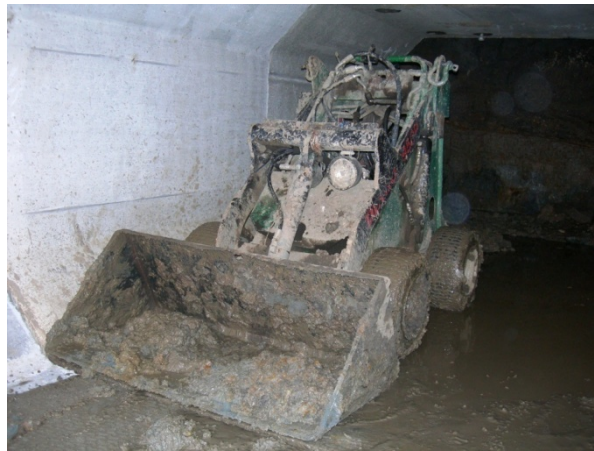
Figure 4.17. Skid loader used to move spoil from pipe to trench box to be removed by backhoe

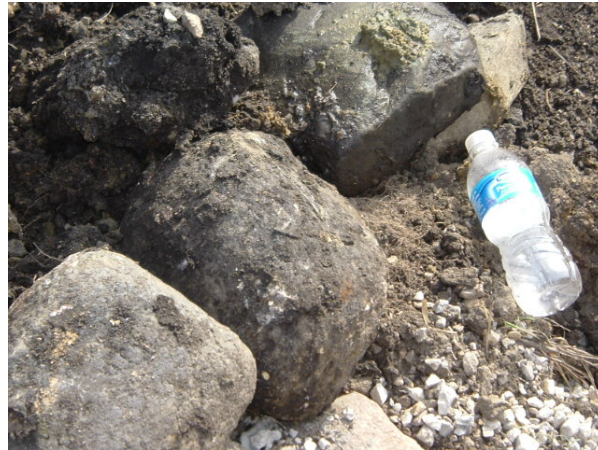
Figure 4.23. Boulders removed from the borehole (12 to 18 inches in diameter)

TBM was jacked into the bore to advance the excavation. A large number of glacial boulders between 12 and 18 inches in diameter that were encountered significantly slowed progress (see Figure 4.23). A much larger quantity of these boulders was found than had been expected. The reason they were found at such a high concentration and close to the surface is likely because past highway construction practices allowed boulders to be included in the fill.

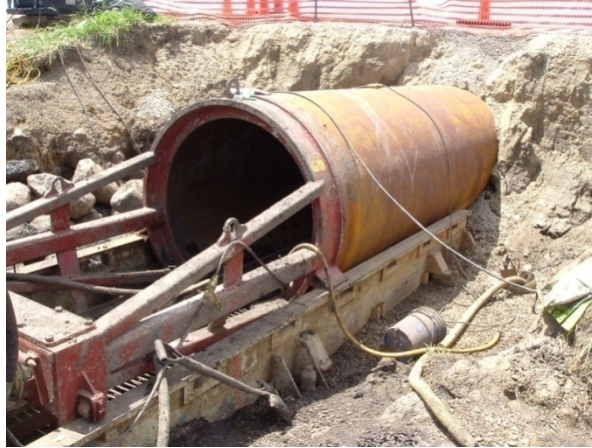
Figure 4.24. Pipe being jacked into the soil behind the TBM

The pipe sections were attached behind the TBM and jacked into the borehole as the TBM was advanced (see Figure 4.24). The pipe sections were each 20 feet in length and were welded together. The drill head was 14 feet long.

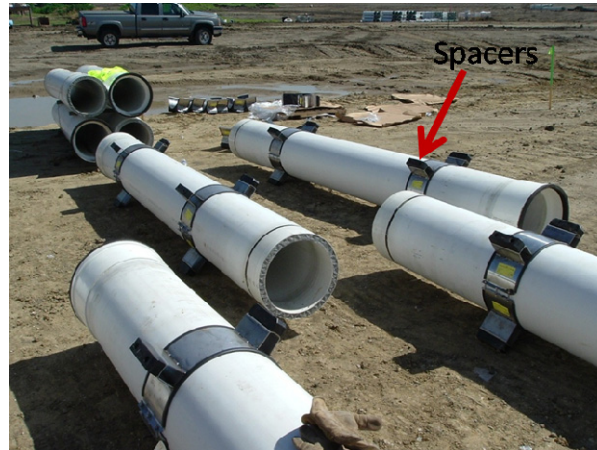
Figure 4.32. PVC carrier pipe with visible spacers

After the last section of steel casing pipe was placed, the PVC carrier pipe was installed. Casing spacers were fastened to the PVC pipe to allow it to “float” in the casing and correctly position the carrier pipe (see Figure 4.32). The PVC pipe was then placed in the casing using a backhoe. This completed the pipeline. No additional problems were encountered on this project, and no surface heave or settlement was observed.

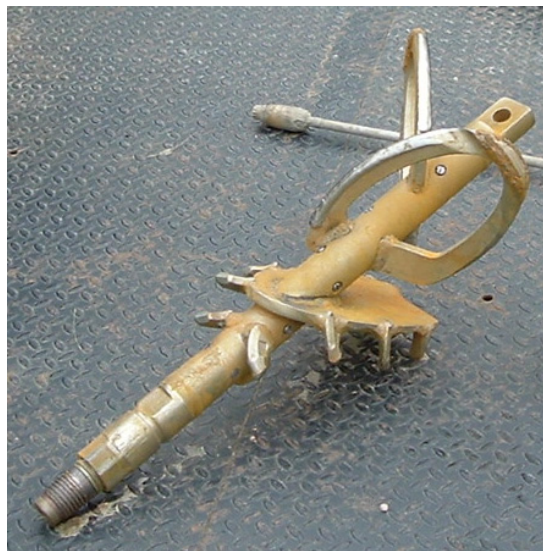
Figure 4.37. Twelve-inch-diameter reamer

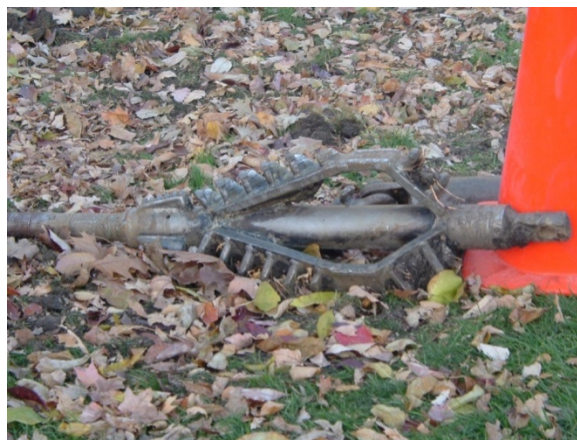
Figure 4.61. Fourteen-inch reamer

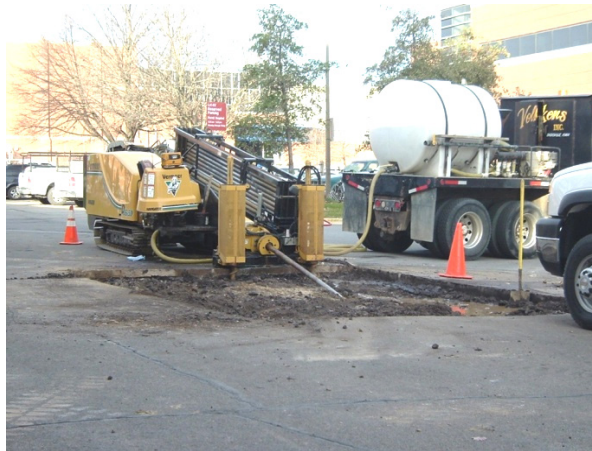
Figure 4.77. Directional drilling machine

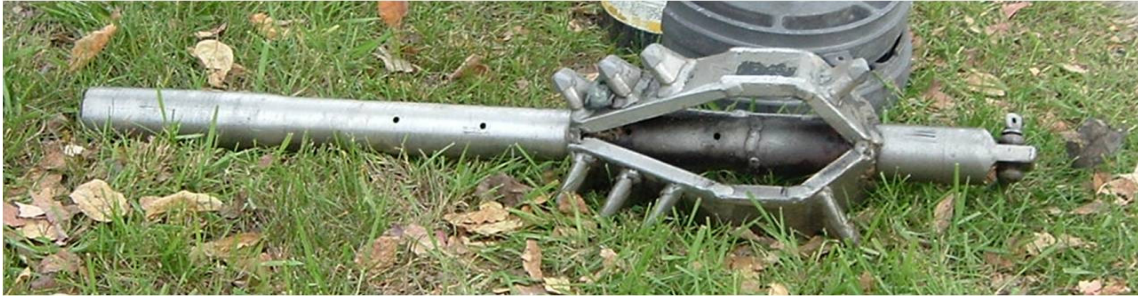
Figure 4.78. Ten-inch reamer

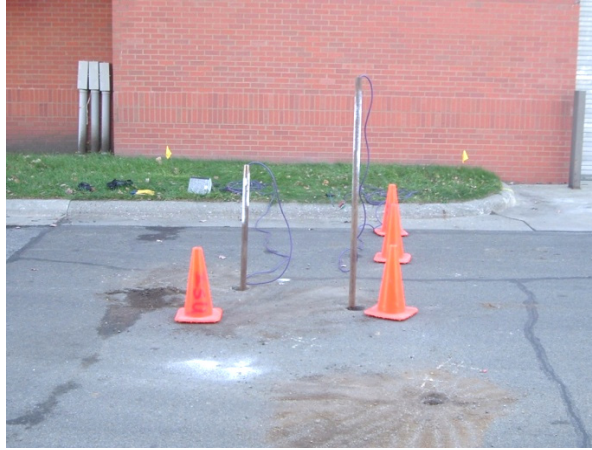
Figure 4.82. Push-in pressure cells in place at point B (looking south)

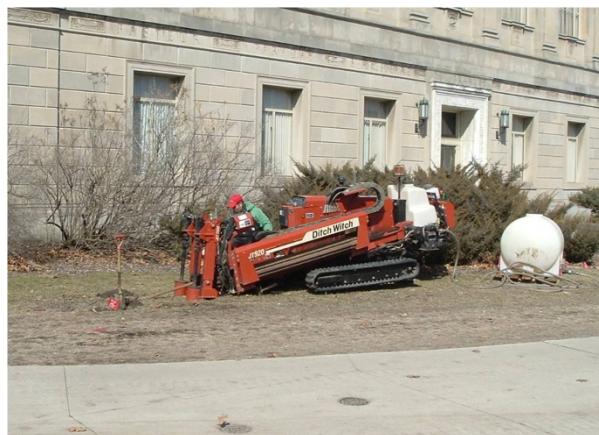
Figure 4.87. Directional drilling machine

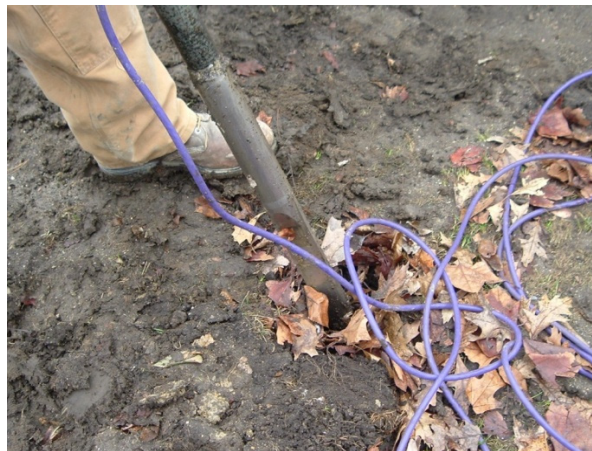
Figure 4.91. Push-in pressure cells being removed

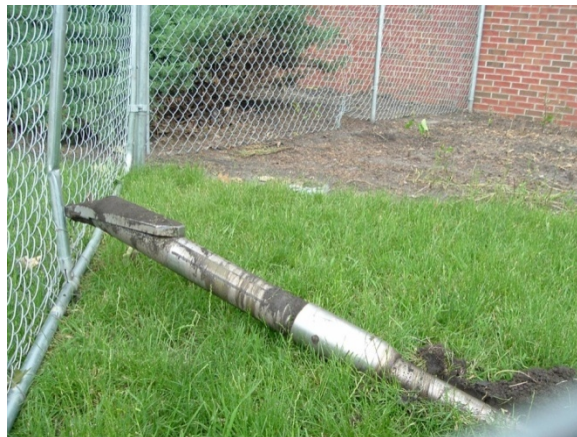
Figure 4.100. Drill bit (5-inch diameter) emerging at point A

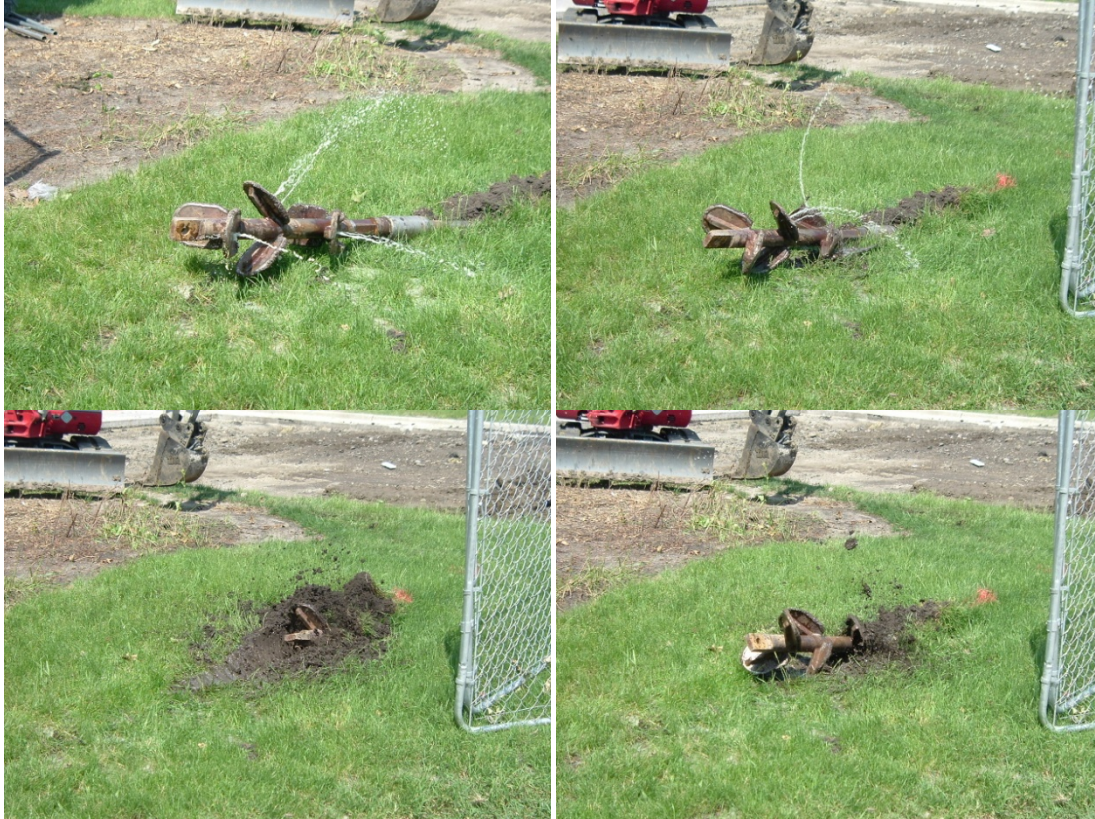
Figure 4.101. Reamer (14-inch diameter) pulled into borehole at point A (clockwise from upper left)

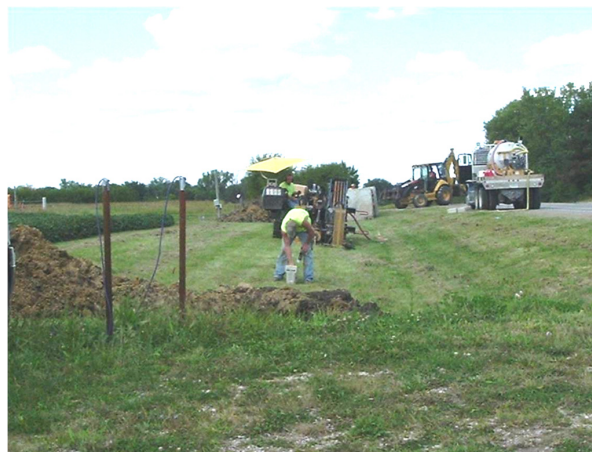
Figure 4.128. Bore approaching two pressure cells

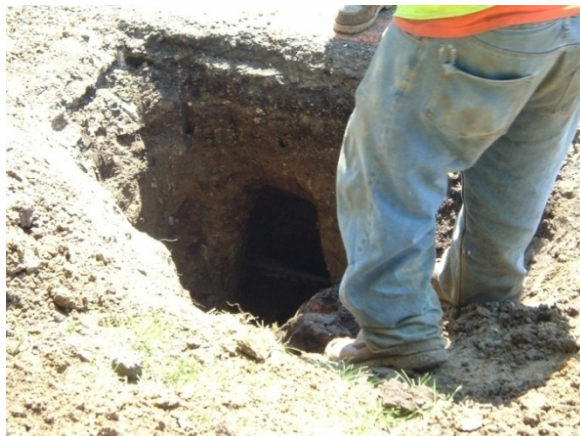
Figure D.2. Potholing by edge of pavement

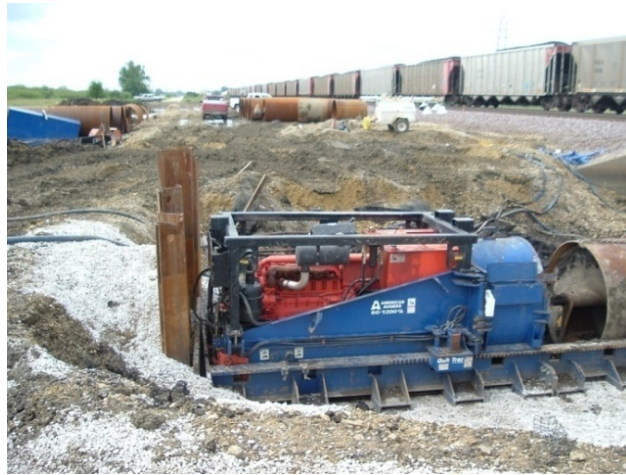
Figure D.27. Auger boring machine on its track against the sheet pile thrust block

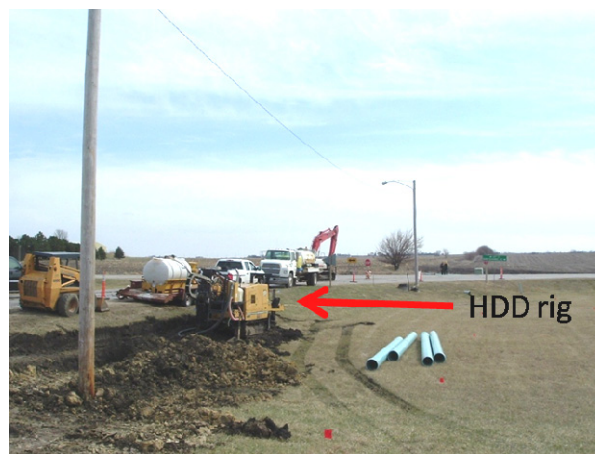
Figure D.37. The directional drilling machine

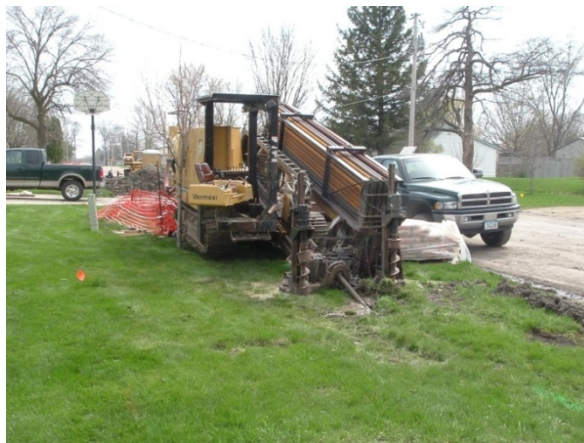
Figure D.43. The directional drilling machine
