Ames Municipal Airport

Pavement Management Report

JULY 2023

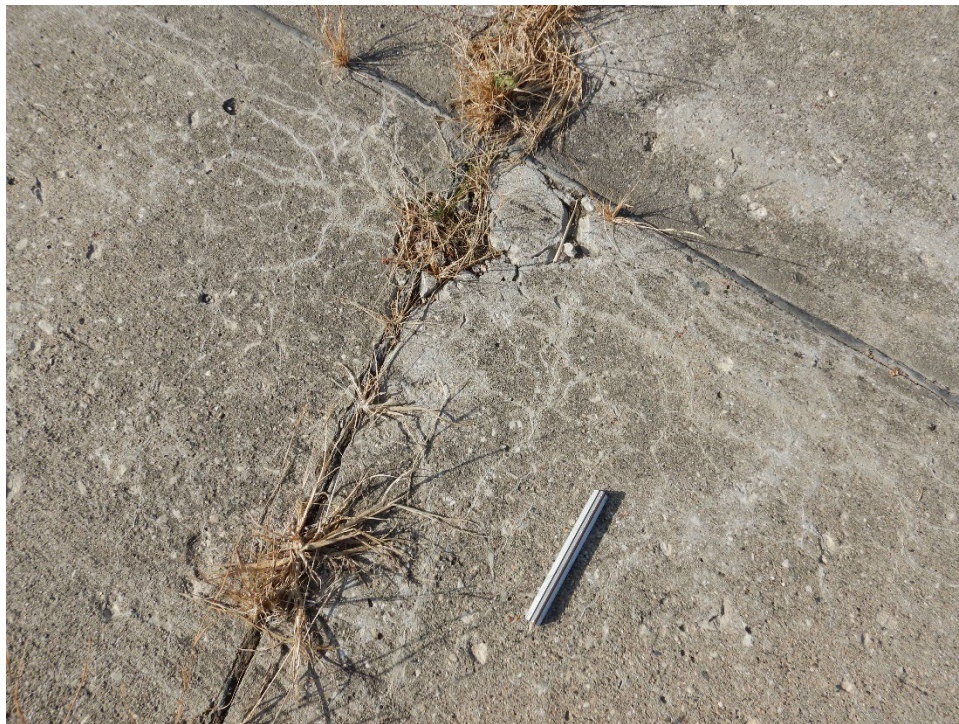
T01AM-01. ASR (Sample Unit No. 05).

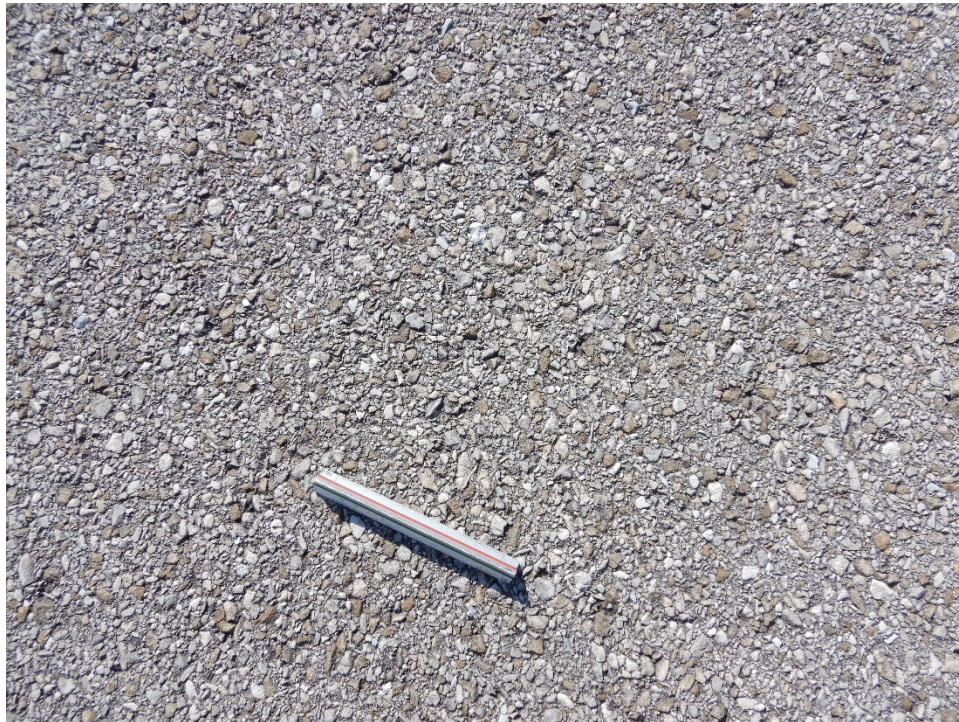
T01AM-02. Weathering (Sample Unit No. 04).

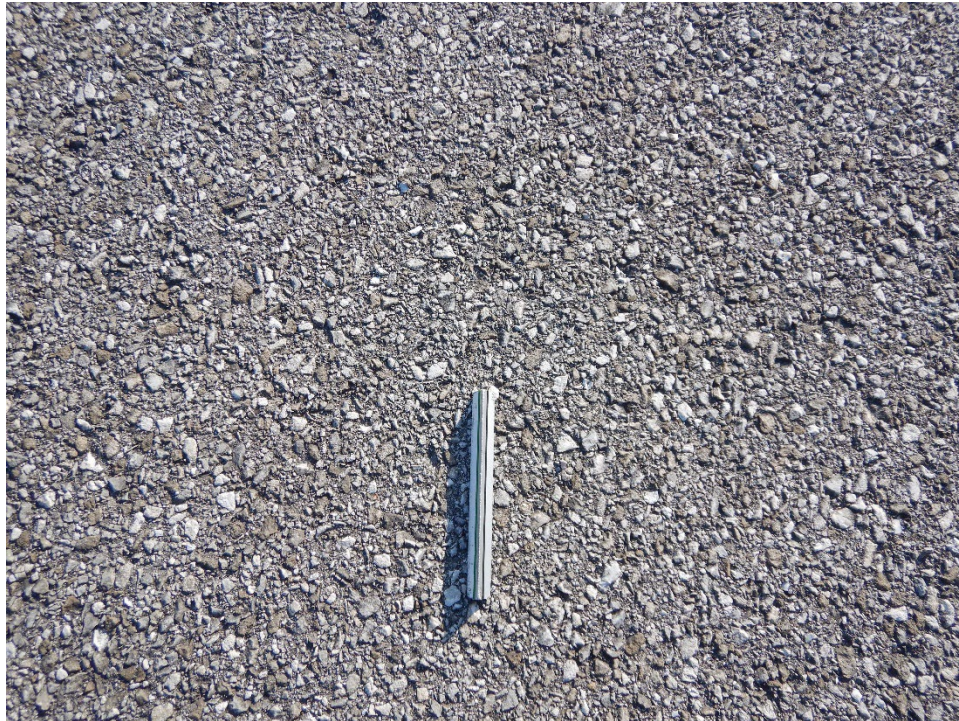
T01AM-03. Weathering (Sample Unit No. 01).

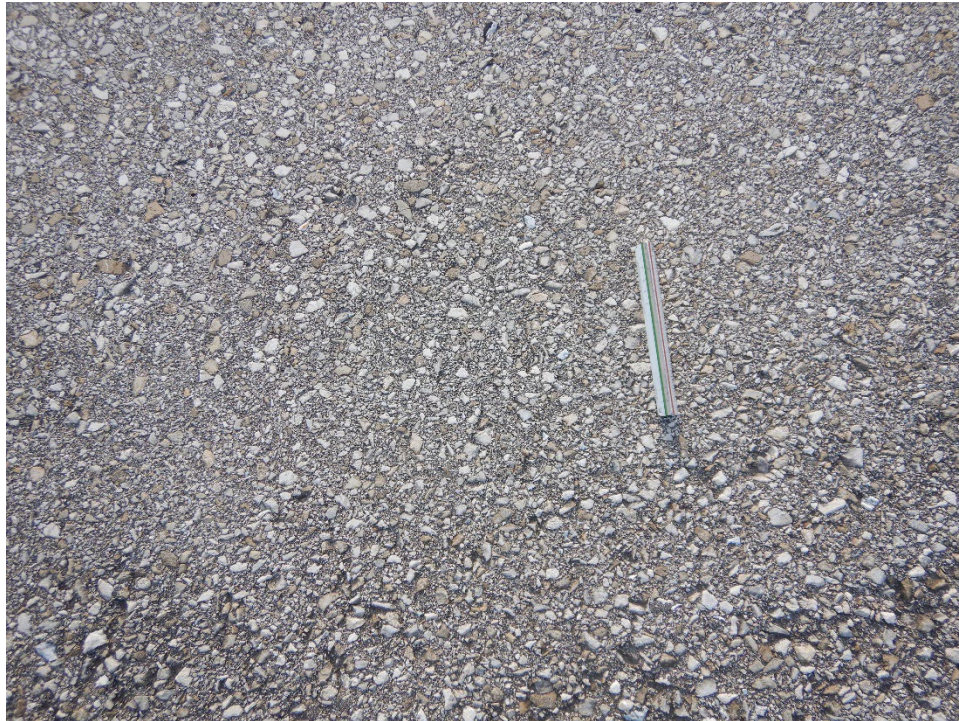
T02AM-03. Weathering (Sample Unit No. 01).

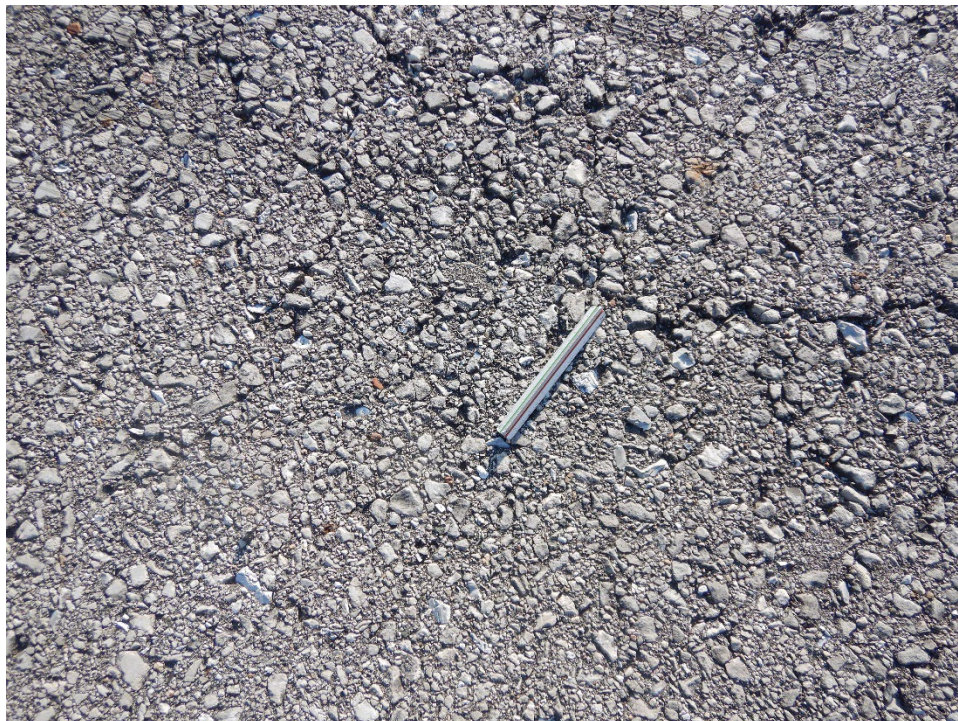
T02AM-04. Weathering (Sample Unit No. 10).

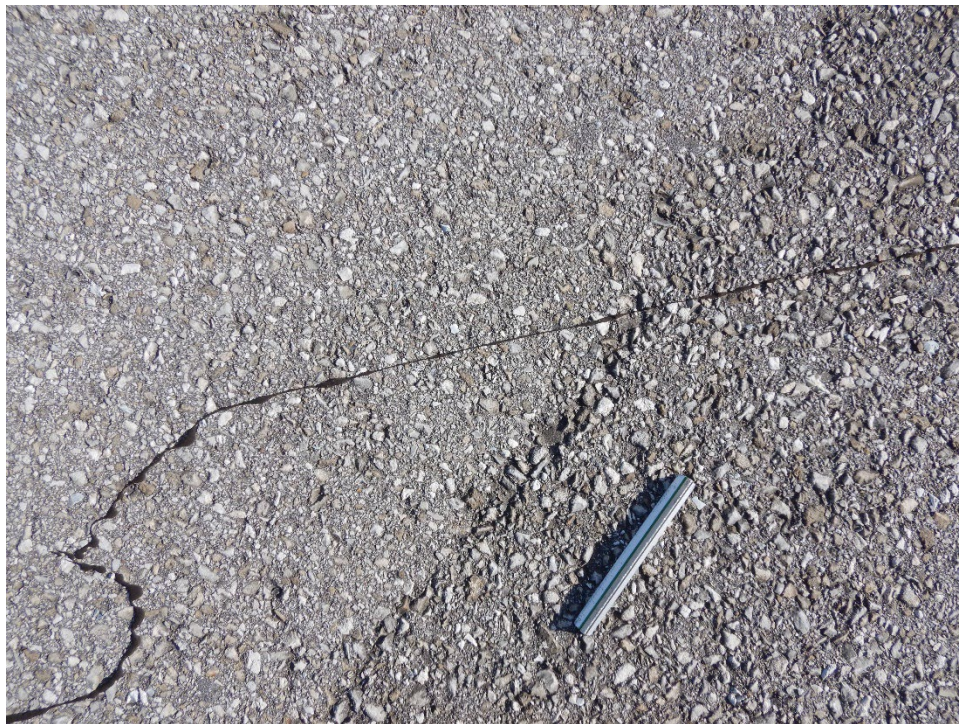
T03AM-02. Weathering (Sample Unit No. 01).

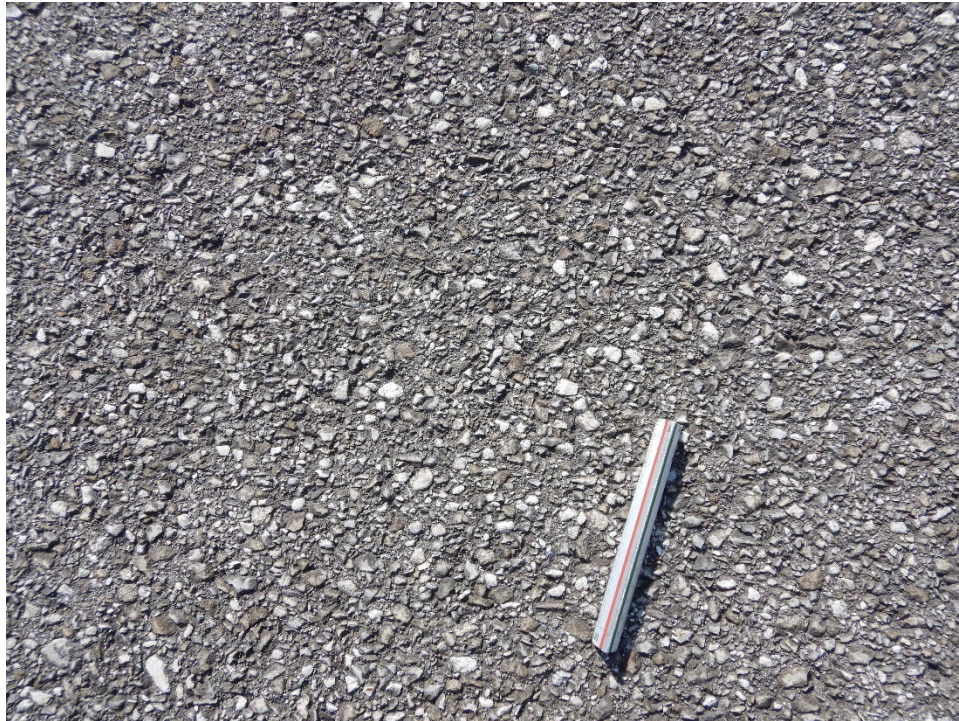
T04AM-01. Weathering (Sample Unit No. 01).

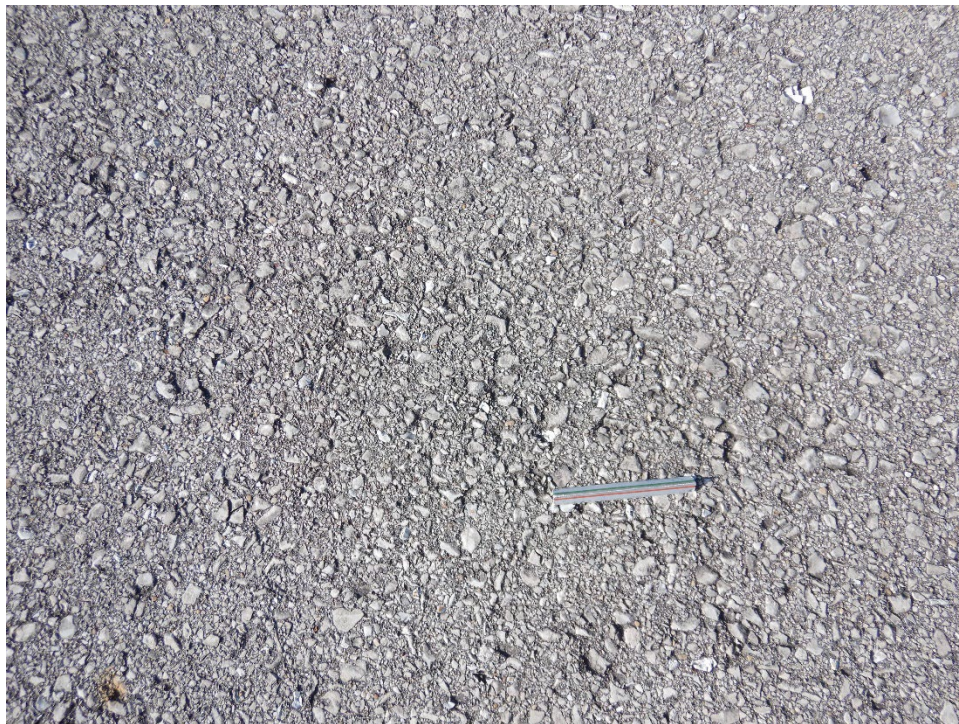
T05AM-01. Weathering (Sample Unit No. 01).

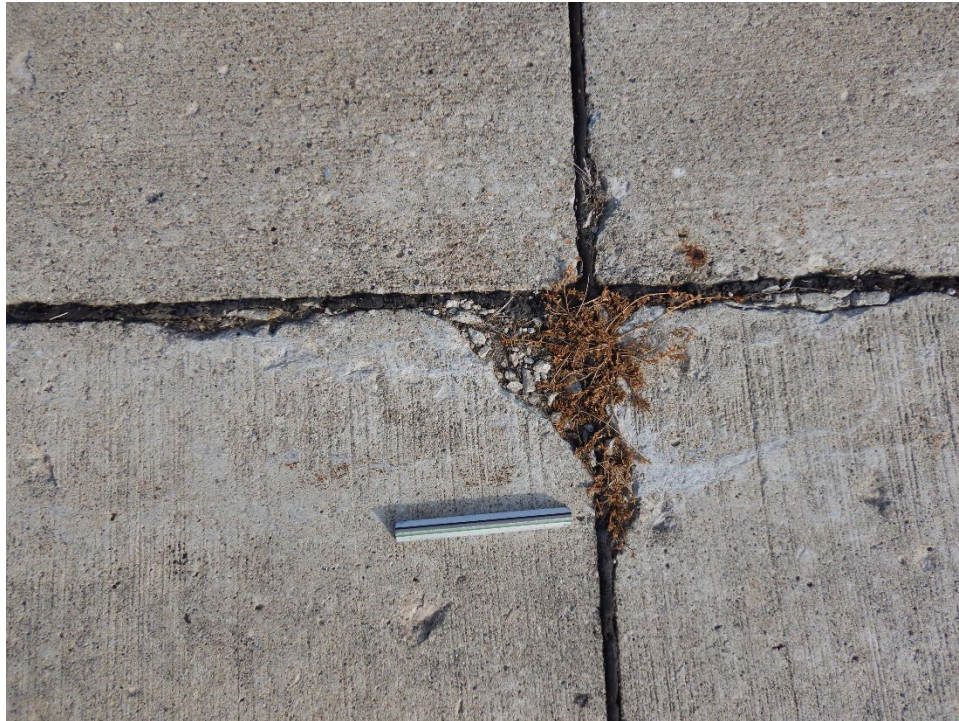
T12AM-01. ASR (Sample Unit No. 04).

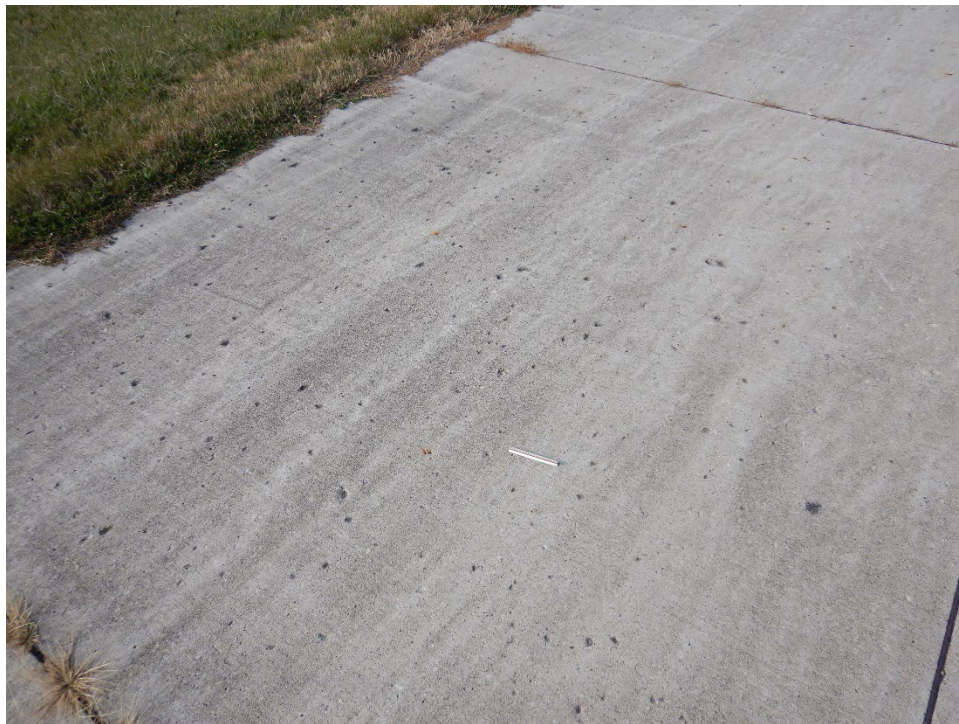
T12AM-01. Popouts (Sample Unit No. 04).

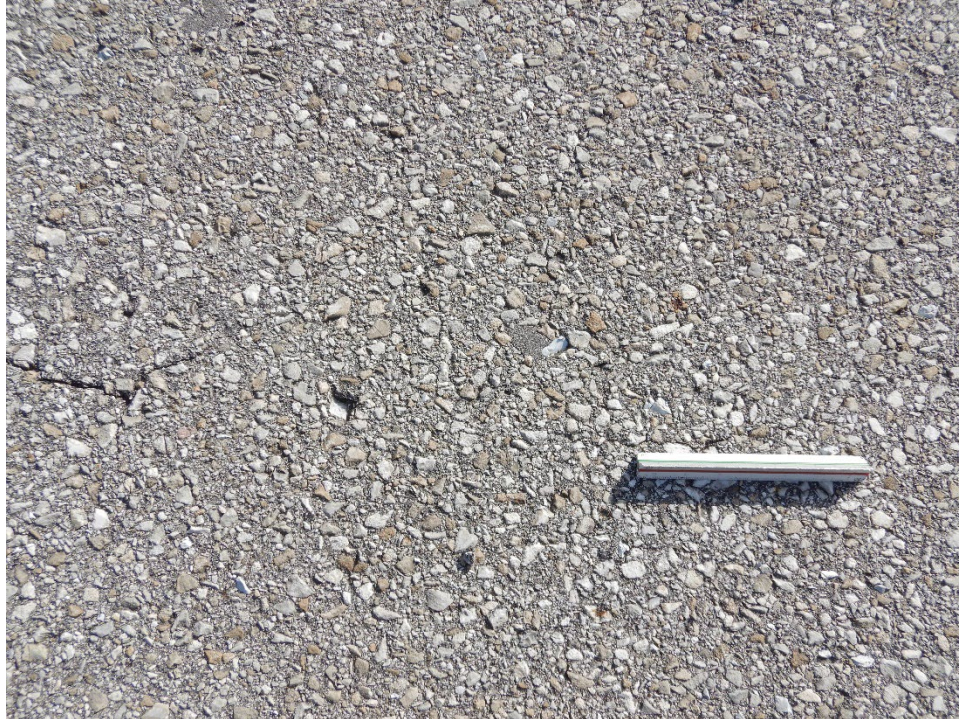
T12AM-02. Weathering (Sample Unit No. 01).

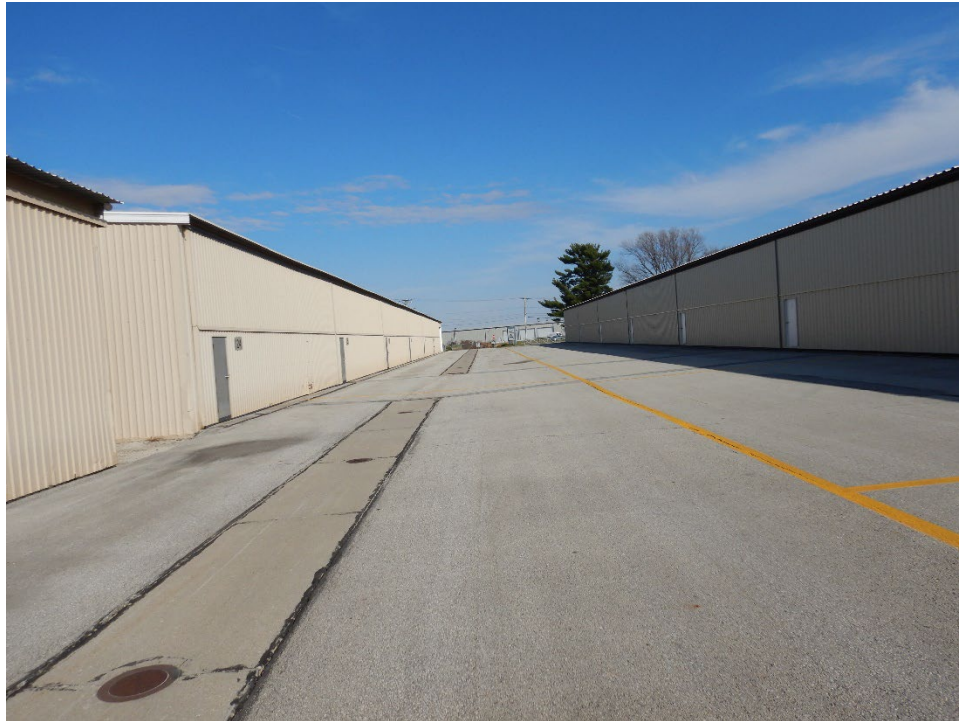
TH01AM-01. L&T Cracking (Sample Unit No. 07).

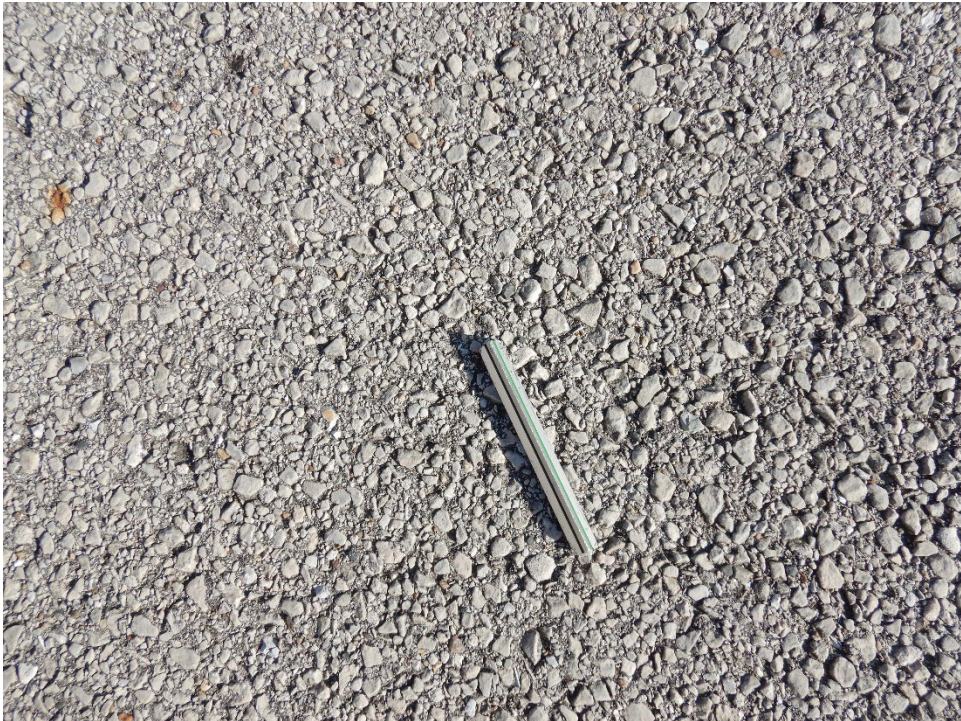
TH01AM-01. Weathering (Sample Unit No. 07).
