Southeast Iowa Regional Airport

PAVEMENT MANAGEMENT REPORT

AUGUST 2019

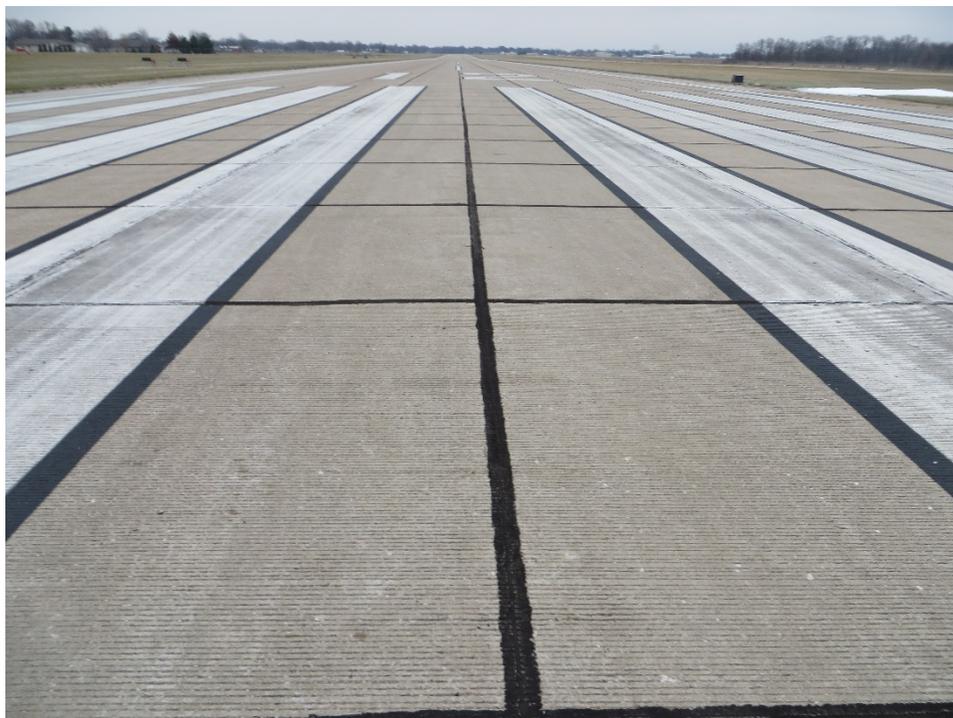
R12BR-01. Overview.

Runway 12/30, the secondary runway, consisted of four sections. Section 01 had high-severity joint seal damage recorded along with isolated amounts of low-severity longitudinal, transverse, and diagonal (LTD) cracking and shrinkage cracking. Low-severity ASR, medium-severity corner spalling and joint spalling, and high-severity joint seal damage were observed in Section 02. Section 03 had low-severity, unsealed block cracking, high-severity raveling located at the edge of the pavement, and low-severity rutting, shoving, raveling, and weathering identified. Low-severity block cracking, raveling, shoving, and weathering were recorded in Section 04. The block cracking was unsealed.

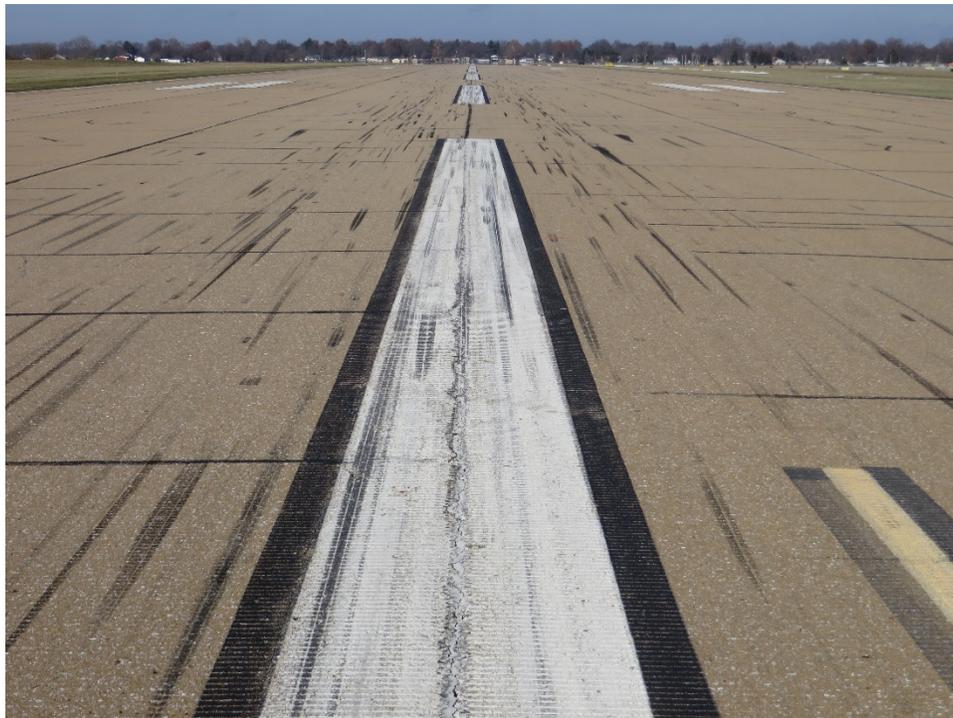
R18BR-01. Overview.

Runway 18/36 was defined by two sections. Low- and medium-severity block cracking and longitudinal and transverse (L&T) cracking, medium-severity joint reflection cracking, all severities of raveling, and low-severity swelling, patching, and weathering were observed in Section 01. The low-severity cracking was either sealed or unsealed, and the medium-severity cracking was due to either unsealed crack widths greater than 1/4 in or unsatisfactory crack sealant. Section 02, the runway extension located at the Runway 36 approach, had medium-severity joint reflection cracking and L&T cracking due to either unsealed crack widths that exceeded 1/4 in or unsatisfactory crack sealant, low-severity, unsealed L&T cracking, and low-severity raveling and weathering identified.

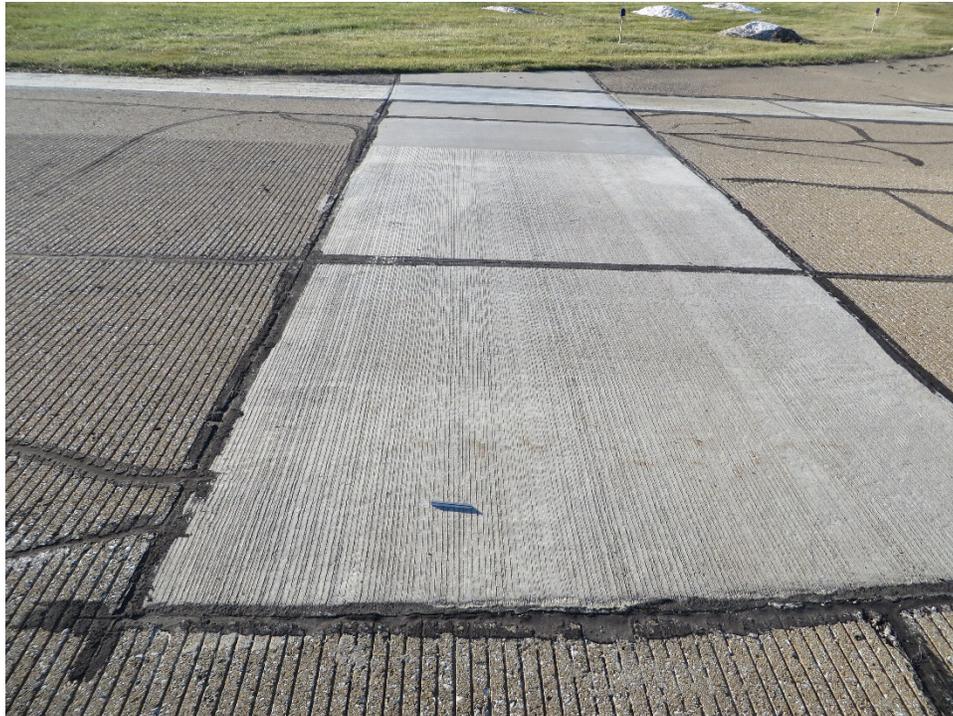
R18BR-01. Patching (Sample Unit No. 43).

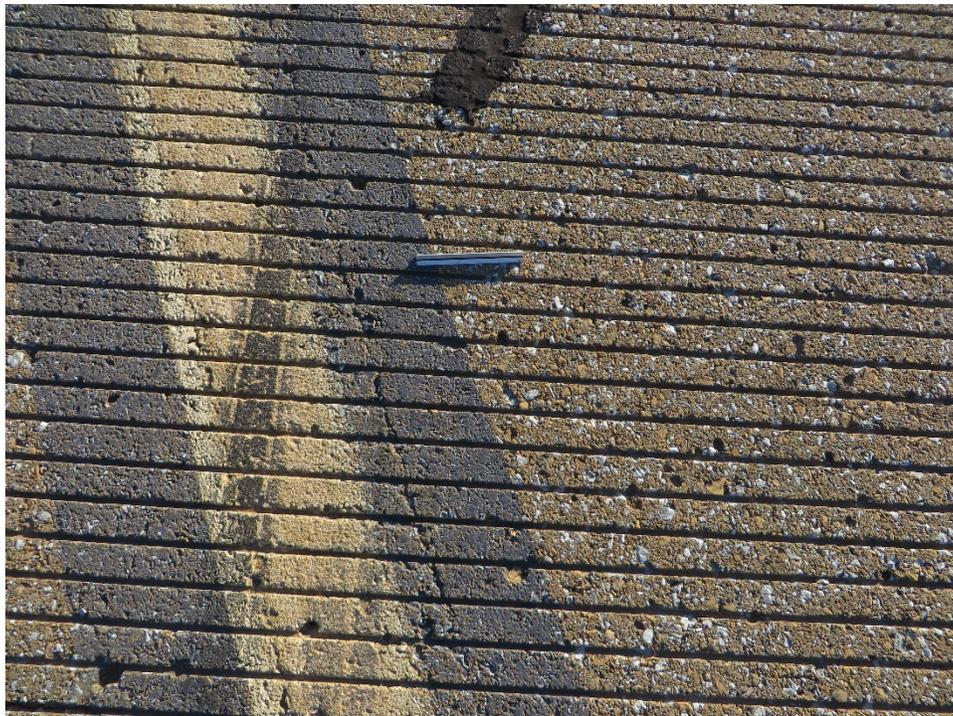
R18BR-01. Raveling (Sample Unit No. 43).

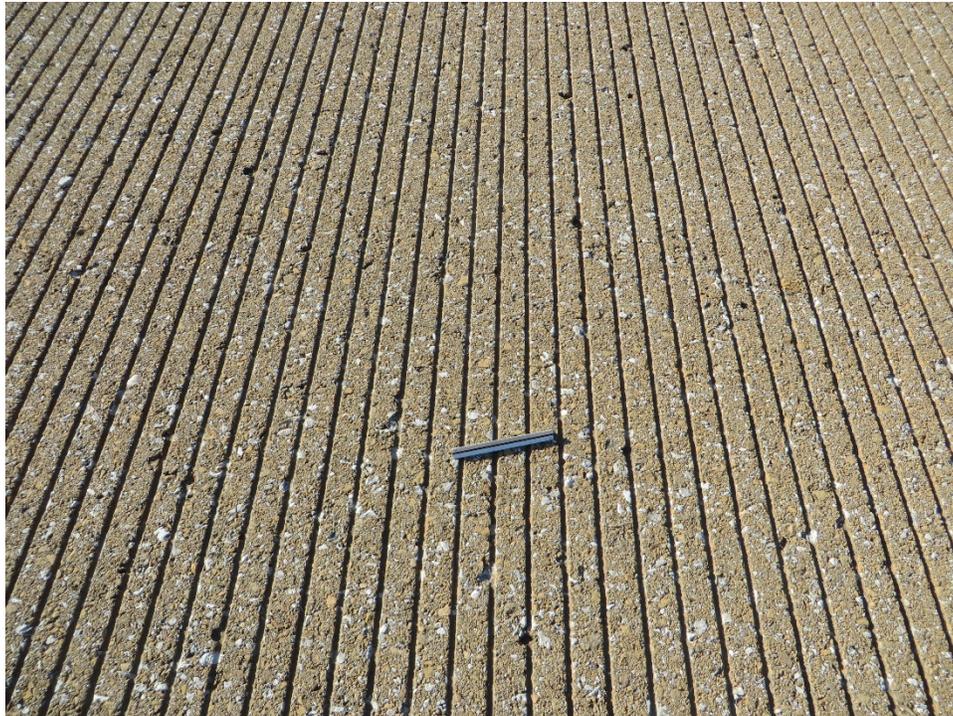
R18BR-02. Raveling (Sample Unit No. 03).

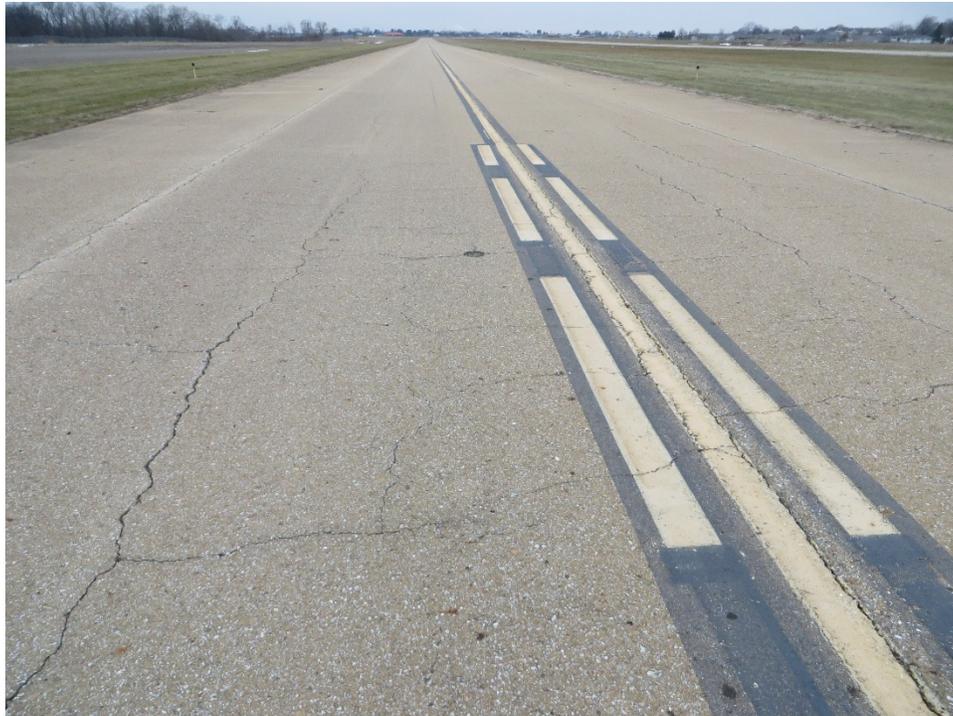
T01BR-01. Overview.

Taxiway 01 consisted of two sections located parallel to Runway 12/30. Section 01 was located west of Runway 18/36 and had low-severity block cracking, patching, raveling, and weathering recorded. Additionally, low- and high-severity L&T cracking, medium- and high-severity raveling, and low-severity swelling were recorded in additional sample units according to ASTM D5340-12. The low-severity cracking was unsealed. High-severity joint seal damage, low- and high-severity joint spalling, and low-severity small patching were observed in Section 02.

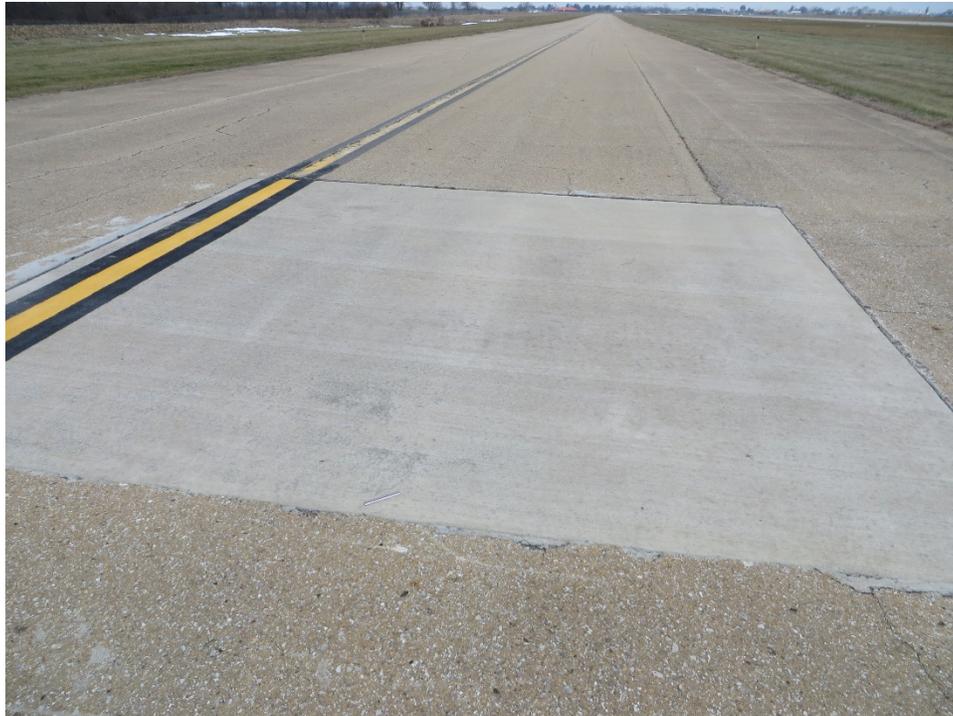
T01BR-01. Patching (Sample Unit No. 31).

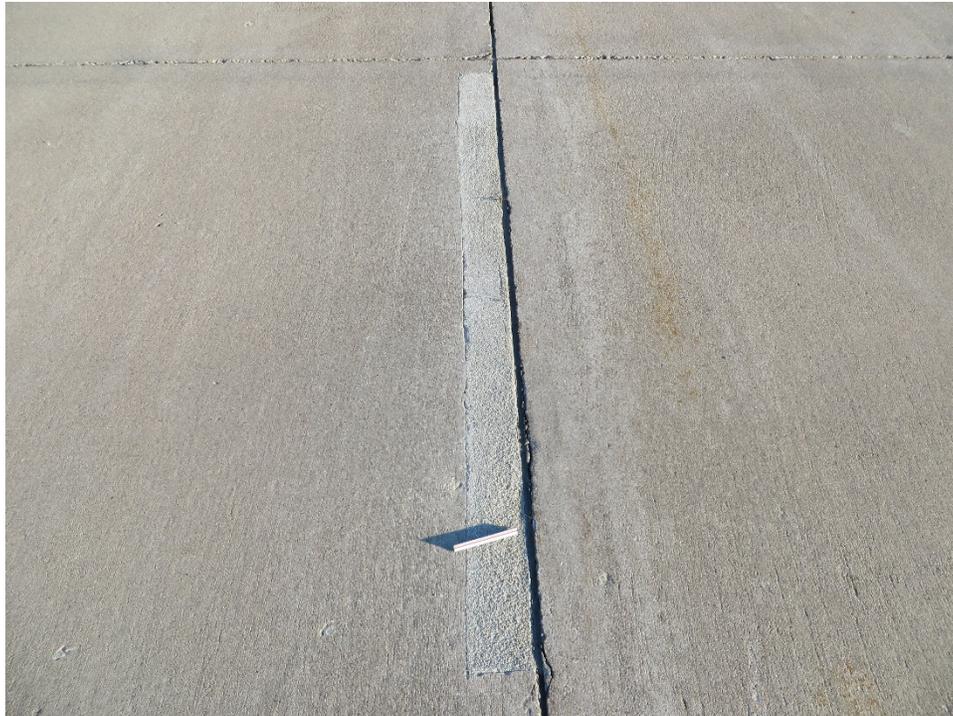
T01BR-02. Small Patching (Sample Unit No. 05).

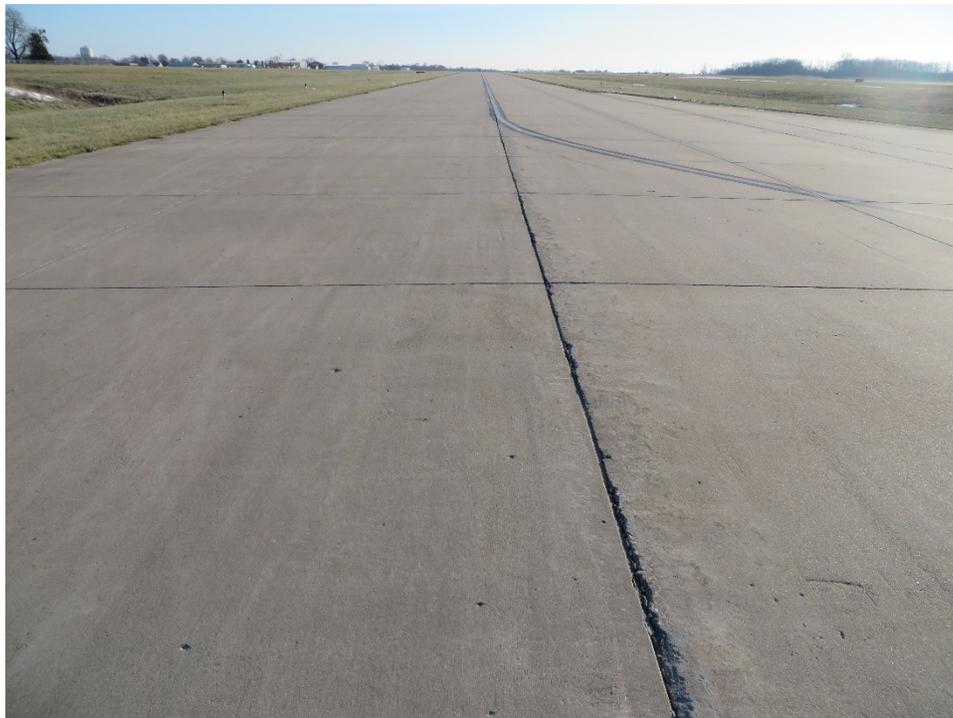
T02BR-01. Overview.

Taxiway 02 contained two sections. Section 01, located parallel to Runway 18/36 between Runway 12/30 and the Runway 18 approach, had low-severity corner break and faulting, high-severity joint seal damage, low- and medium-severity LTD cracking, and medium-severity corner spalling, joint spalling, and small patching identified throughout. Section 02, located parallel to Runway 18/36 between Runway 12/30 and the Runway 36 approach, had low-severity ASR and small patching, high-severity corner spalling, low- and medium-severity faulting, medium- and high-severity joint seal damage and joint spalling, medium-severity LTD cracking, and shrinkage cracking recorded.

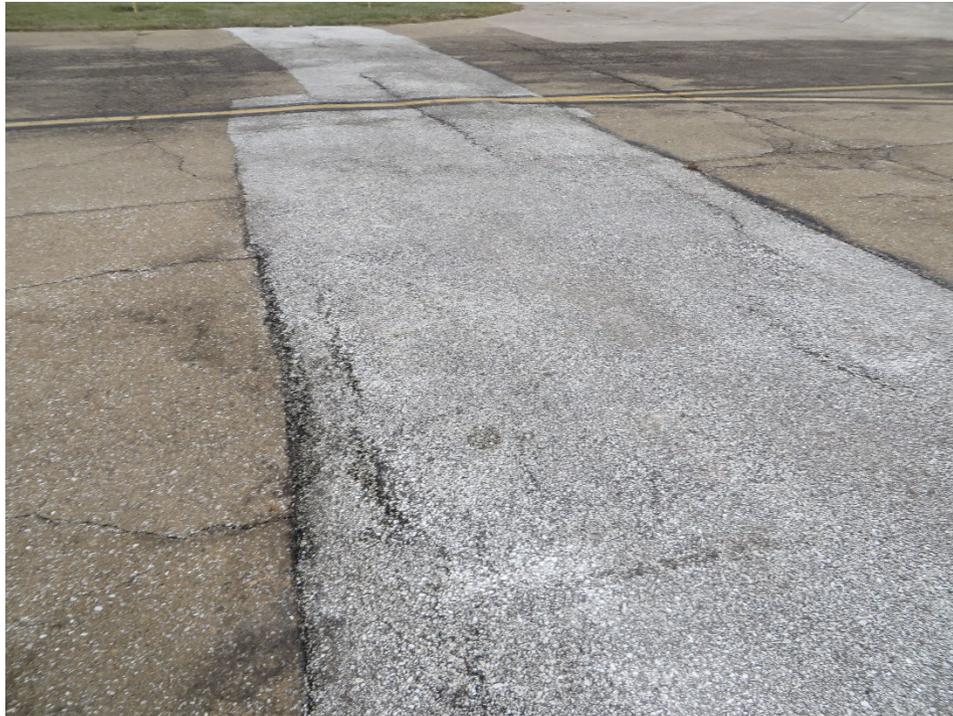
T03BR-04. Patching (Additional Sample Unit No. 07).

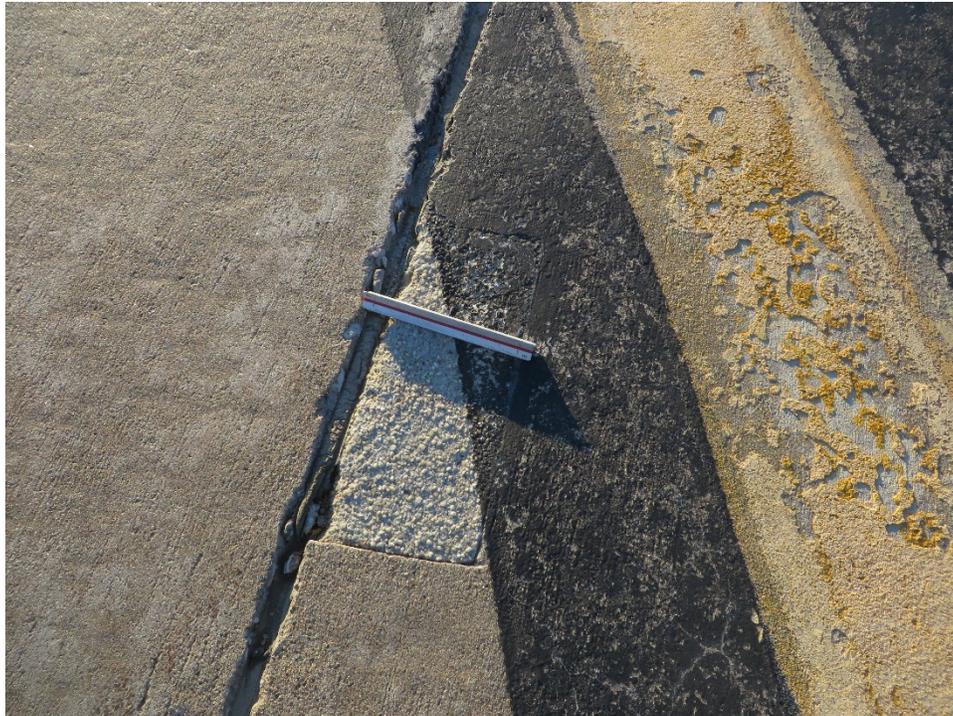
T04BR-01. Small Patching (Sample Unit No. 06).

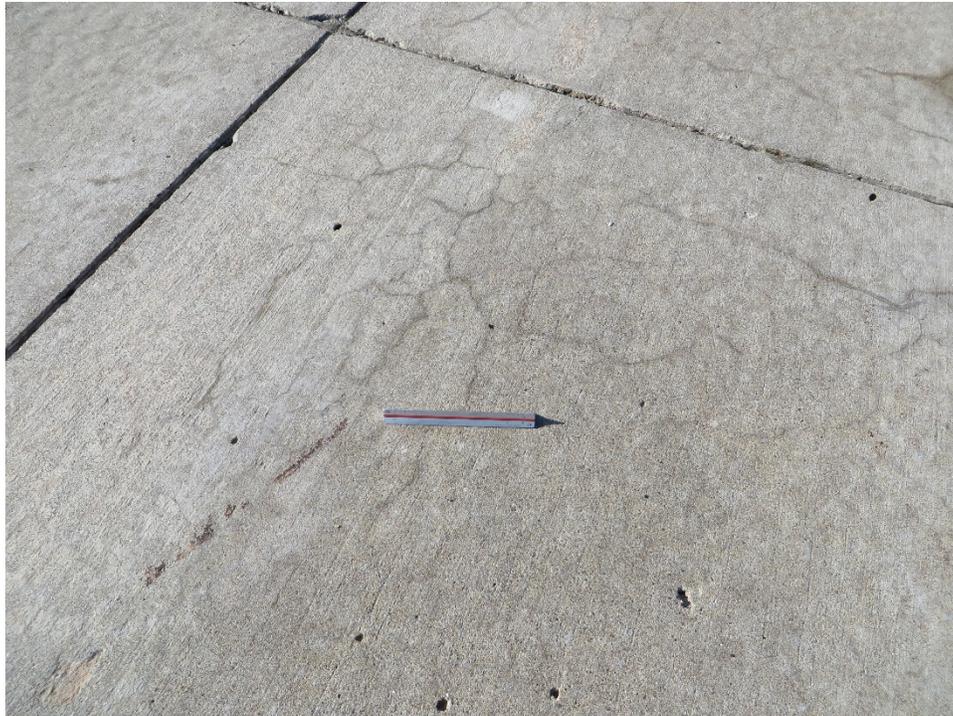
T05BR-01. ASR (Sample Unit No. 06).

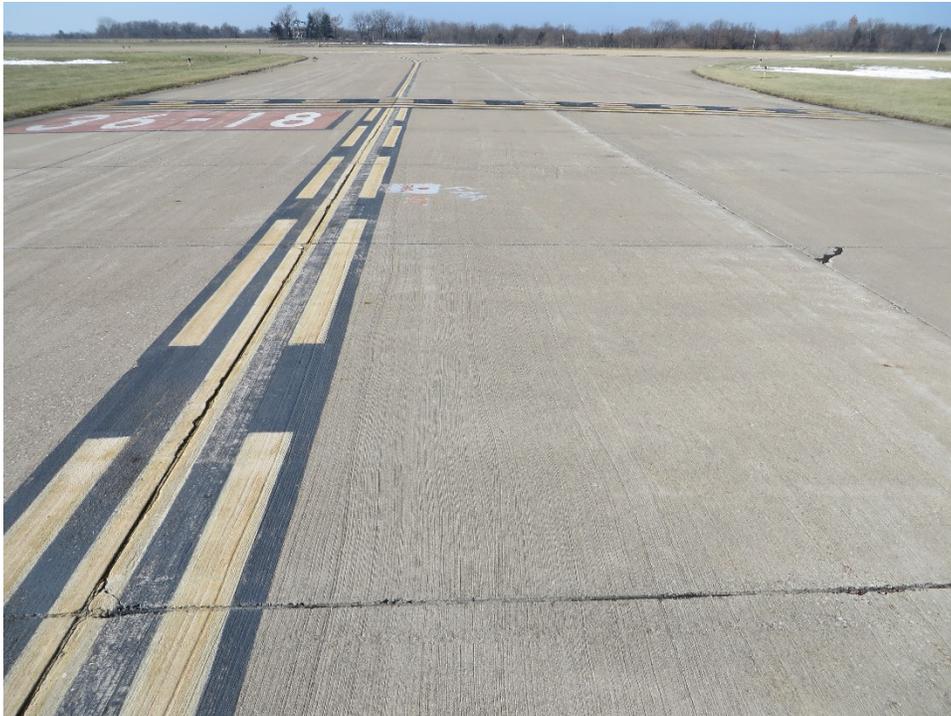
T06BR-01. Overview.

Taxiway 06 contained one section with low-severity ASR, all severities of corner spalling, high-severity joint seal damage, low- and medium-severity joint spalling, and shrinkage cracking recorded.

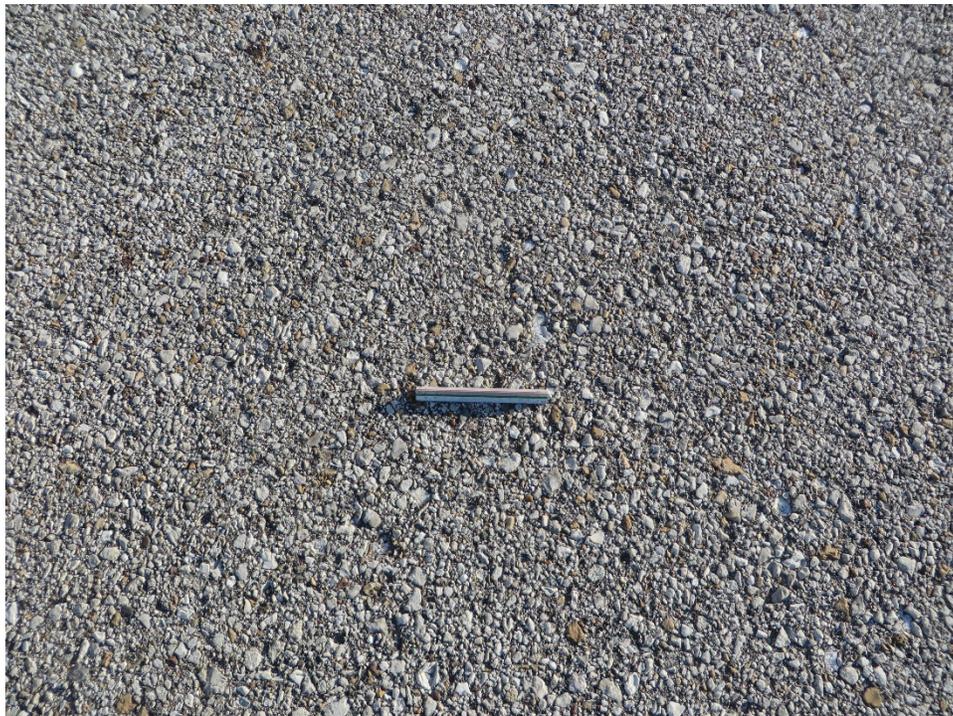
TH01BR-01. Raveling (Sample Unit No. 02).

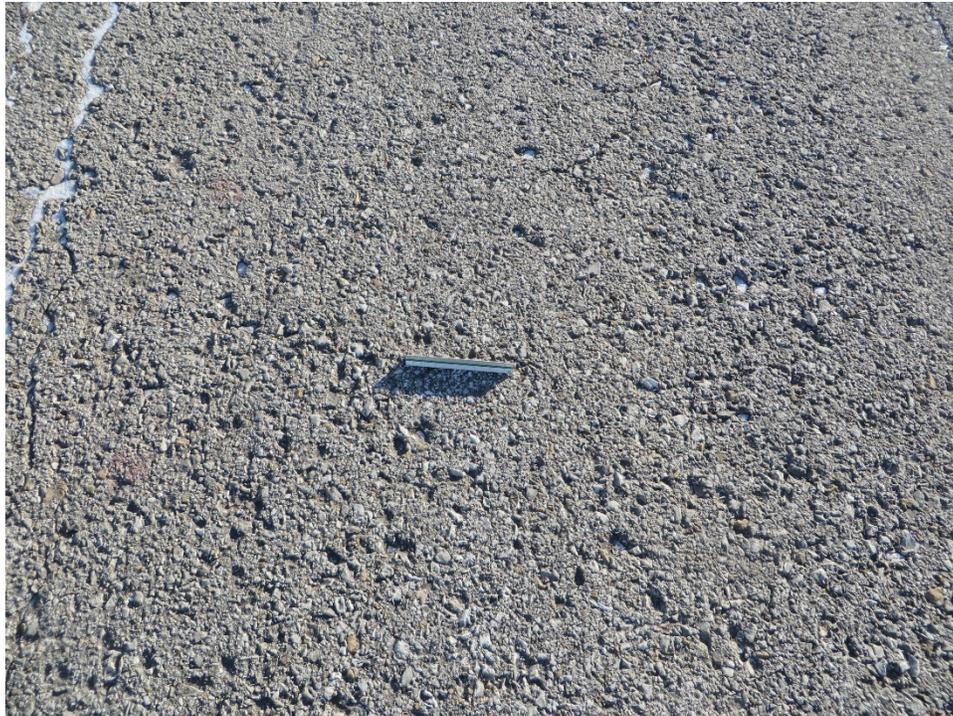
TH01BR-01. Raveling (Sample Unit No. 03).
