Keokuk Municipal Airport

Pavement Management Report

JULY 2024

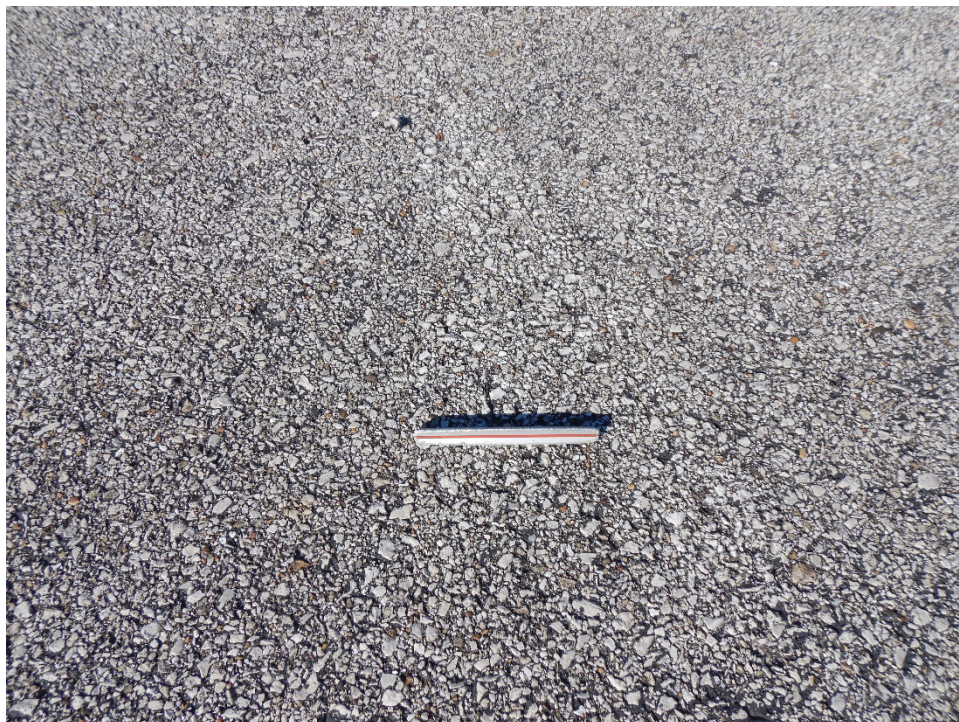
A01KE-02. Weathering (Sample Unit No. 08).

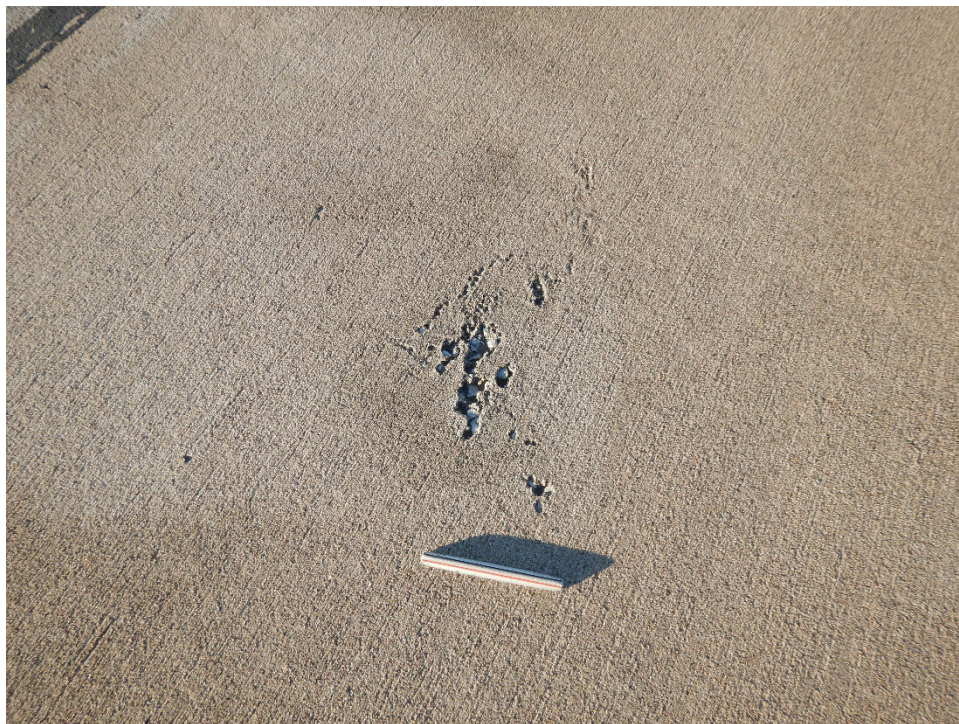
R08KE-01. Scaling (Sample Unit No. 054).

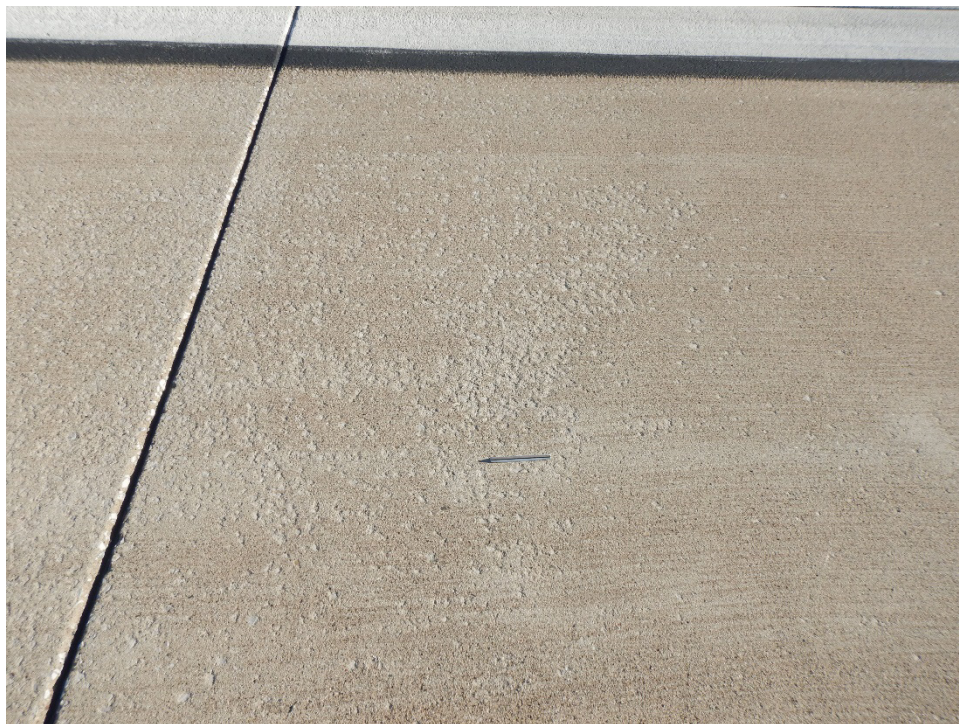
R14KE-04. Scaling (Sample Unit No. 01).

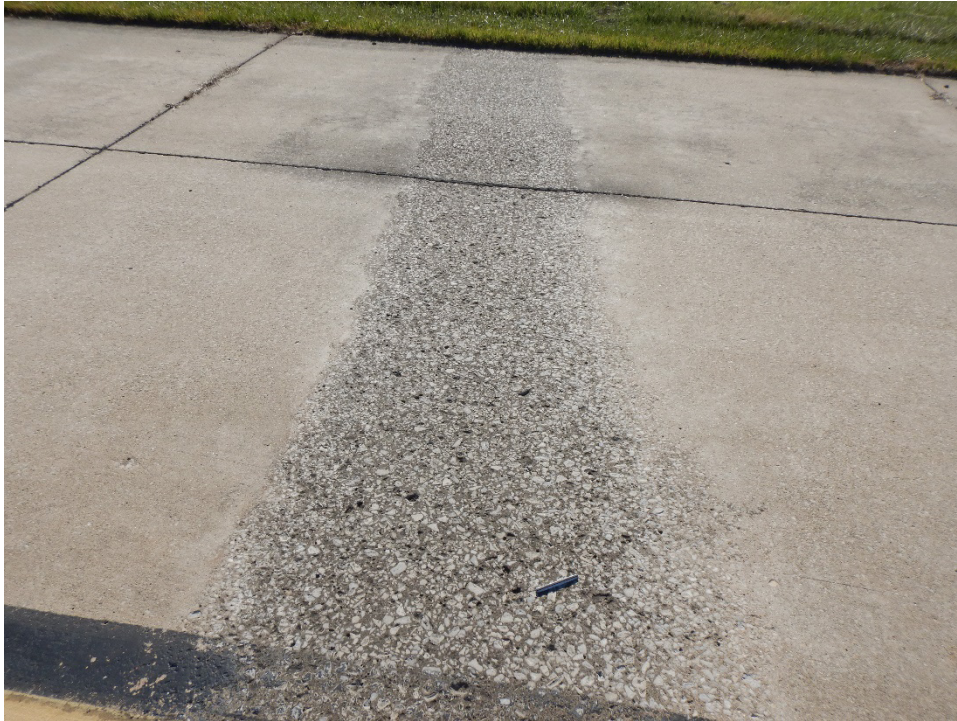
TBKE-01. Scaling (Sample Unit No. 06).

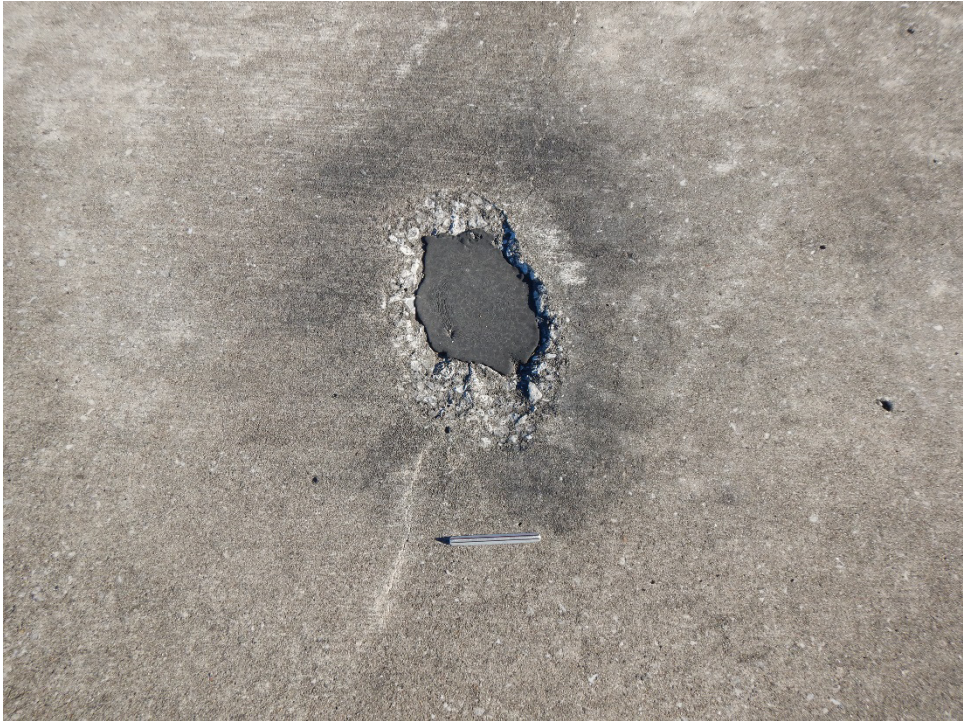
TCKE-02. Small Patching (Sample Unit No. 04).

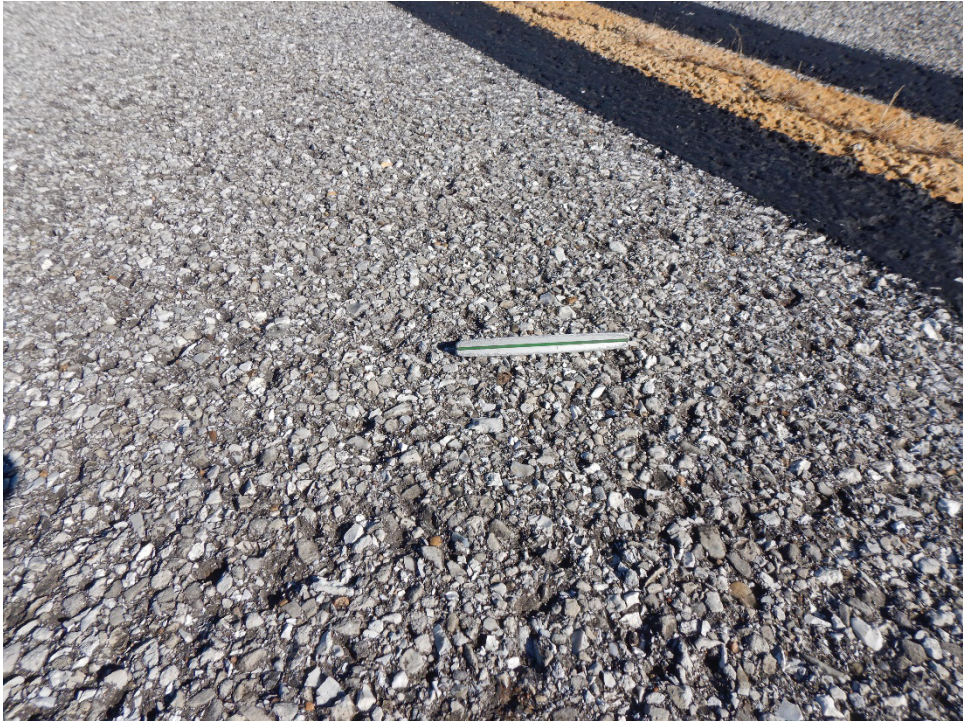
TEKE-01. Raveling (Sample Unit No. 04).
